STAR ONLINE PUBLICATION

Case Number: S1923000018

Symptom/Vehicle Issue: Water Leak From Front Or Rear Of Sky Slider Open Top

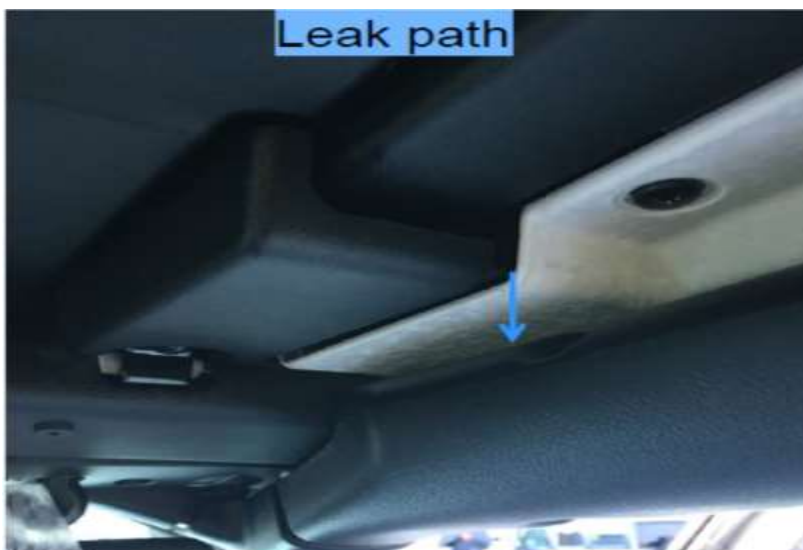
Discussion: A leak coming from the far corners (front or rear) of a Sky Slider could be the result of water leaking under the side seals. The side seals are sealed to the body with butyl. If the butyl is not “bedded” or sticking to both the seal and the body or if there is a skip/void in the butyl water could go under the seal and come in to the Jeep.

Fig 1 water leak path

To repair a front or rear corner leak see the below steps.

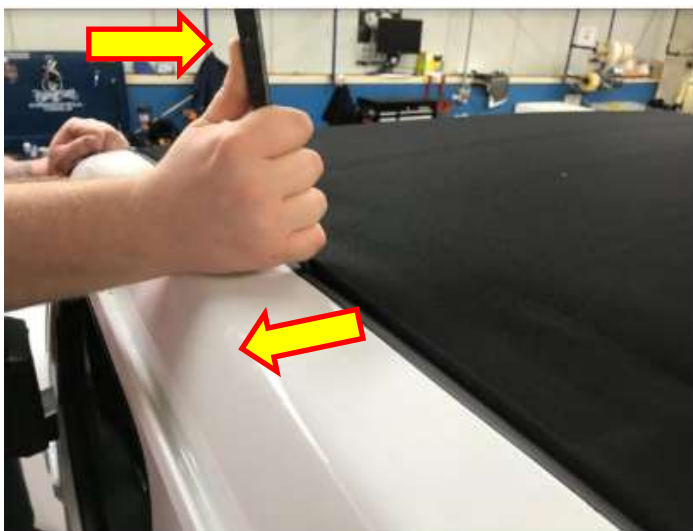
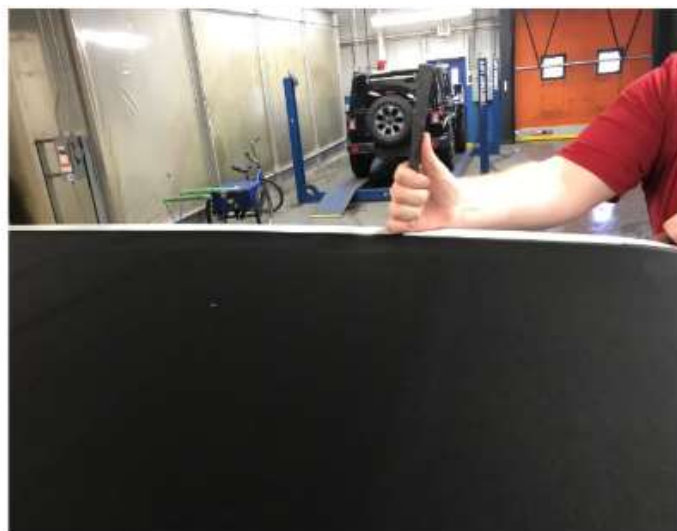
Fig 2 applying pressure to wet out (bed) the butyl.

1. Using a trim stick push the seal towards the body side. Insert the trim stick between the closed Sky Slider top cover and the seal (fig 2). Apply pressure outward pushing the seal against the outside of the roof. Work from front to rear making sure the butyl is wetted out (bedded) the full length of the seal. Then perform a water test to confirm a fix. If still leaking go to step 2. If water leak is resolved- return vehicle to the customer.

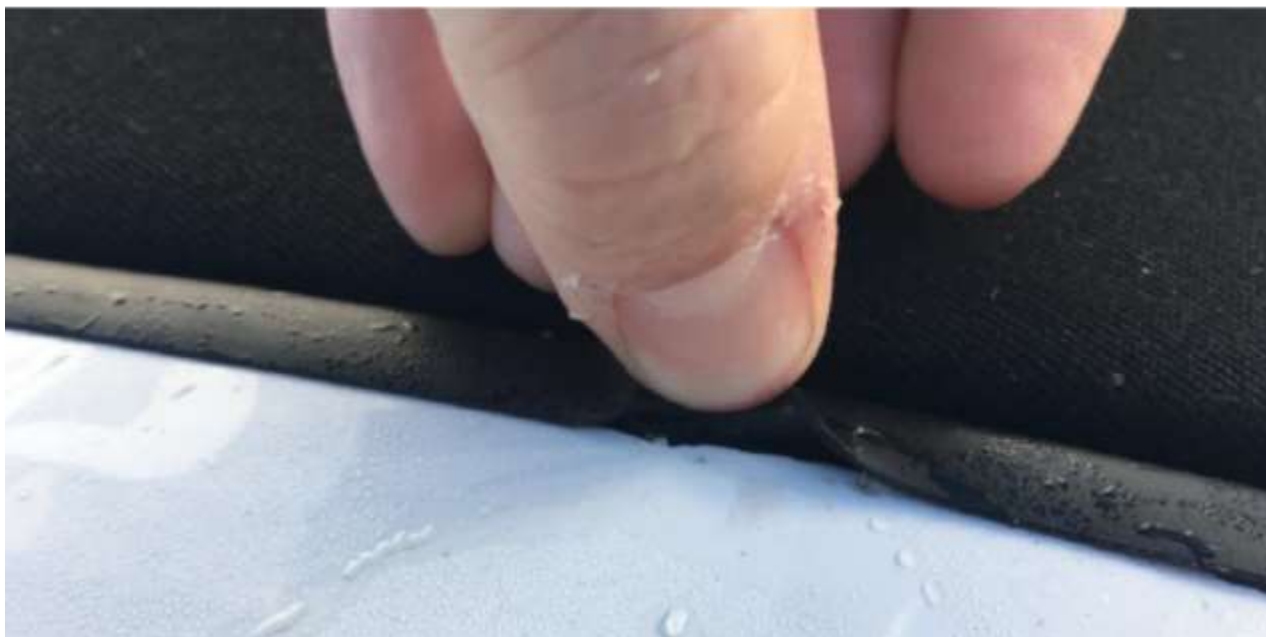
Fig 3 inspect for butyl void(s).

2. Roll the edge of the seal carefully up and inspect for voids in the butyl (fig 3). If any gaps are found, insert a small rope of butyl under the seal. Wet out (bed) the butyl using process in step 1.

3. Perform another water leak test.
