# SERVICE BULLETIN

Communication #: I-20-05

## SUBJECT: INCORRECT MANUFACTURING (MFG) DECAL (INT'L ONLY)

Indian Motorcycle has determined that some units were manufactured with a Manufacturing (MFG) decal and Certificate of Conformity (CoC) that has a typographical error. The affected decal must be removed and replaced with audit.

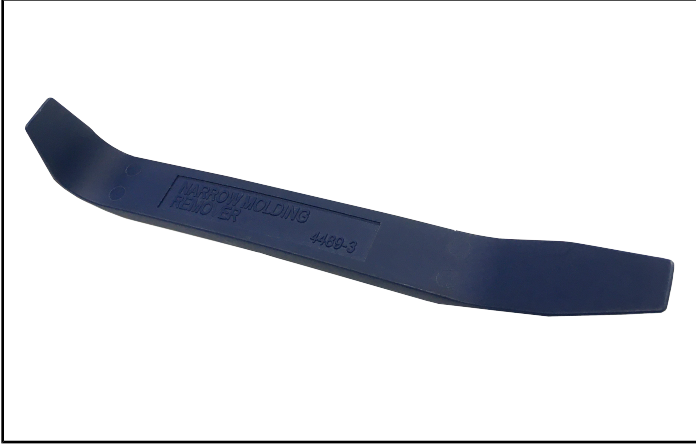
- Isopropyl alcohol
- Clean cloth or shop rag
- Scissors
- Plastic trim tool (shown below)

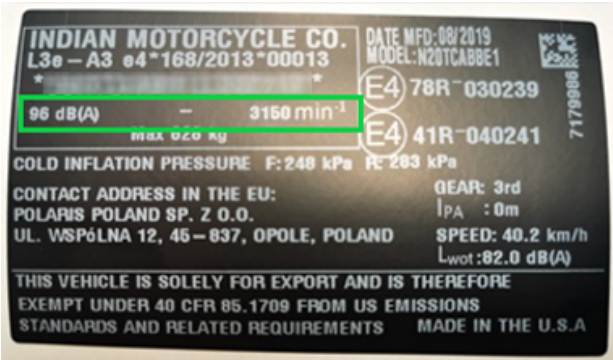
| MFG Decal | |
|---|---|
| GOOD | |

| MFG Decal | |
