GROUP <b>Chassis</b>	MODEL <b>All Applicable Models</b>
	NUMBER <b>PS675</b>	DATE <b>August 2020</b>

### SUBJECT: BRAKE CALIPER LEAK INSPECTION

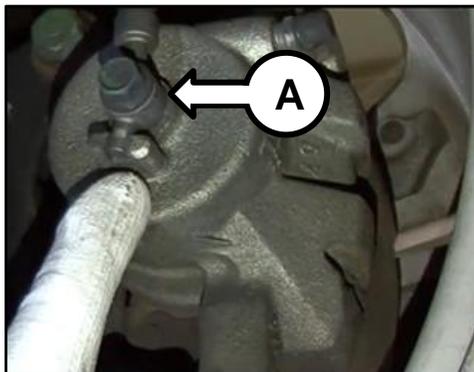
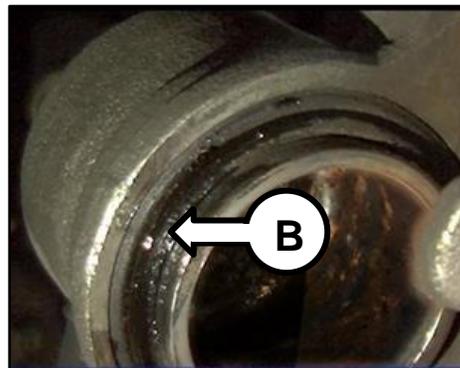
- Confirm where the suspected leak is originating from.
- If a leak appears from the eyebolt (A), replace copper gaskets, torque to specification and test for leak.
- If the oil appears to be from the caliper piston or piston boot (B), proceed to page 2.

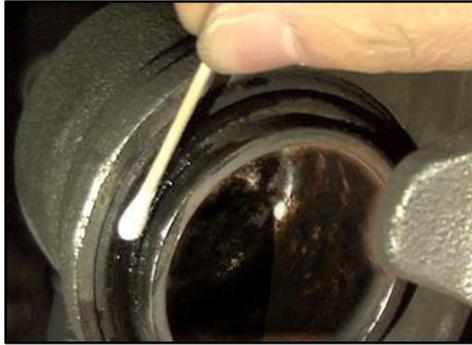
1. Obtain a large oil sample using the cotton swab from the suspect area.

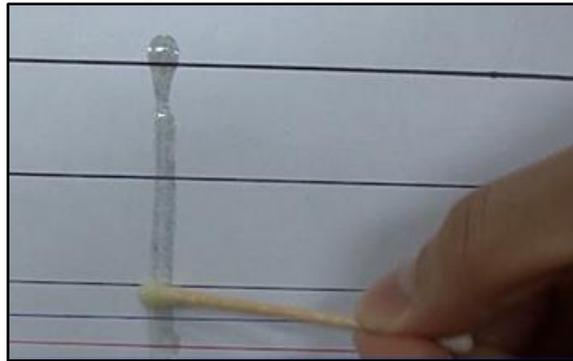
2. With the oil or water based pen, draw multiple lines going across the sheet of paper.
3. With the cotton swab containing the oil sample, wipe the fluid across the pen marks.

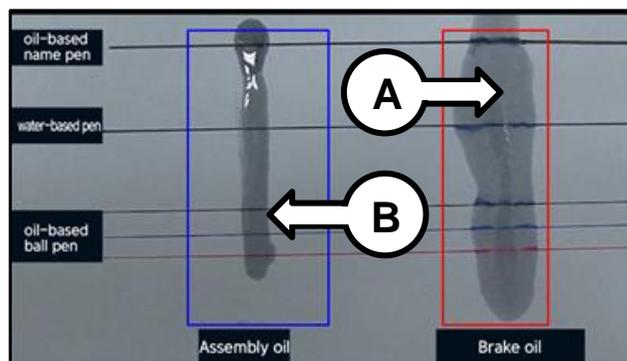
- A. If the pen ink smears it can be determined that the leak is brake fluid. Refer to the applicable repair procedure chapter in the applicable Shop Manual on KGIS.
- B. If pen ink does not smear it can be determined that the substance is excess assembly oil. Proceed to wipe clean any excess assembly oil using a clean shop towel.
