Spare Parts Requirements for Rear Window - Observe Additional Measure Required (132/20)

Vehicle Type: **Taycan (Y1A)**

Model Year: **As of 2020 up to 2021**

Subject: **Replacing rear windows**

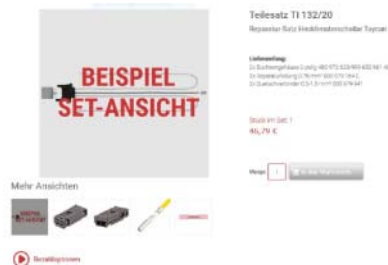
Parts kit TI 132/20

Items supplied:

- 2x plug socket, 2-pin 4B4 972 623/999 650 961 40
- 3x repair line, 0.75 mm² 000 979 164 E
- 3x crimp connector, 0.5-1.0 mm² 000 979 941

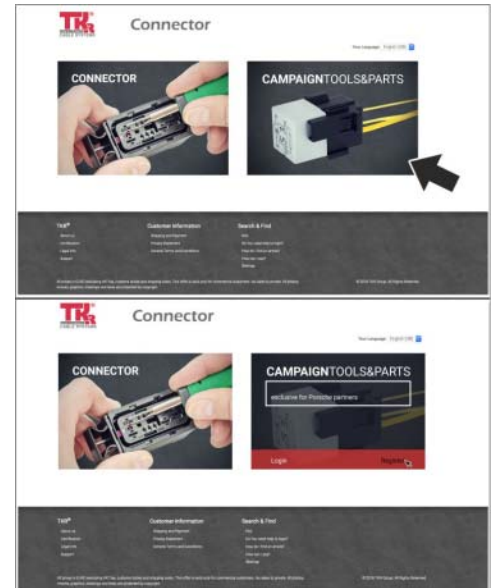
TKR Automotive GmbH online shop

Various search functions are available to help you identify the **parts kit for TI 132/20**, e.g. by entering the part number or using a graphic search function.

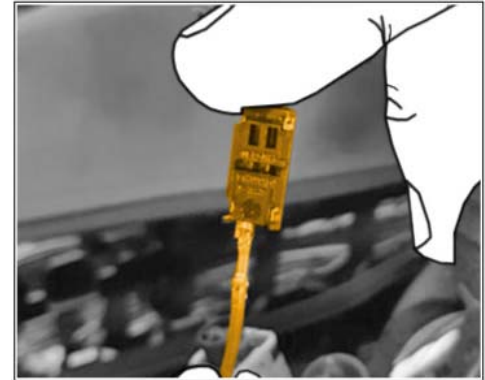
Connector housing

- 4 Insert line with plug contact in chamber 1 on the connector housing ⇒ *Connector housing* and check that the pin is installed securely in the connector housing by pulling on it.

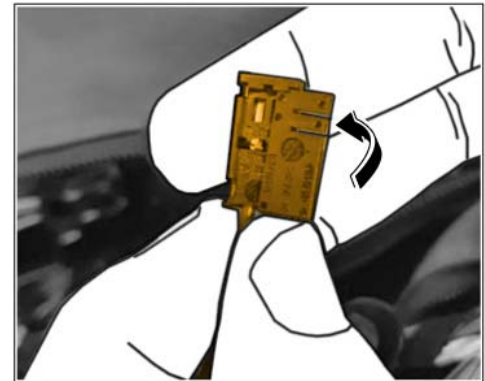
Closing connector housing

- 5 Close the cap on the connector housing ⇒ *Closing connector housing*.
- 6 Repeat steps 1 to 5 for the right side of the vehicle.
