ITS: 58848	
<b>SECTION:</b>	526 – Seats & Stanchions
<b>WRITTEN BY:</b>	Scott Geier
<b>SUBJECT:</b>	R & R Driver's Barrier Upper Door Frame Assembly

# ITS-58848

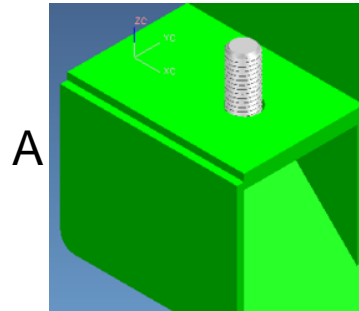
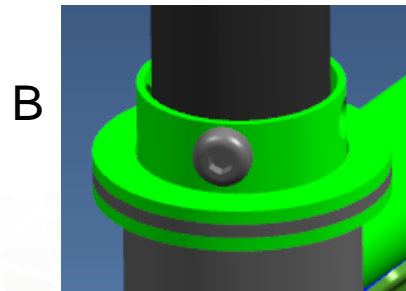
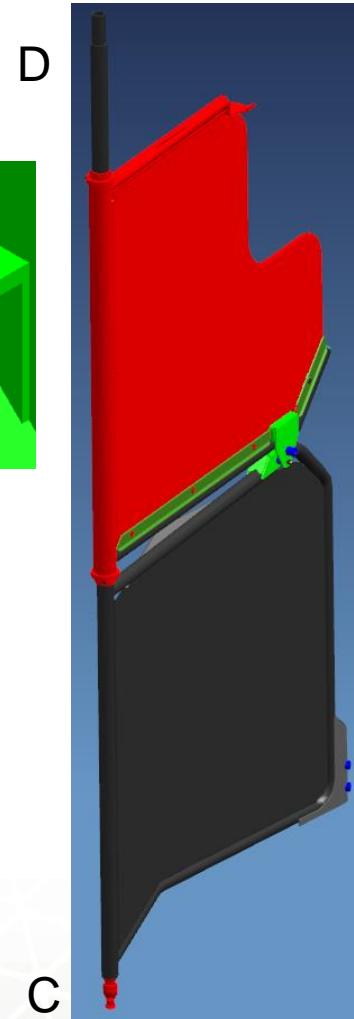
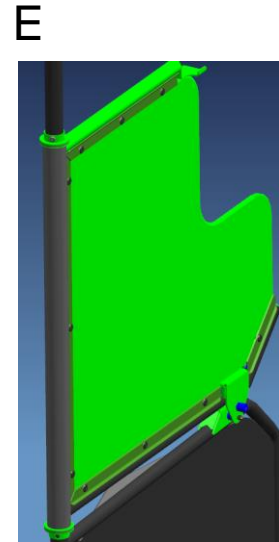
## MAJOR PART NOMENCLATURE

A - LOWER SUPPORT BRACKET  
B - 501245 COLLAR

C - 12mm INLINE BALLJOINT  
D - TOP PIVOT TUBE  
E - TOP FRAME AND BARRIER GLASS

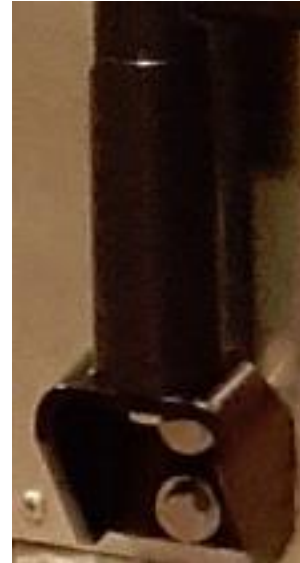
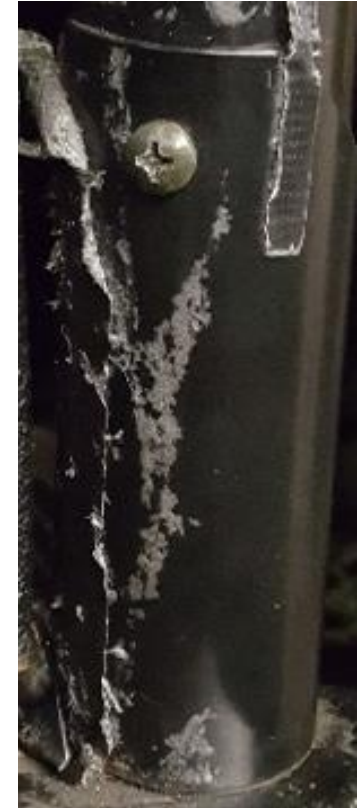
## Sequence 1: Sleeve Set Screw Removal

Remove the self tapping screw with the appropriate tool.

If the head of the screw is stripped or the screw is seized, use a cold chisel or pliers to remove.

When ready to reinstall the ball joint sleeve use a 5/32" bit to drill out screw. Install a new or equivalent self tapping screw (NF PN: 36S00012).

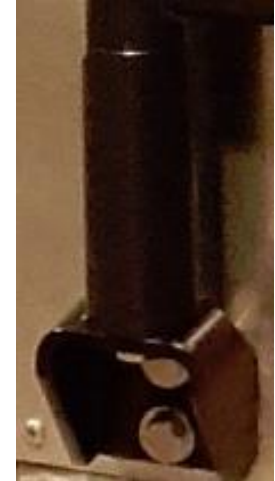
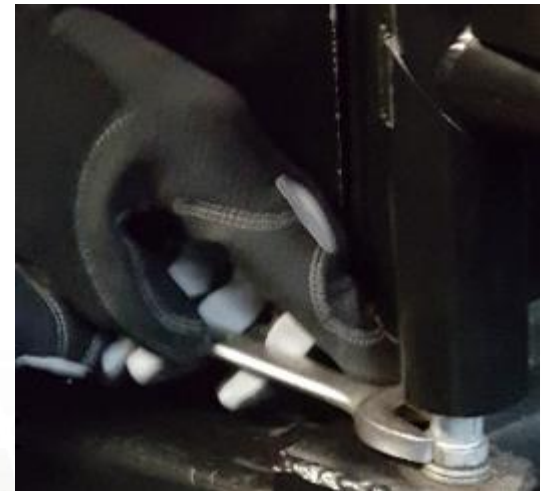
## Sequence 2: Loosen Ball Joint

With the ball joint tube-cover raised and out of the way, partially loosen the ball joint from the mounting bracket using a  $\frac{3}{4}$ " (19mm) or equivalent wrench. One to one and a half revolutions should suffice.

Observe the door mount flange for any looseness. Tighten as required.

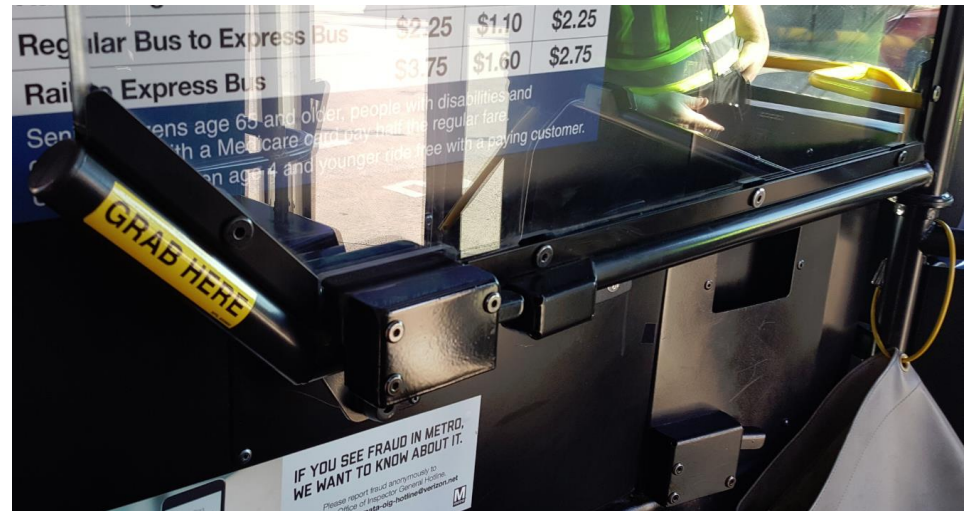
## Sequence 3: Barrier Glass Removal

Remove the 3/16" and 5/32" allen head bolts with the appropriate impact socket and ratchet. Remove the mounting brackets and set aside. Remove the glass from the frame and set aside. The glass may be stuck in the frame, use care to pry it out from the frame.

Care must be taken to not drop the glass out of the frame during disassembly.

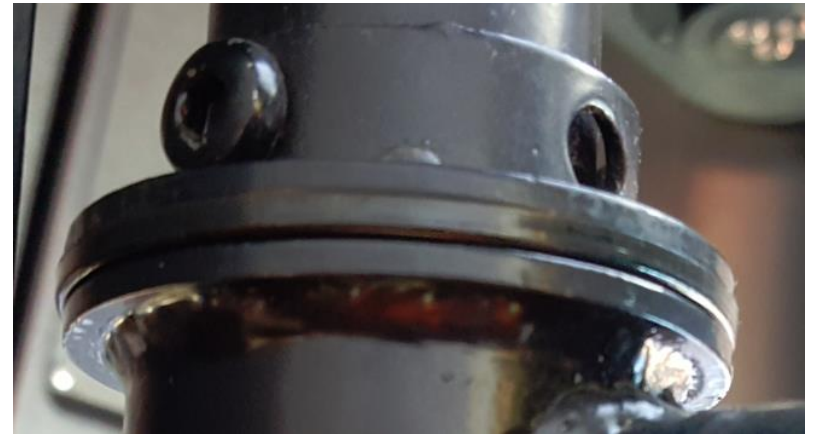
## Sequence 4: Upper Flange Removal

Remove the allen head bolts with a ratchet and place in a recycle bin.

Care must be taken to not strip out the head of the screw.

If the head of the screw is stripped this can be remedied after door removal, with the use of pliers.

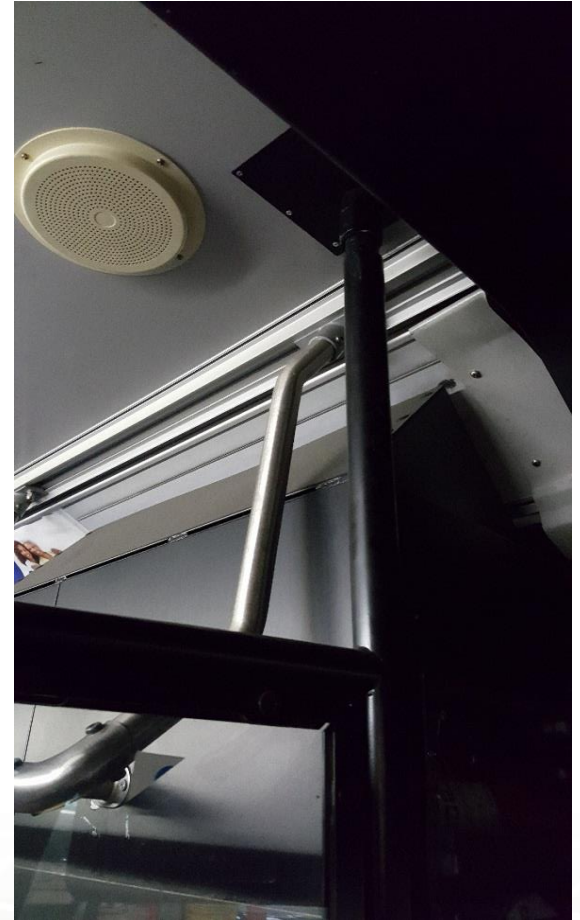
## Sequence 5: Remove Door

Once the previously loosened ball joint is removed from the support bracket, remove the top pivot tube from the ceiling flange. Again, have a partner support the door assembly during this operation.

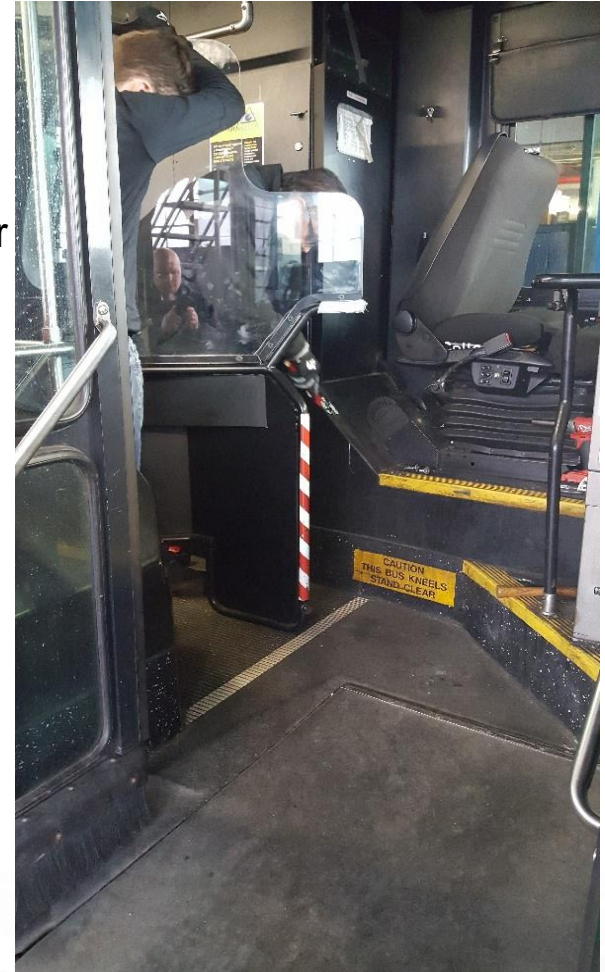
## Sequence 6: Set door aside and support.

The door assembly can be moved to a stable area on the floor of the bus for top frame removal. Remove the upper door flange and bushings for recycling.

The main barrier tube can be properly lubricated at this time for future reassembly.

Remove upper door frame and transport to a workstation along with glass and hardware for upper door reconstruction.

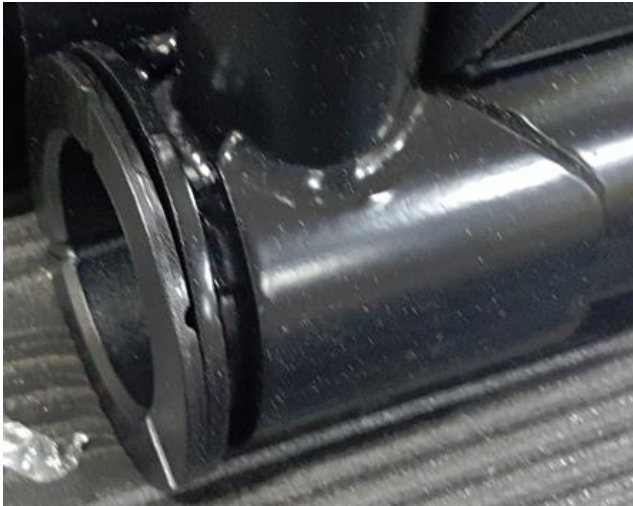
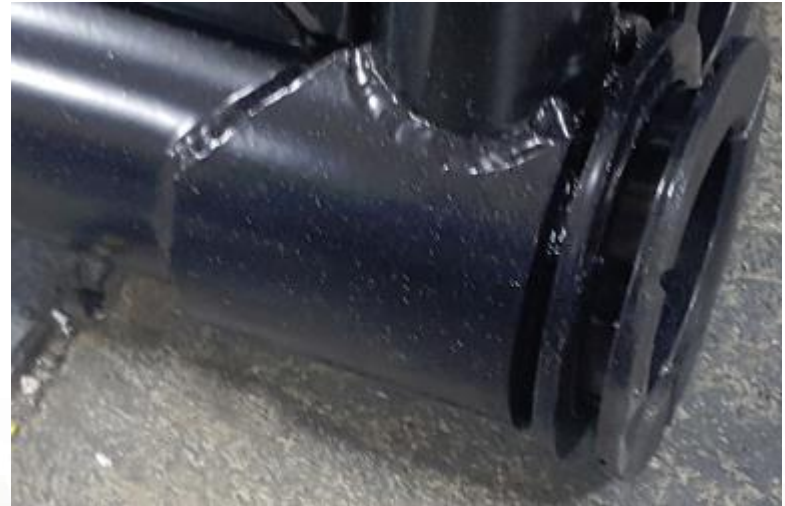
## **Sequence 7: Rebuild upper door with new upper frame.**

Reinstall safety shield on to the new upper door frame. Secure the safety shield using the existing 3/16" and 5/32" allen head bolts hardware. Apply 1-2 drops of Loctite (NF PN: 081034) on the thread and torque hardware to 80-88 in-lbs.

Install the new Delrin bushing (NF PN: 698035) to the upper and lower tube assembly.

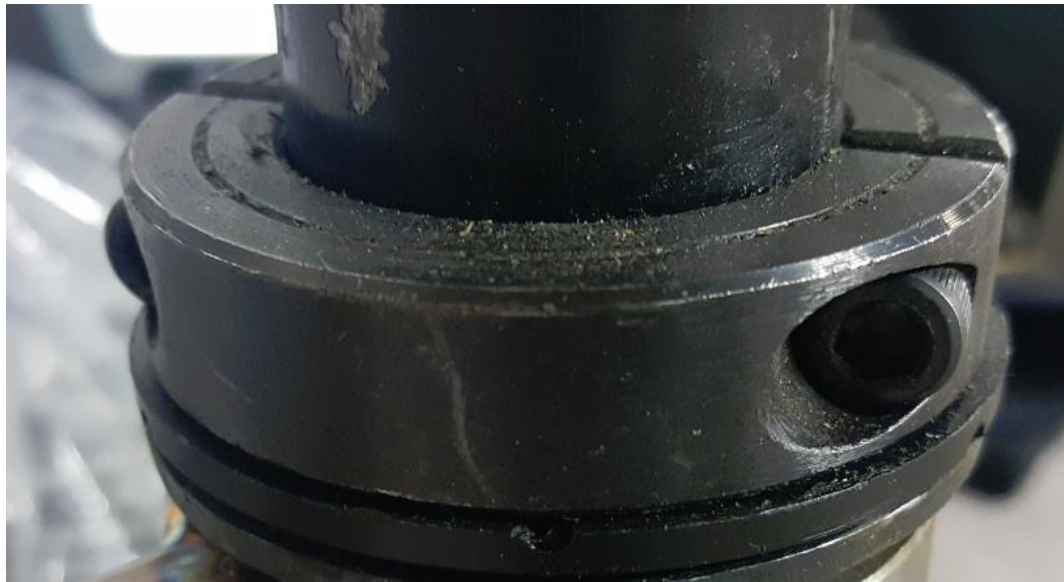
## Sequence 8: Replace Upper Door Assembly

Slide new assembled upper door onto existing lower frame. Insure proper Delrin bushing fit and install split ring collar (NF PN: 701428), leave collar loose.

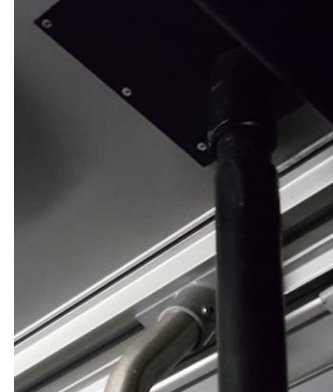
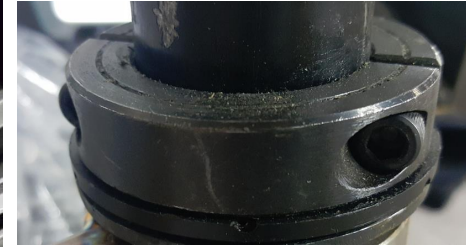
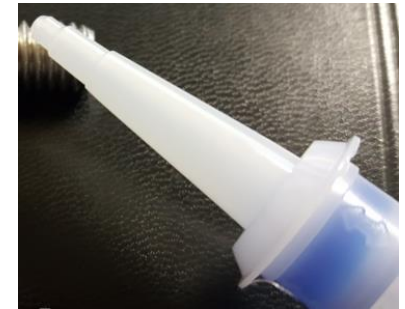
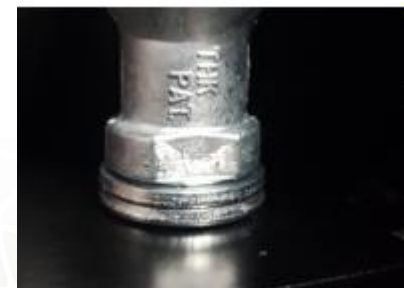
## Sequence 9: Re-attach barrier door.

Install the rebuilt door. Installation is the reverse of disassembly.

- Install main tube into upper ceiling mount. Insure the screws are tight on the cup mount to ceiling location.

**NOTE:** Upper and lower door assembly mounting hardware should be torque per installation drawing.

- Tighten split ring collar as required.
- Apply Loctite (NF PN: 081034) to the first few threads of the main bj bolt.
- Align ball joint, and reinstall with washers. Install main bj bolt and tighten to 5 ft-lb. of torque.

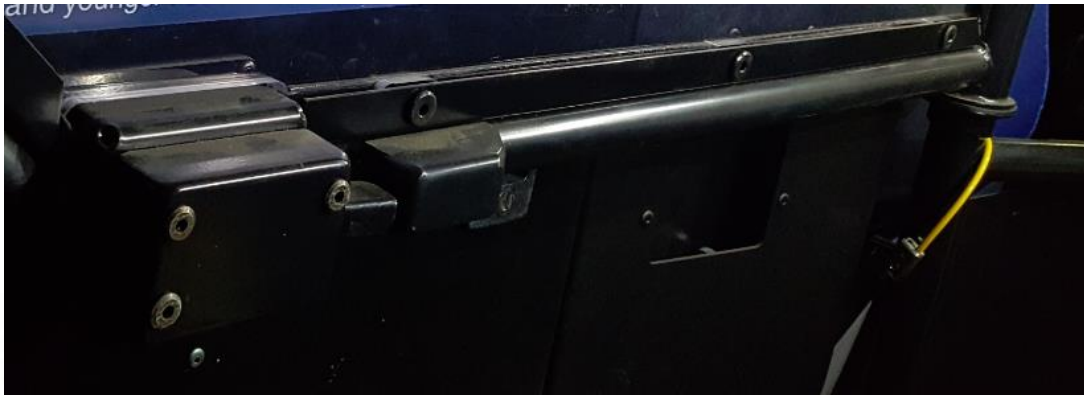
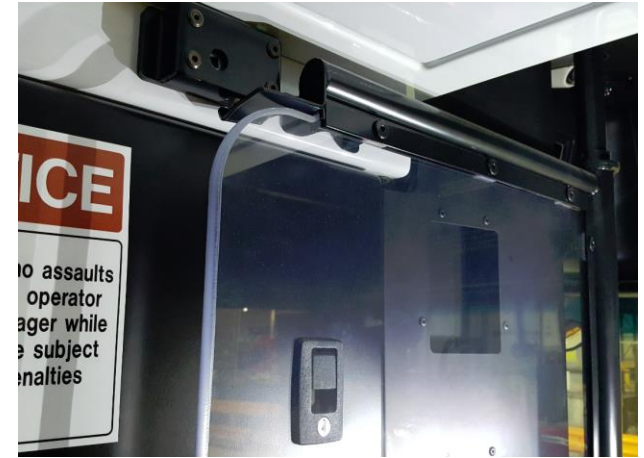
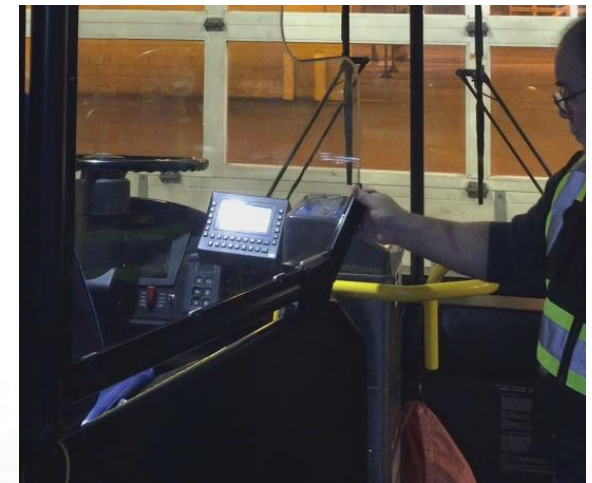
## Sequence 10: Adjust latches ensure smooth operation.

Swing upper door into the closed position behind the driver's seat, adjust the door tab up or down as required.

Swing entire door into the latched driver's position, adjust the door as required.

Open the upper door assembly and replace the latch cover.
