SERVICE BULLETIN

APPLICABILITY: All 2011MY+ Vehicles with FA or FB Engines **NUMBER:** 02-161-15R
SUBJECT: New Installation Procedure for Front Crankshaft Oil Seal **DATE:** 04/16/15
REVISED: 08/04/20

INTRODUCTION:

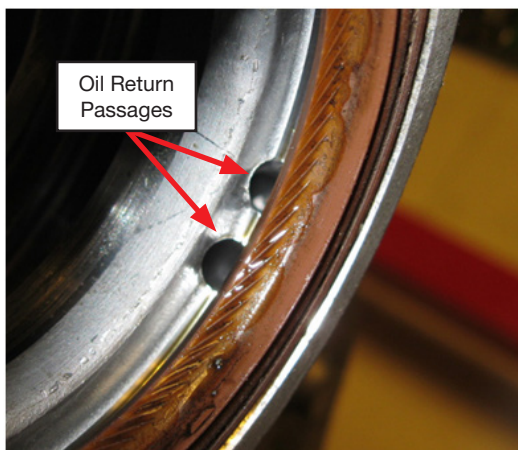
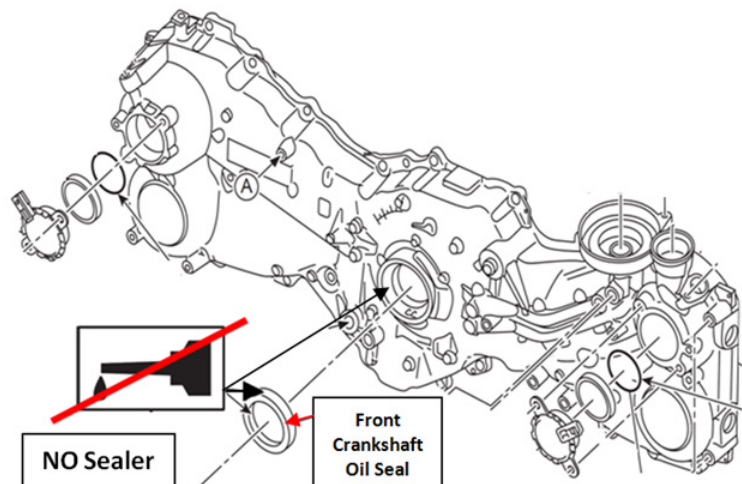
Follow the procedure supplied in the applicable Service Manual for accessing and removing the front crankshaft oil seal. To enhance retention of the oil seal and to eliminate any chance of blocking the oil return passages in the timing chain cover, make sure the seal bore in the cover is clean, dry and free of any fluids or contamination.

IMPORTANT: Do not apply any oil or sealer to the outside or inside of the seal or seal bore in the timing cover before installation.

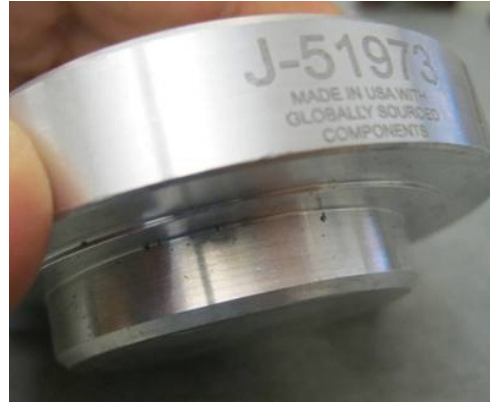
S/T# J-51973

When installing the seal into the timing cover, the proper seal installer must be used: S/T# J-51973.

NOTE: J-51973 replaces the SSTs called for in the service manual (41399FG020 and 398437700).

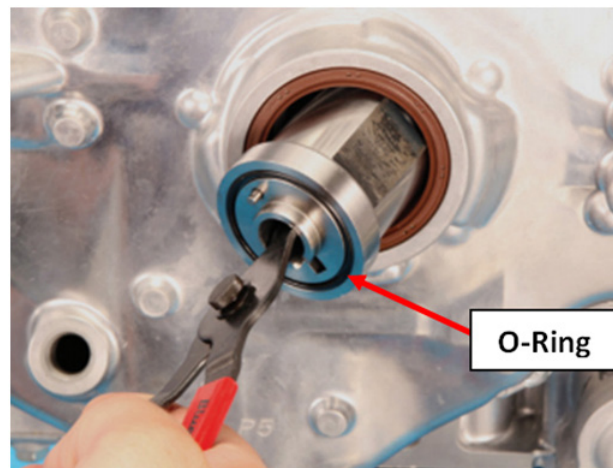
REMINDER: Whenever removing the crankshaft extension, the o-ring on the extension must always be replaced during reassembly as it is a **one-time use** part.

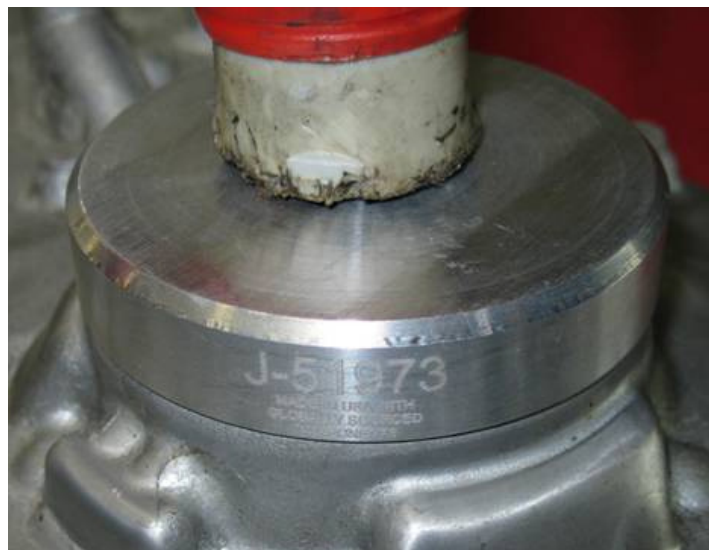
CAREFULLY tap the new oil seal into position flush with the face of the timing cover as shown in the photo below using a plastic hammer and the specified installation tool.

TIP: Use a piece of cardboard against the radiator cooling fins as extra protection against damage from the hammer.
