**APPLICABILITY:** 2000 – 2014MY Legacy and Outback  
 2003 – 2007MY Baja  
 2001 – 2018MY Impreza  
 2013 – 2018MY Crosstrek  
 2001 – 2018MY Forester  
 2015 – 2017MY WRX

**NUMBER:** 03-82-18R

**SUBJECT:** Clutch Release (Throw-Out) Bearing-Design Change

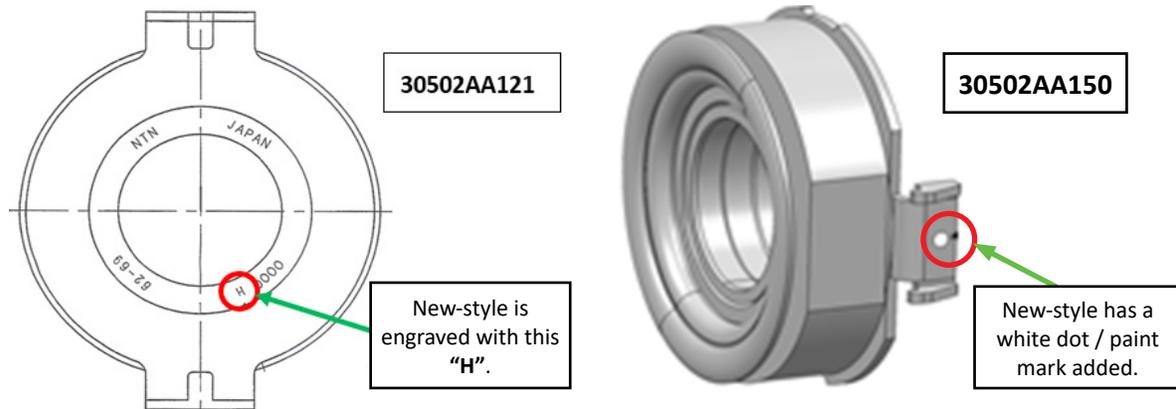
The new release bearing part numbers are **30502AA121** and **30502AA150**. Always order the most updated part number based on the specific VIN. Comparison images for identification purposes are supplied below.

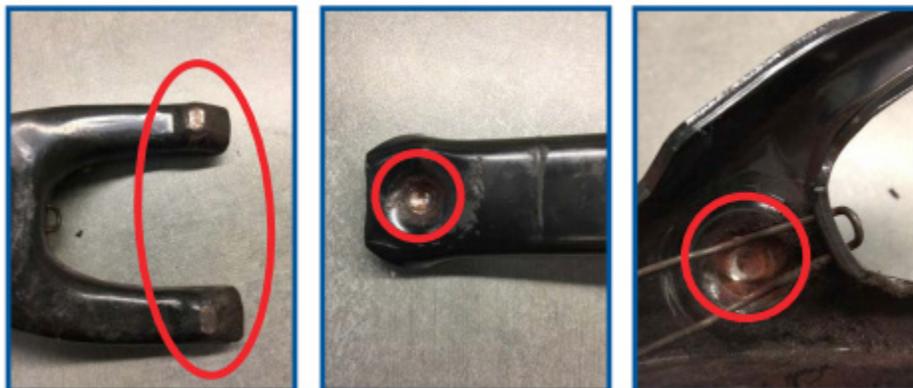
- To avoid customer concerns of a post-repair creaking, squeaking or clicking sound possibly accompanied by increased pedal effort (stiffness) when operating the clutch pedal, always thoroughly clean, inspect for signs of wear and re-lubricate the clutch release components. Any worn components identified should be replaced. For example: see the photos below which show excessive wear on areas of the release fork which was the root cause of a squeaking sound heard while the engine was running.

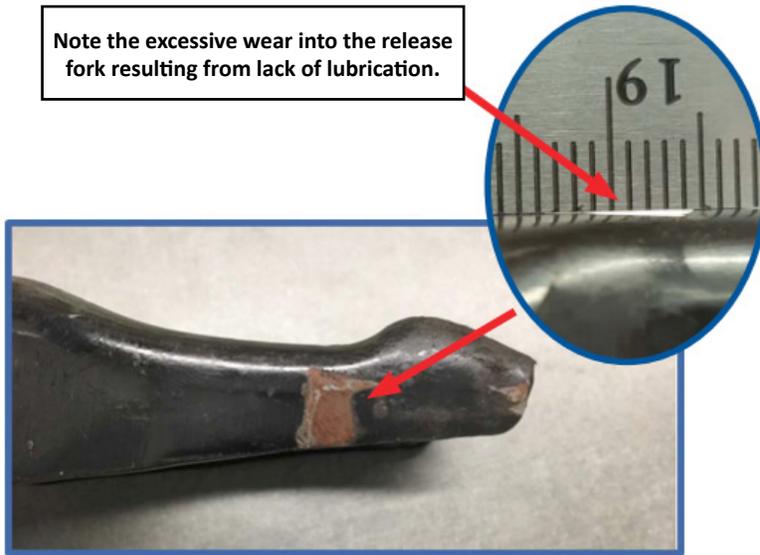
Note the excessive wear into the release fork resulting from lack of lubrication.

- Cleaning the transmission case surrounding the clutch assembly is also necessary to prevent dirt or debris from contaminating the lubricant and interfering with release lever or bearing operation.
- Where applicable, the release lever (fork), shaft, pivot ball / stud, ends of the operating cylinder rod, release bearing contact points on both the release lever and pressure plate along with the input shaft splines should all be properly lubricated with the grease specified in the Service Manual (Nichimoly N-130, Conoco-Philips Multiplex Red #2 or Subaru p.n. 000041000) then checked closely for smooth operation before reinstalling the transmission. It is also important to apply the grease **sparingly** as shown below, especially on the transmission input shaft splines to avoid grease contamination of the clutch disc's friction material.
