Technical Service Bulletin

Topic	Brake noise identification
Market area	Bentley: worldwide (2WBE),Hongkong-Macau (5HK)
Brand	Bentley
Transaction No.	2052785/5
Level	EH
Status	Released for publishing
Release date	Aug 3, 2020

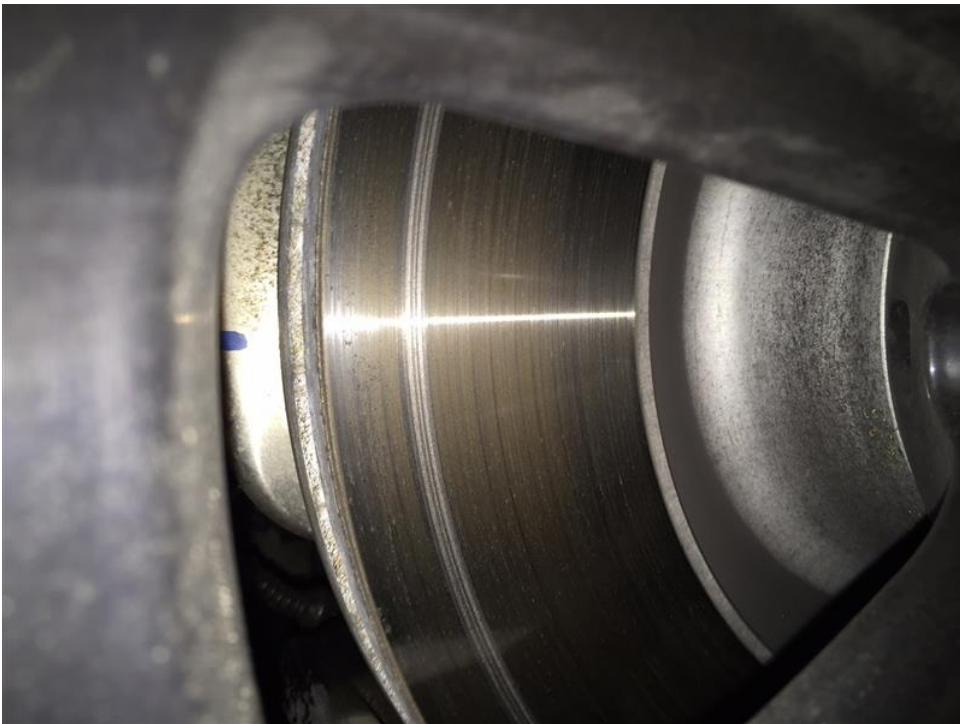
Figure 2

6. Discs have a groove in them (Figure 2)

1. Check the overall condition of the brakes to determine if the brake noise can be attributed to one of the causes listed in the *Technical Background* section of this TPI. If the noise is not a result of one these causes, proceed with point 2.
2. Record the noise and frequency

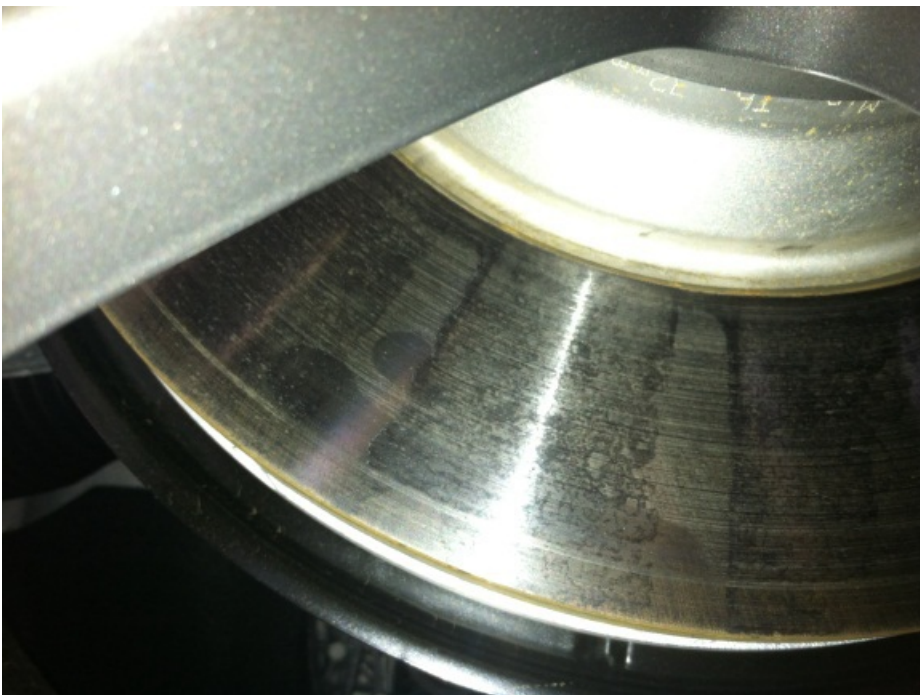
Figure 3

7. There is chemical contamination on the braking surface of the disc due to a wheel or tyre cleaner being sprayed directly onto the disc (Figure 3).

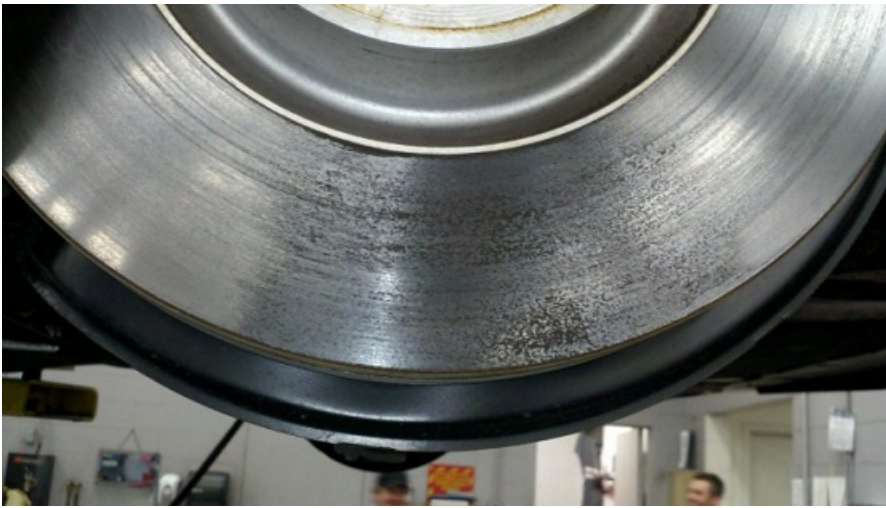
Figure 4

8. There are 'pad marks' on the brake disc as a result of the brake pad material transferring to the discs. This can occur when a vehicle has been stood for long periods of time in a wet or snowy environment (Figure 4).
