SAFETY RECALL BULLETIN

| SUBJECT: | | No: SR-20-003REV_2 | |
| CROSSMEMBER CORROSION - SAFETY RECALL CAMPAIGN | | DATE: August 2020 | |

This bulletin provides directions for inspection and repair of affected vehicles' Crossmembers.

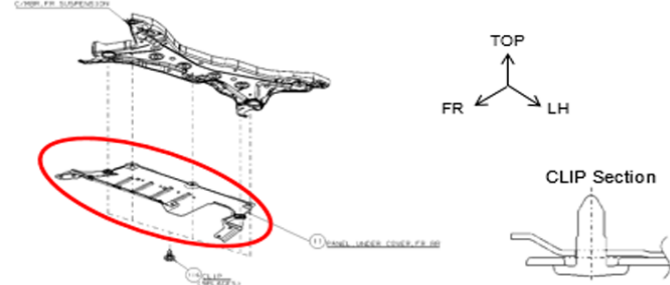
| <ul style="list-style-type: none"> • 08-13MY Outlander (L4 Engine) • 11-16MY RVR • 08-10MY Lancer | <div style="border: 1px solid black; padding: 5px; margin-top: 10px;"> <ul style="list-style-type: none"> • 5370A311 (PANEL, UNDER COVER, FR RR) • 5370B840 (PANEL, UNDER COVER, FR RR) : RVR 13-16MY ONLY • MR328954 (CLIP) 5pcs </div> |

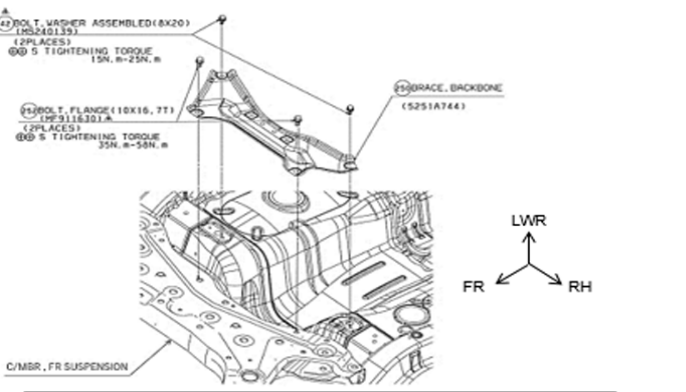
| <ul style="list-style-type: none"> • 08-10MY Lancer(only) | <p>• Taking off Brace, Backbone</p> <div style="border: 1px solid black; padding: 5px; margin-top: 10px;"> <ul style="list-style-type: none"> • 5251A744 (BRACE, BACKBONE) • MS240139 (BOLT, WASHER ASSEMBLED (8X20)) 2pcs • MF911630 (BOLT, FLANGE(10X16)AS-ROLLED) 2pcs </div> |

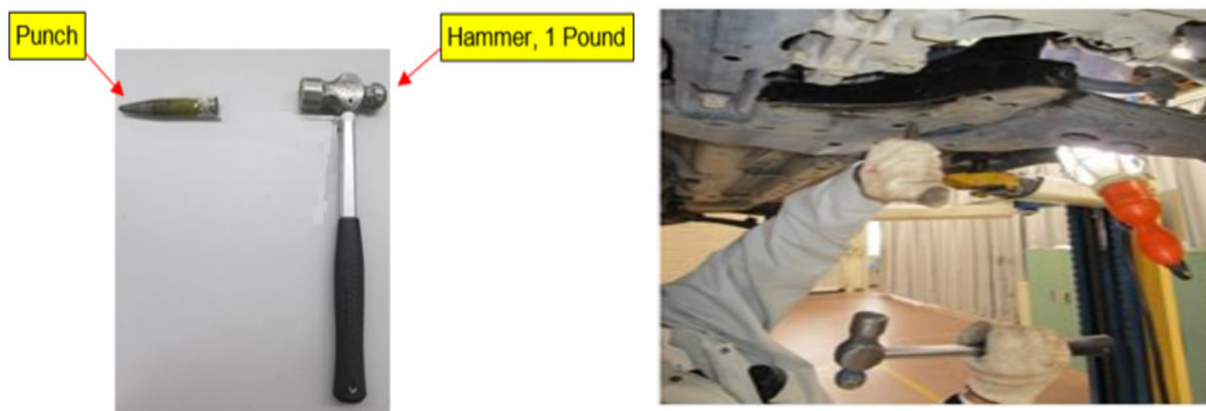
5. Inspection by punch testing.
 - a. Prepare punch and hammer.

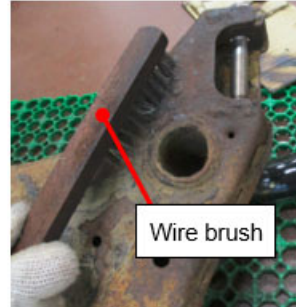
NOTE: Crossmember removed from vehicle for illustration purposes only, in the photos below.

<Before rust removal>

<After rust removal>

6. Clean the Crossmember and remove rust without removing the Crossmember from the vehicle.
 - a. Remove any dirt, mud and water from outside and inside of the Crossmember by using compressed air.
 - b. Remove loose rust and rust scales from the external surface of the Crossmember by using a scraper, chisel, or flathead screw driver.

- c. Remove any remaining rust or dirt from the Crossmember by using a wire brush until the surface is smooth and clean.
- d. Visually inspect the Crossmember during the rust removal process. If rust perforation is found, proceed to the Crossmember replacement.

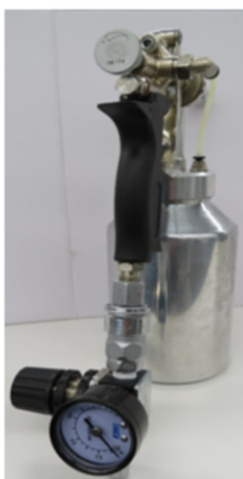
- c. Remove the cap on the gun container and fill with anti-corrosion agent.
- d. Attach the air regulator and hose to the gun.
- e. Adjust the discharge and fineness adjustment knob.

| Discharge adjustment knob | | Open from fully closed position 3 turns. |
| Fineness adjustment knob | | Open from fully closed position 2 and 1/4 turns. |
| Compressor air pressure | | 51 PSI (350 KPa) (in summer) to 71 PSI (490 KPa) (in winter) Never exceed 71 PSI |

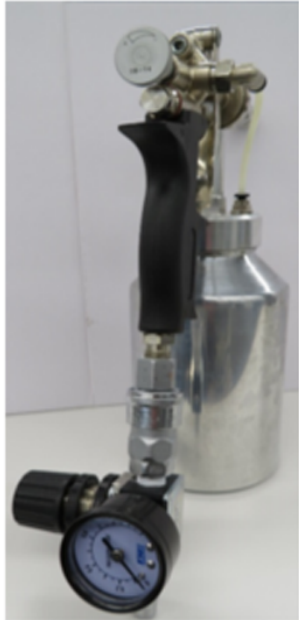
- c. Remove the cap on the gun container and fill with anti-corrosion agent.
- d. Attach the air regulator and hose to the gun.
- e. Adjust the discharge and fineness adjustment knob.

| Discharge adjustment knob | | Open from fully closed position 4 and 1/2 turns. |
| Fineness adjustment knob | | Open from fully closed position 1 turn. |
| Compressor air pressure | | 51 PSI (350 KPa) (in summer) to 71 PSI (490 KPa) (in winter) Never exceed 71 PSI |

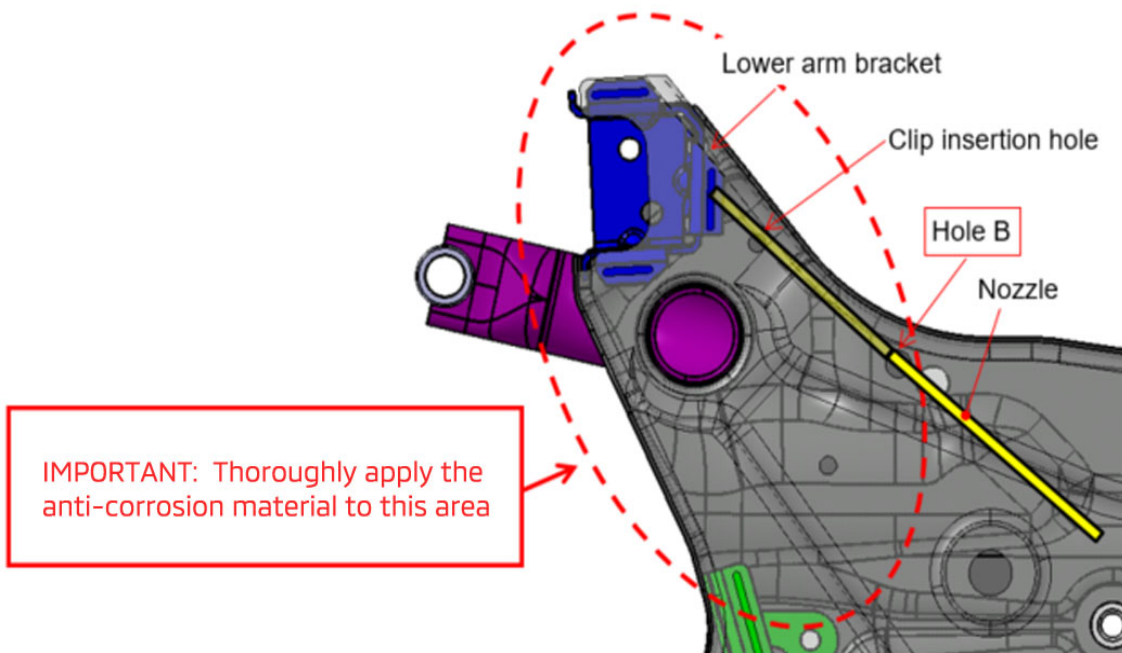
b. Spraying into the Hole B (RH) / B' (LH)

- Insert the nozzle through Hole **B (B')** in the direction shown below until it contacts the lower arm bracket (Insertion length: 100mm or 4 inches). Confirm that the nozzle has been fully inserted in the correction direction by looking in the clip insertion hole.
- Apply **MZ341024EX** fully by engaging the trigger fully at this position for 10 seconds and continue spraying while removing the nozzle, which should take another 10 seconds.

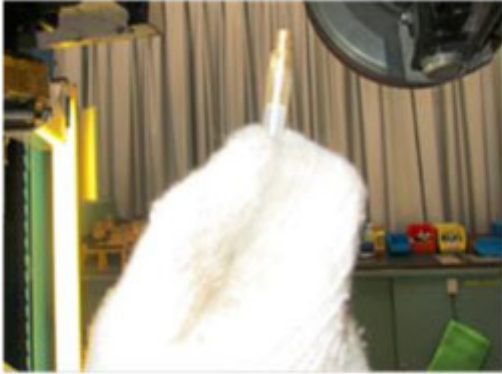
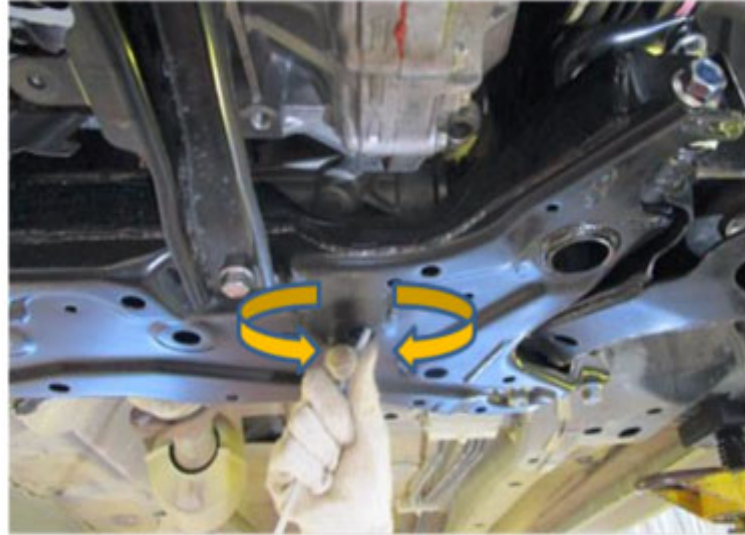
c. Spraying into the Hole C (RH) / C' (LH) and D

- Insert the nozzle through the Hole **C (C') or D** upwards (Insertion length: 25 mm or 1 inch).
- Apply **MZ341024EX** fully by engaging the trigger fully and continue spraying while moving the nozzle in a circular motion for 10 seconds at each hole.

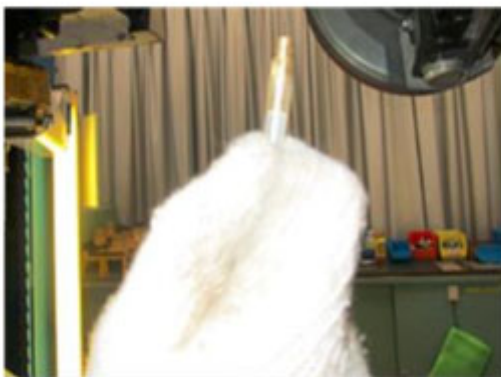
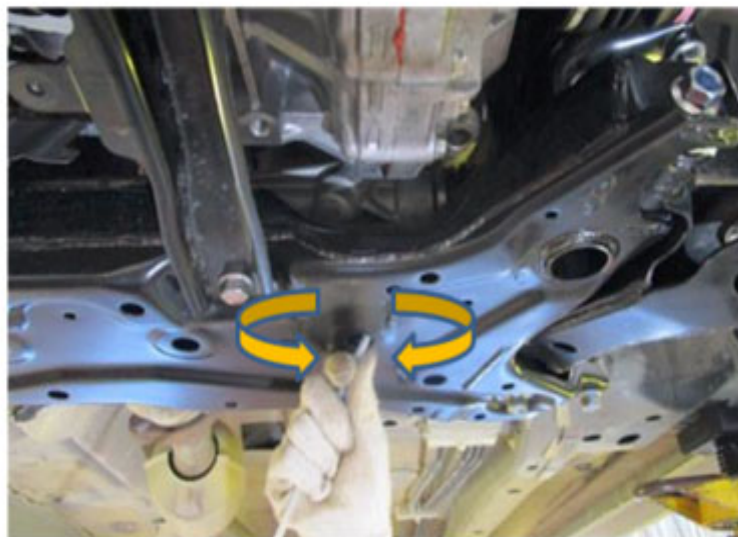
f. Spraying into the Hole C (RH) / C' (LH) and D

- Insert the nozzle through the Hole **C (C') or D** upwards (Insertion length: 25 mm or 1 inch).
- Apply **MZ321015 (used in Canada)** by engaging the trigger fully and continue spraying while moving the nozzle in a circular motion for 10 seconds at each hole.

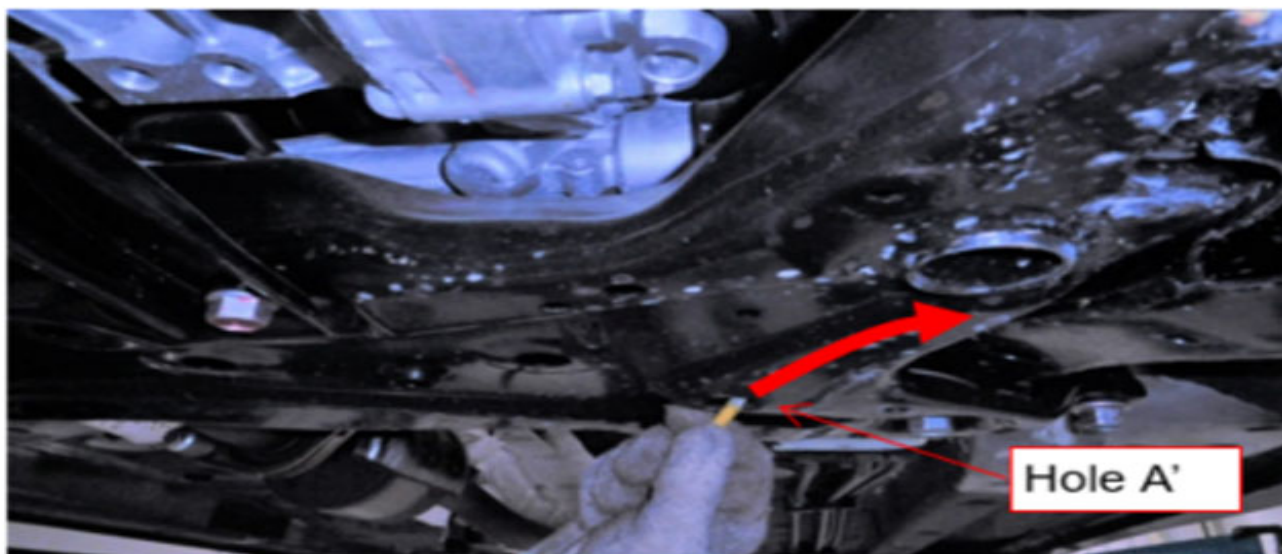
g. Spraying into the Hole A (RH) / A' (LH)

- Insert the nozzle through Hole **A(A')** in the direction shown below until it contacts the lower arm bracket (Insertion length: 180mm or 7 inches). Confirm that the nozzle has been fully inserted in the correct direction by looking in the opening of the lower arm bracket.
- Apply **MZ341024EX** by engaging the trigger fully at the position demonstrated below and confirm the **MZ341024EX** leaks out of the opening of the lower arm bracket. Continue spraying while removing the nozzle, which should take 10 seconds.

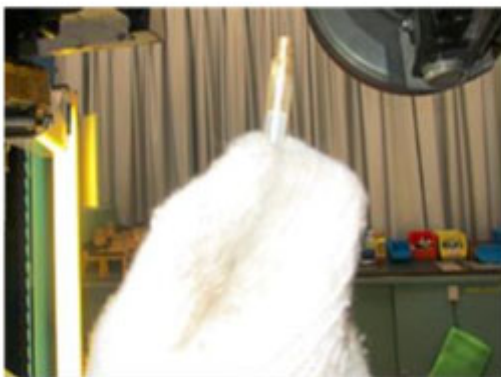
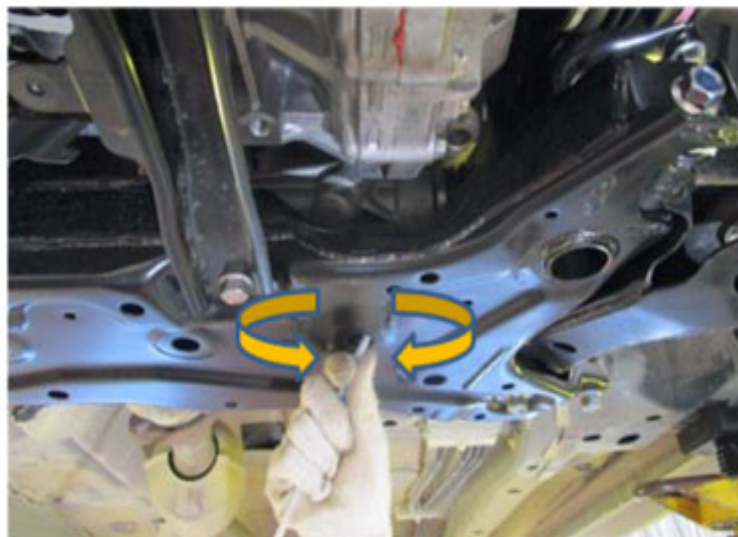
- i. Spraying into the Hole C (RH) / C' (LH) and D
- Insert the nozzle through the Hole **C (C')** or **D** upwards (Insertion length: 25 mm or 1 inch).
 - Apply **MZ321015 (used in Canada)** by engaging the trigger fully and spray for 10 seconds at this position.

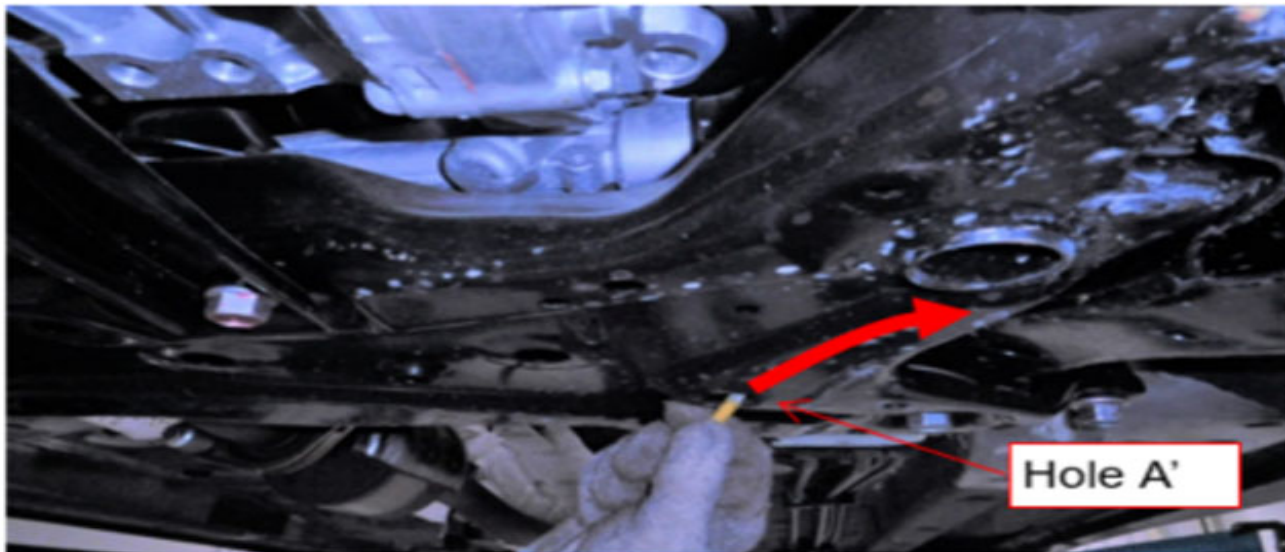
k. Spraying into the Hole A (RH) / A' (LH)

- Insert the nozzle through Hole **A(A')** in the direction shown below until it contacts the lower arm bracket (Insertion length: 180mm or 7 inches). Confirm that the nozzle has been fully inserted in the correct direction by looking in the opening of the lower arm bracket.
- Apply **MZ321015 (used in Canada)** by engaging the trigger fully at the position demonstrated below and confirm the **MZ321015 (used in Canada)** leaks out of the opening of the lower arm bracket. Continue spraying while removing the nozzle, which should take 10 seconds.

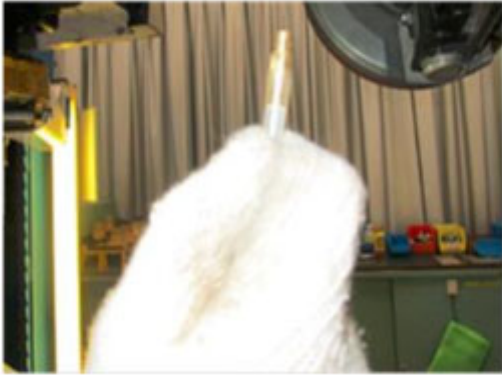
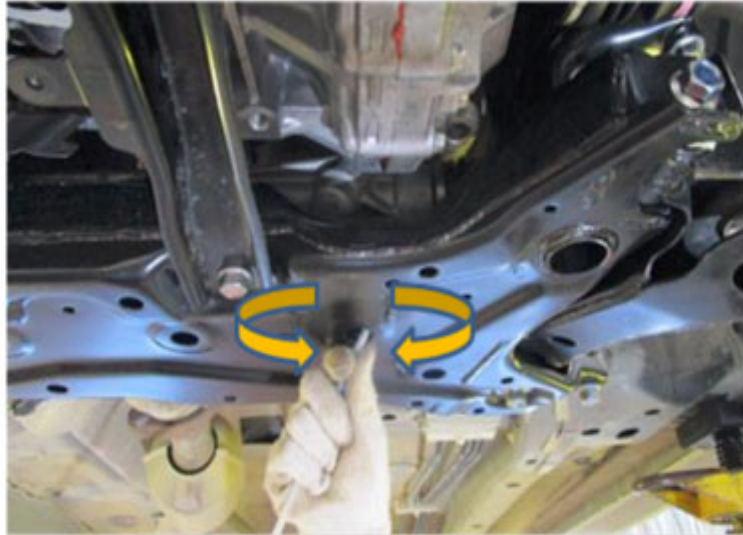
m. Spraying into the Hole C (RH) / C' (LH) and D

- Insert the nozzle through the Hole **C (C') or D** upwards (Insertion length: 25 mm or 1 inch).
- Apply **MZ321015 (used in Canada)** by engaging the trigger fully and spray for 10 seconds at this position.

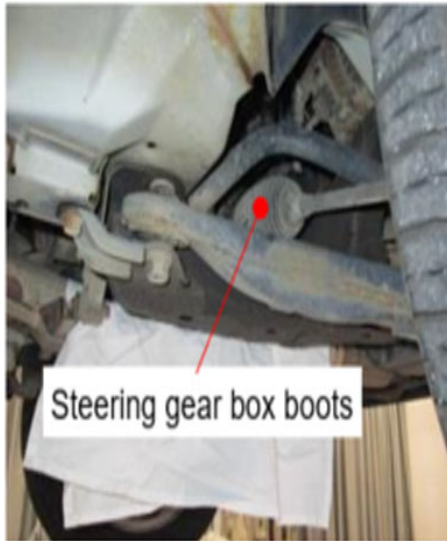
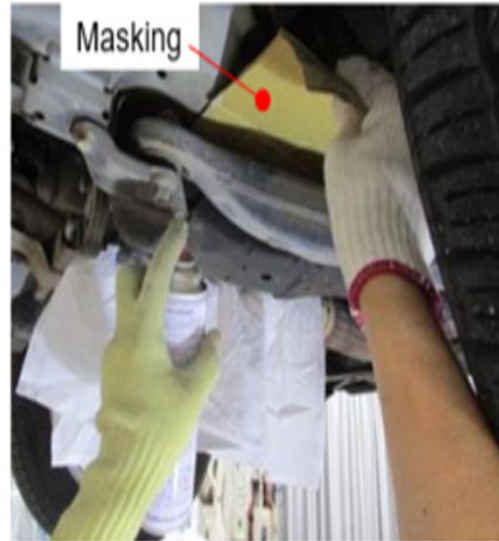
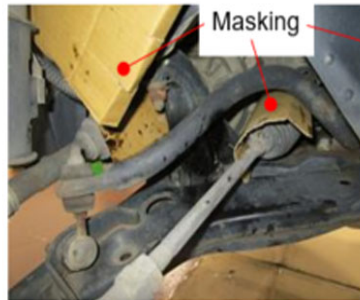
- b. Step 2 - Right side surface / Step 4 - Left side surface:
- Mask suspension bushings, steering gear box boots, drive shaft boots, and brake hoses.

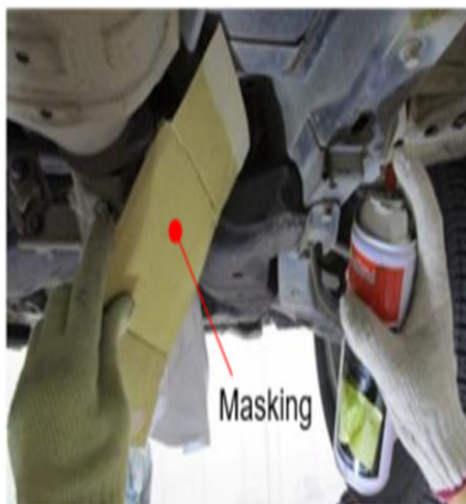
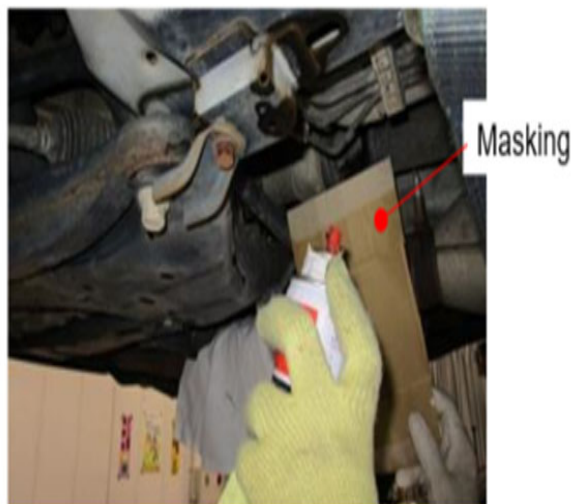
- c. Step 3 - Rear surface / Step 5 bottom surface:
- Mask exhaust pipe.
