September 8, 2020

## Driver's Seat Squeaks or Squeals When Adjusted

### AFFECTED VEHICLES

| Year | Model | Trim Level | VIN Range |
|---|---|---|---|
| 2019 | RDX 2WD | ALL | 5J8TC1...KL000001 thru 5J8TC1...KL023571 |

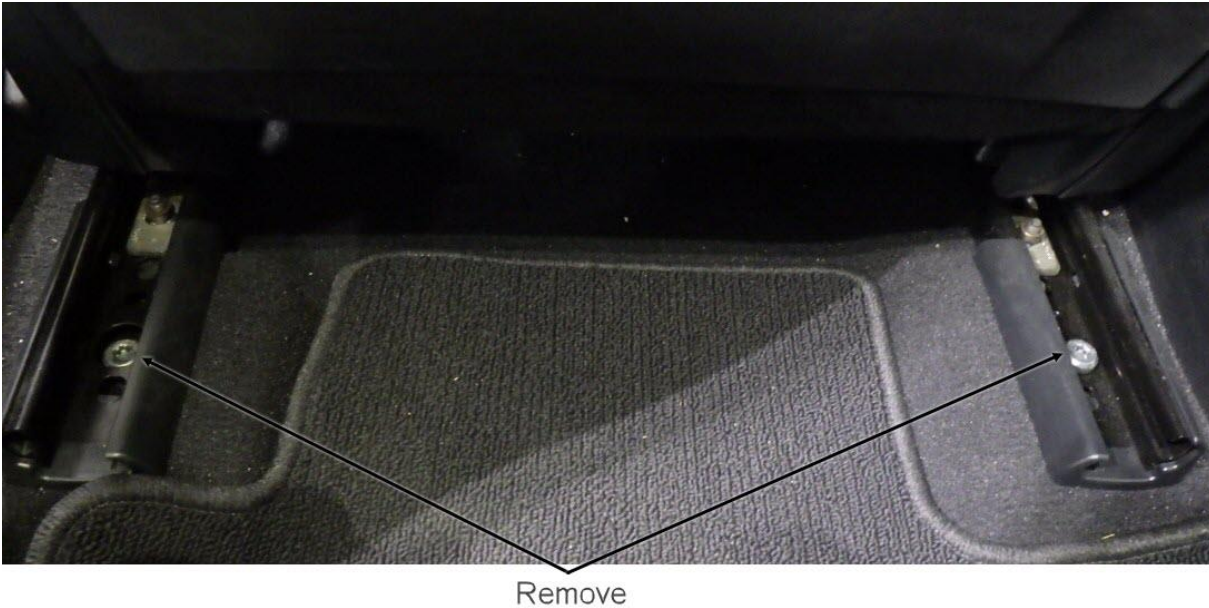
1. Move the driver's seat all the way forward, then adjust it to the highest position to access the two rear seat mounting bolts. Remove them with a TORX Plus 50IP Bit Socket.

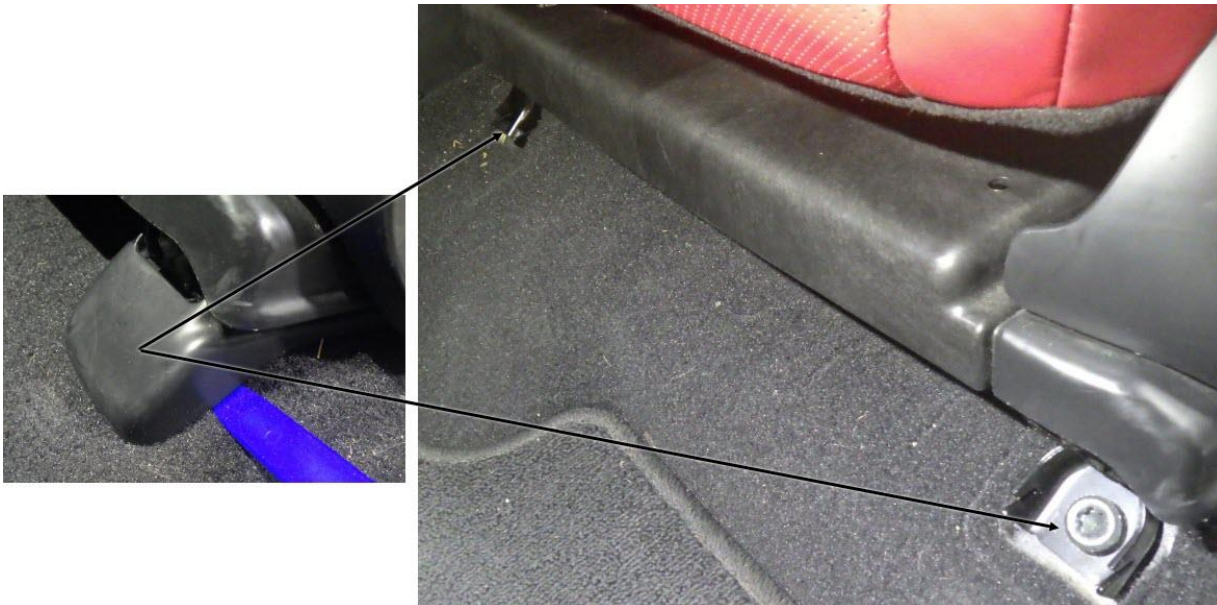
2. Adjust the driver's seat all the way back, Remove the two bolt covers, then remove the two front seat mounting bolts with a TORX Plus 50IP Bit Socket.

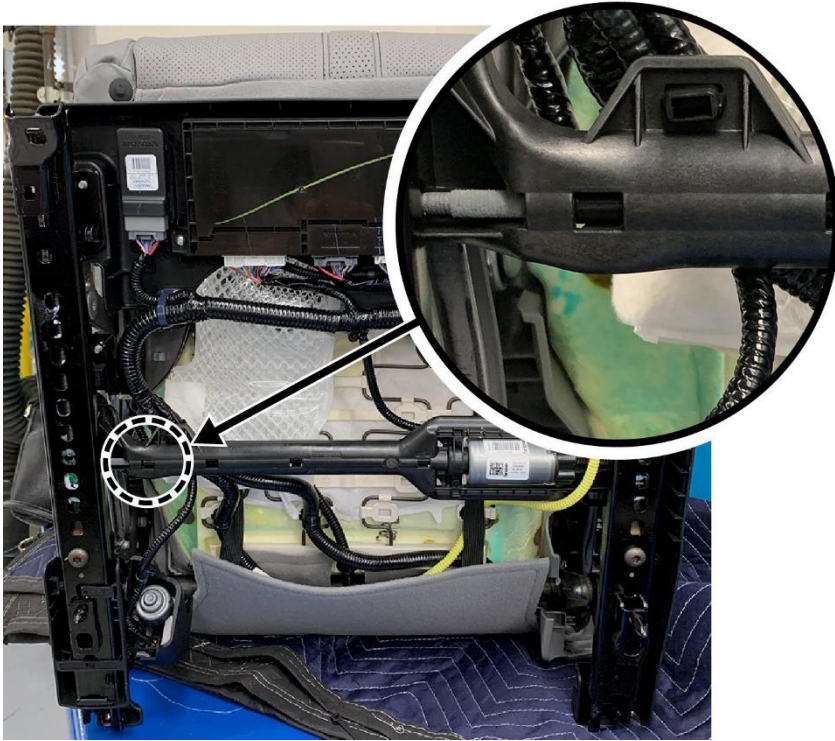
3. Tilt the driver's seat back, and locate the last hole on the flex shaft cover as shown.

This repair is done with the driver's seat inside the vehicle. To provide a clear view of where to install the wire tie, the seat was removed from the vehicle for this photo.

The driver's seat flex shaft cover spins while adjusting the seat forward or backward.

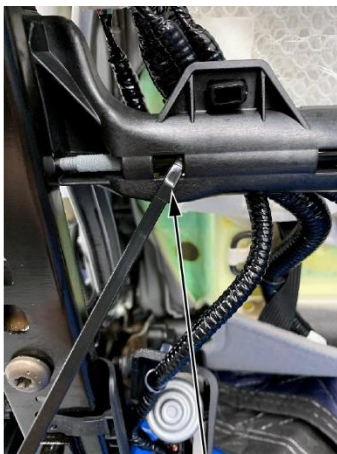
4. Route and secure the cable tie through the hole as shown. The cable tie must be above the shaft, toward the front of the vehicle, and to the right of the tab holding the rod.

Route the cable tie.

Do not wrap the wire tie around the harness. Wrap it only around the flex shaft cover and the shaft.

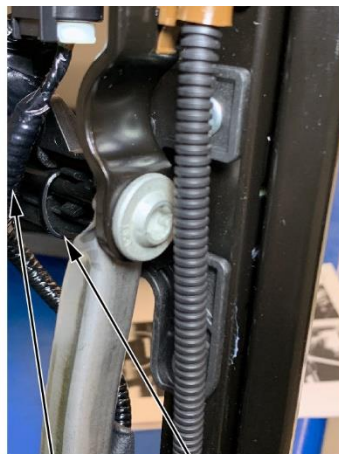
**HARNESS**

**CABLE TIE**

Make sure the harness is not being secured by the cable tie.

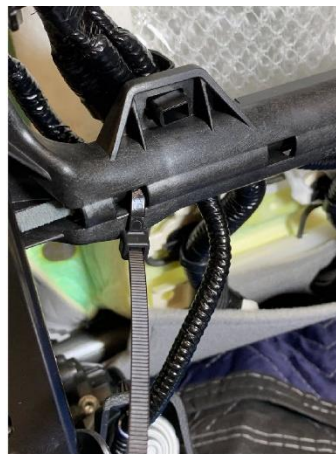
Secure the cable tie.

5. Cut off the excess cable tie.

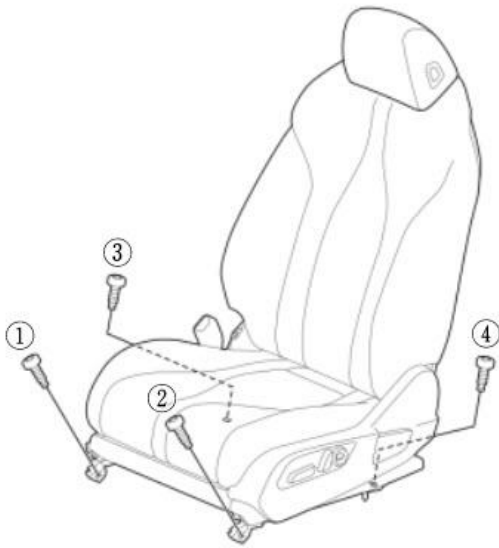
6. Move the seat forward and backward to make sure the noise is gone.
7. Hand-tighten the bolts in order as shown, then tighten them to **43 N•m (32 lb-ft)** with the TORX Plus 50IP Bit Socket.
