| REFERENCE: | Nova Bus Manuals |
| RS N°: | MQR 7621-1030 |

| SUBJECT: | Right wall structure with 1:6 ramp |
| JUSTIFICATION: | Vertical beam might crack above front door, second post capping. |

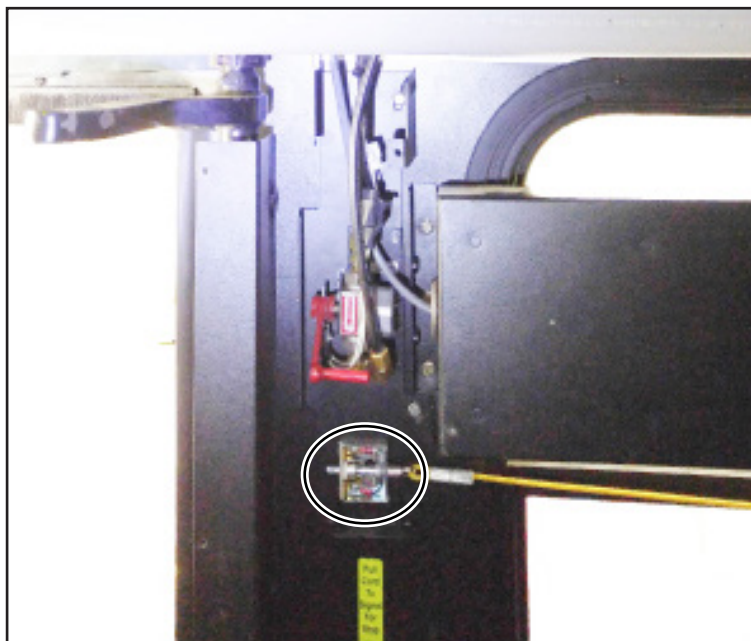
*Figure 4 - Remove Chime Cord Assembly*

- 1.7. Remove the emergency valve capping.
- 1.8. Disconnect the two chime cord wires and remove chime cord assembly. See Figure 4.
