EMISSIONS RECALL

COE FUEL CUT VALVE REPLACEMENT

CAMPAIGN NO: AAJK0

SUBJECT VEHICLES: Certain 13MY COE (Cab Over Engine) 195 and 195h (Model code: XJC, XFC) trucks equipped with a J05 engine

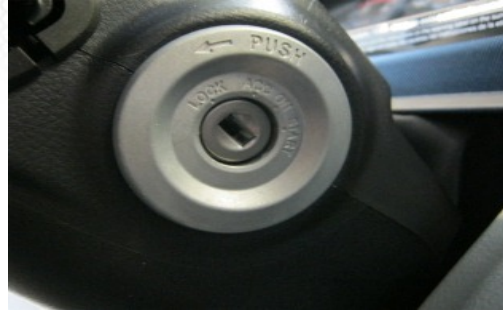
1. Park the vehicle on a flat, level and solid surface. Confirm the engine is stopped, the ignition switch is in the off (LOCK) position, and the key is removed.

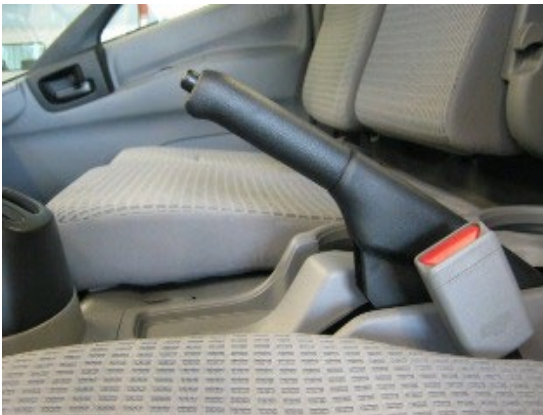
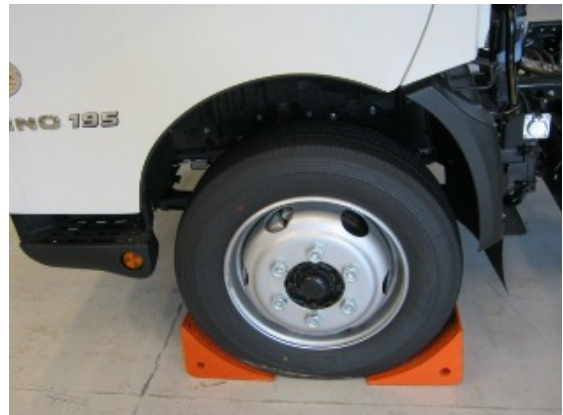
2. Apply the parking brake. Chock all of the wheels.

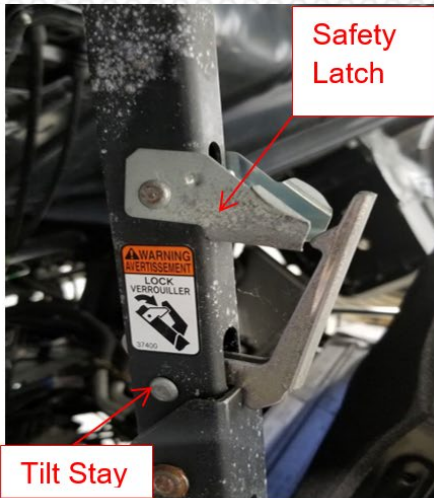
1. Lift the cab and engage the tilt stay safety latch. Locate the fuel cut valve on the rear of the engine, above the transmission.

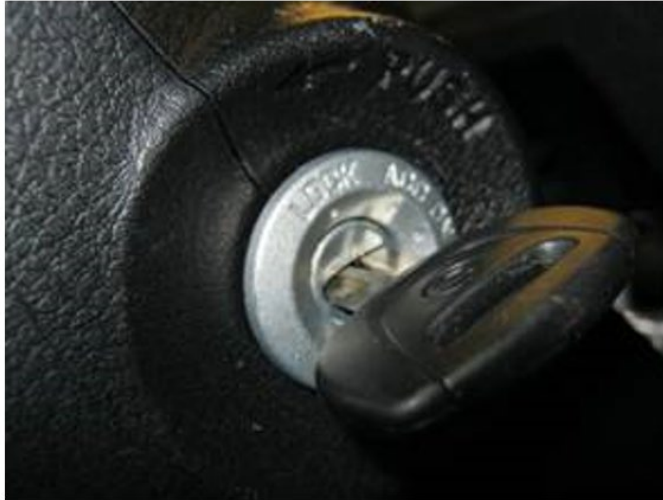
11. Start the engine and make certain no fuel leaks are present from the bleeder screw or fuel cut valve connections. Shut the engine off. Repair any fuel leaks as needed. Start the engine a second time to ensure the cranking time is normal. If the cranking time seems excessive, repeat steps 8-10, above to purge air from the fuel system.

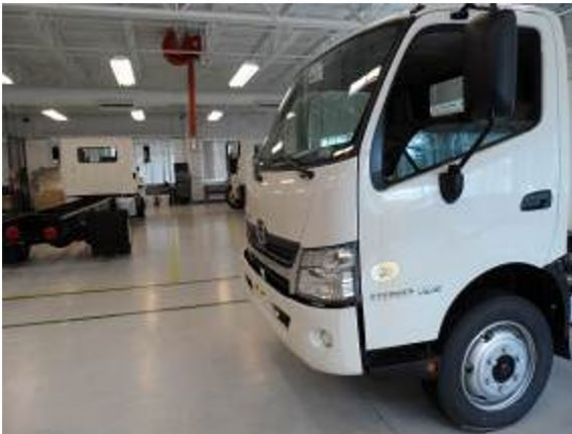
12. Lower the cab and engage the cab lock. Proceed to the Final Inspection procedure.
