RECREATIONAL VEHICLE SERVICE CAMPAIGN

Service Advisory: 20-383

SERVICE ADVISORY # 20-383

Kodiak Self-Leveling Roof Sealant

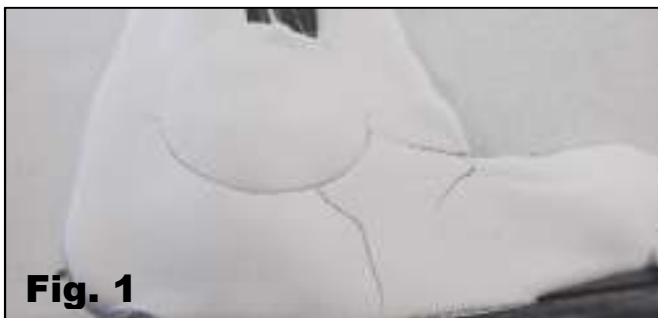
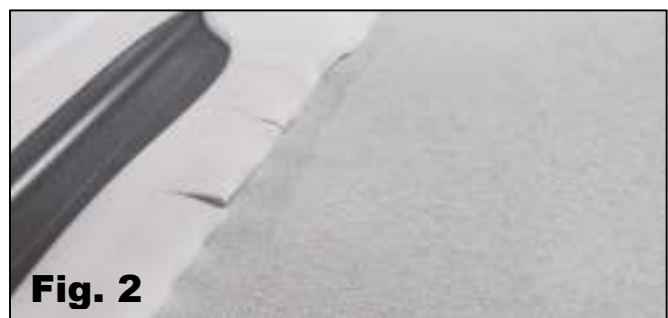
It has been determined certain Kodiak travel trailers may have defective self-leveling roof sealant that exhibits a hard, cracked appearance. The defective sealant exhibits poor adhesion and cracking within 96 hours of application and can be easily removed from the roof by pulling it up by hand. A visual inspection will reveal the defective sealant lifting from the roof due to poor adhesion properties. The following procedure describes how to correct the issue. Campaign closes November 30, 2020.

The remedy is to inspect the self-leveling roof sealant and replace if cracked and lifting. See Figure 1 and 2.

- Step 1.** Locate the trailer on a level, flat, hard surface. Chock the wheels.
- Step 2.** Visually inspect the roof sealant for cracking and/or lifting.
- Step 3.** If the sealant is cracking or lifting go to the Repair Instructions.
- Step 4.** If the sealant exhibits normal characteristics go to Warranty Reimbursement Inspection Only.

- Step 1.** Test the adhesion properties by pulling the sealant by hand.
- Step 2.** If it is not easily removable by hand then it is adhered properly and will be left in place. In these cases, touch up or reseal any void at the base edges of the existing bead seal and reseal any surface cracks as necessary.
- Step 3.** If the sealant can be easily removed by hand, remove it and apply new self leveling roof sealant per the instructions on the caulk tube. The roof must be clean and dry when applying sealant.
