September 29, 2020

Warranty Extension: A/C Condenser Leaking

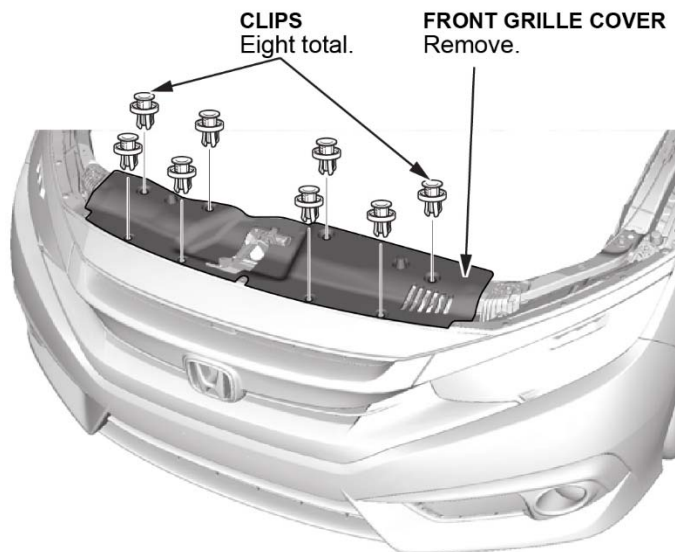
4. Remove clips and hardware securing the front bumper.

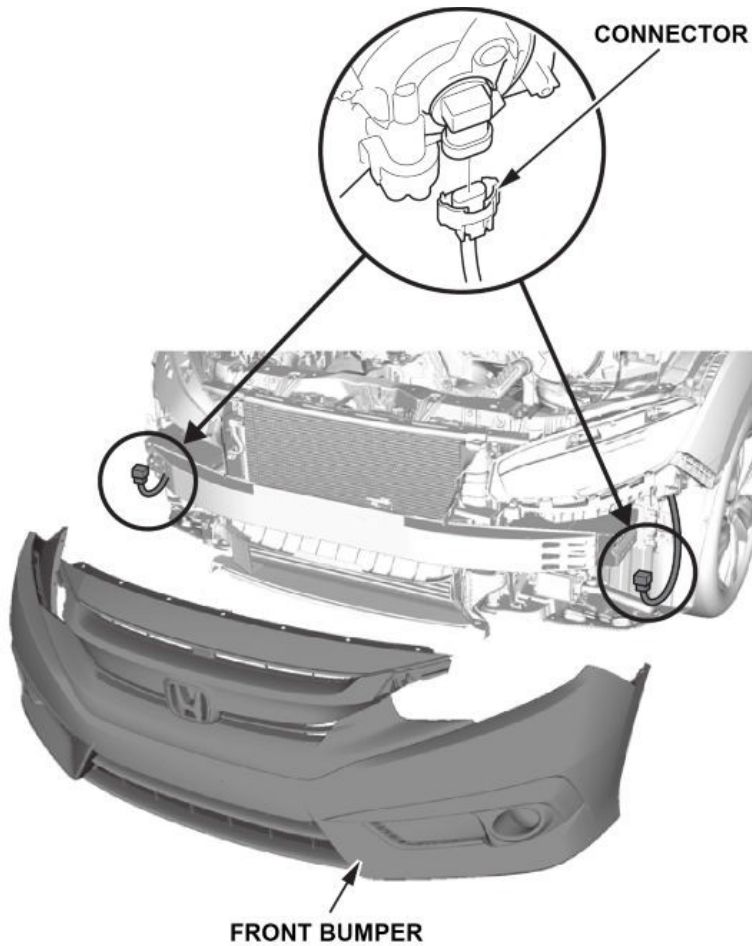
7. Check for leaks in the central condenser area.

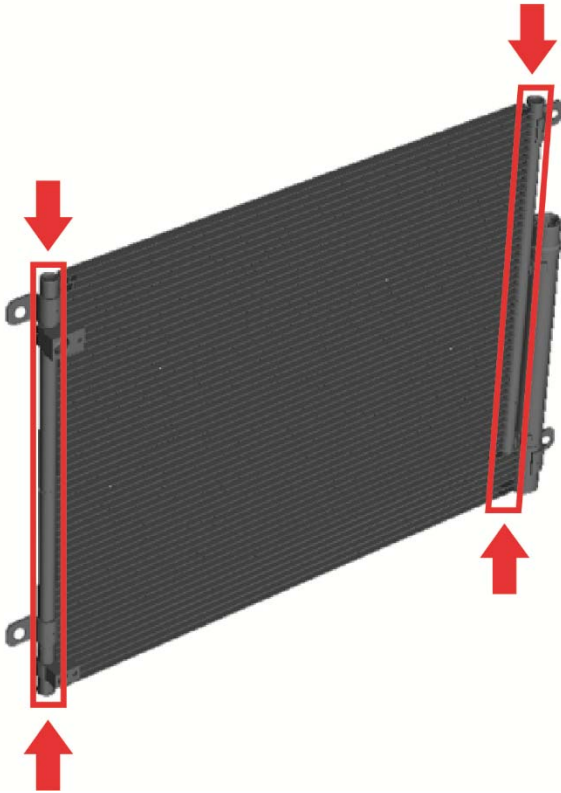
9. Check the inlet and outlet joints and the dryer cap for leaks.

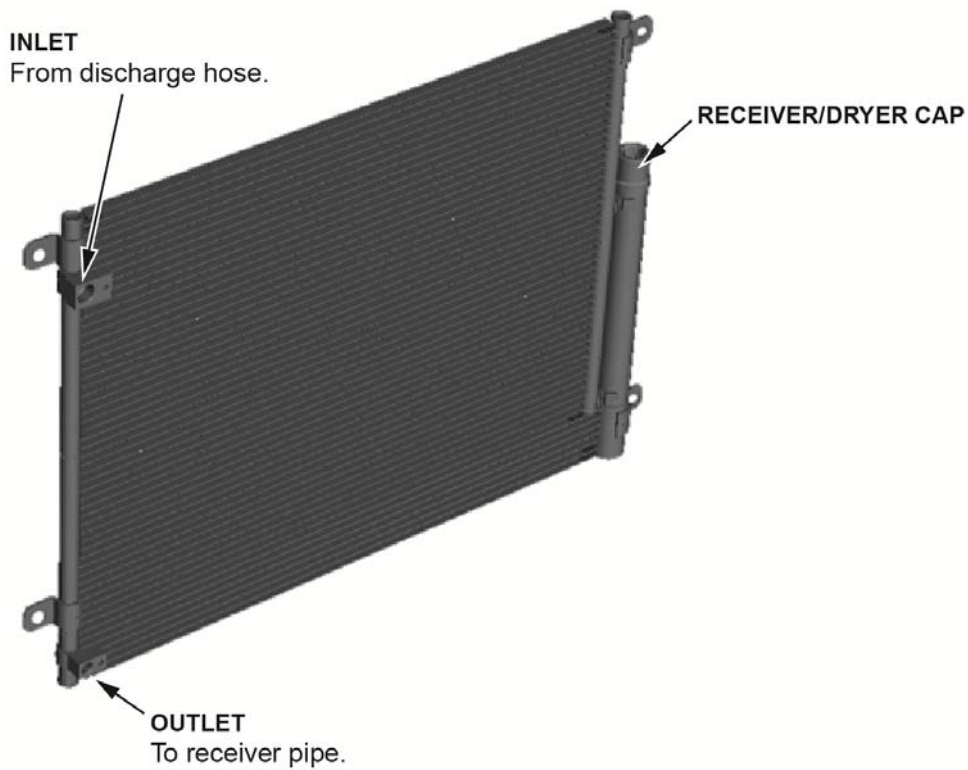
Examples of leaks detected with dye

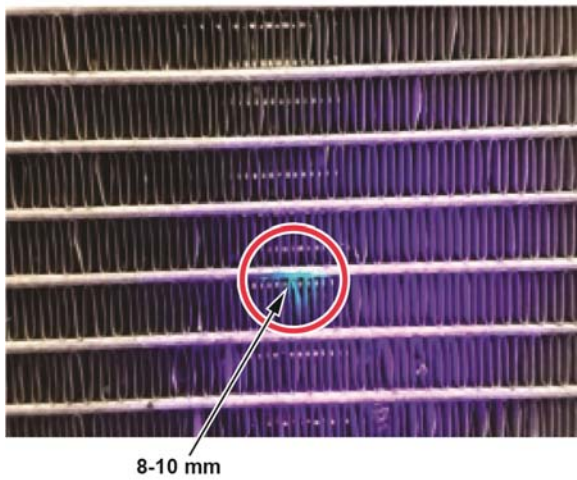
Some leaks are visible with the correct angle of UV light. This leak is deep in the groove between fins.

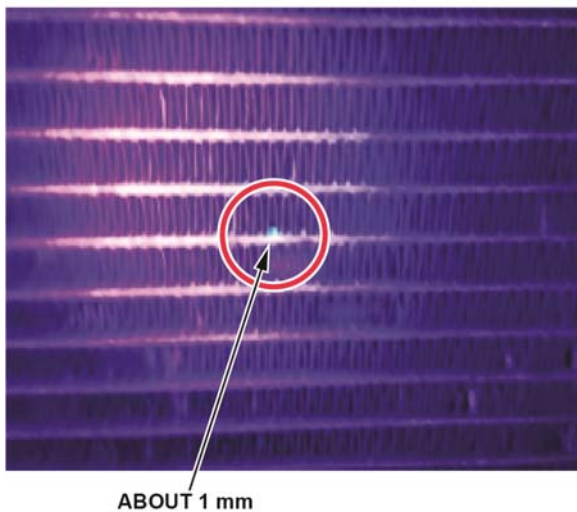
Some leaks may not be visible from certain angles. Aim the UV light from different angles to detect leaks on horizontal tube surfaces.

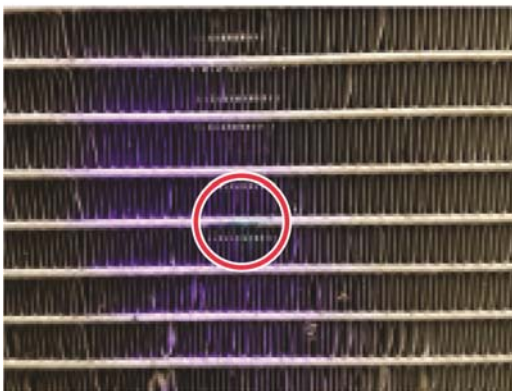
UV LIGHT POINTING UP

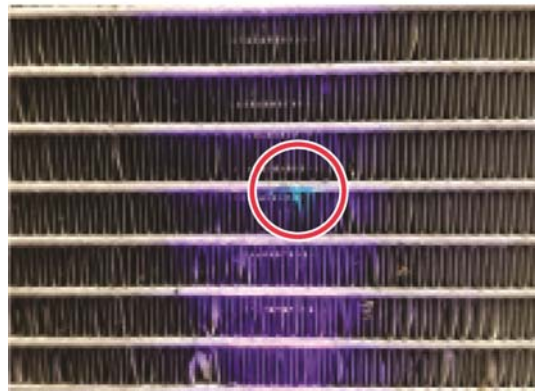
Some condensers may have multiple leaks.

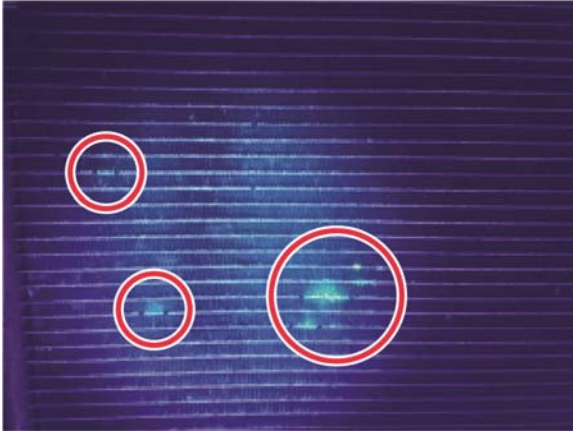
- If the condenser is leaking, go to the next step.
- If the condenser is not leaking, this bulletin does not apply. Continue with normal troubleshooting.

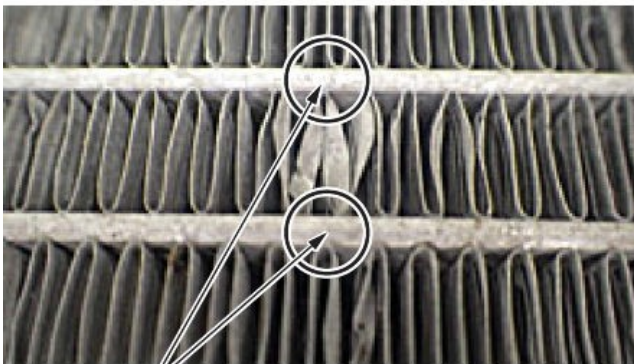
Fin damage without impact
damage to the tube face.

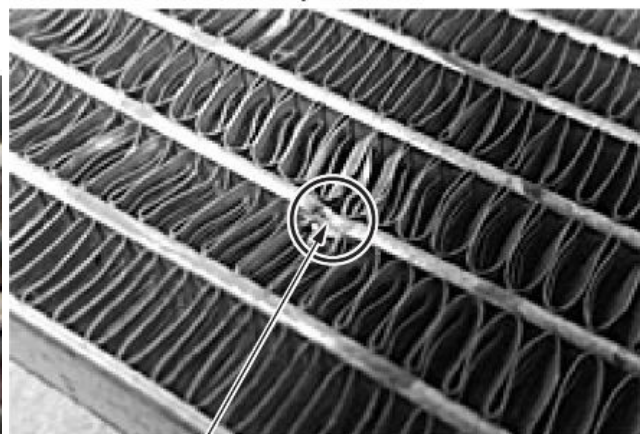
Impact damage
on the tube face.
