September 25, 2020

Version 1

Driver's Seat Squeaks or Squeals When Adjusted

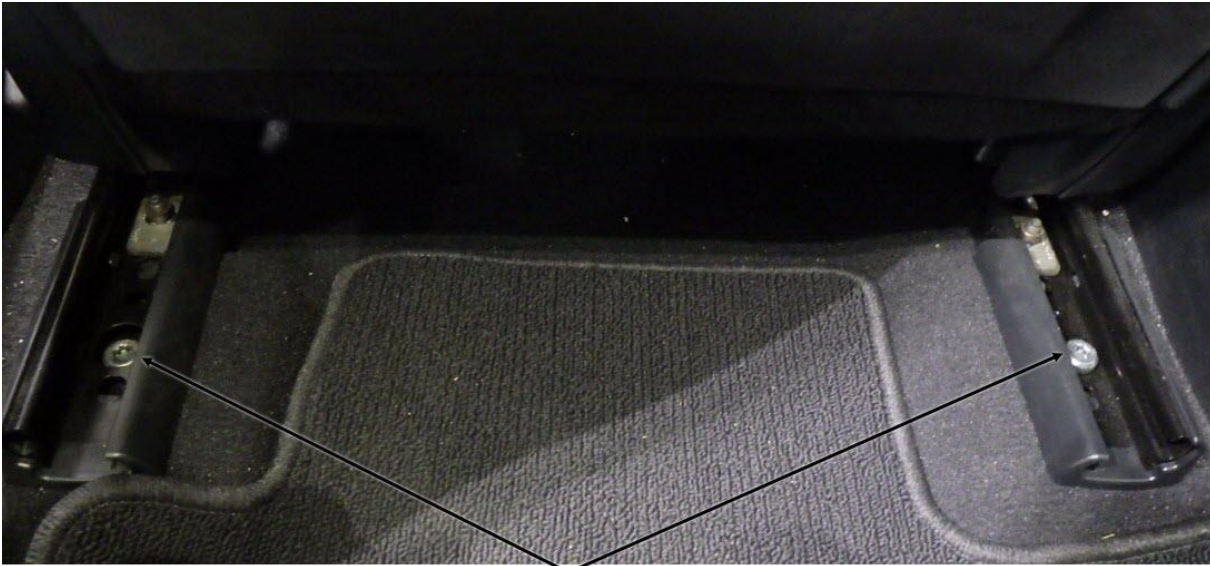
1. Move the driver's seat all the way forward, then adjust it to the highest position to access the two rear seat mounting bolts. Remove them with a TORX Plus 50IP Bit Socket.

Remove

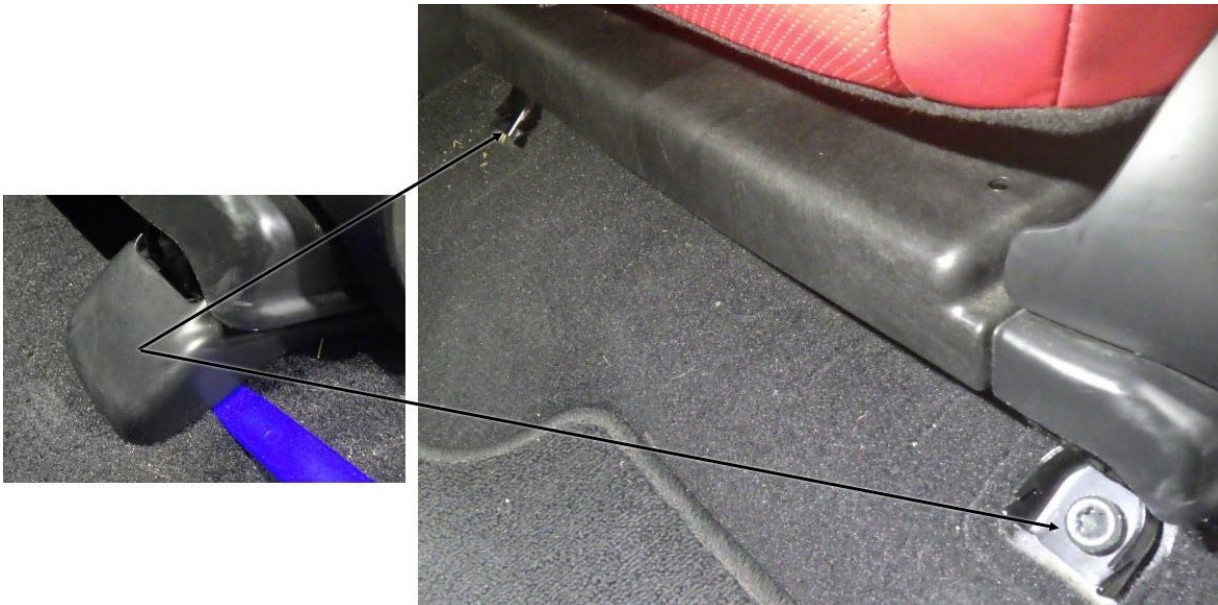
2. Adjust the driver's seat all the way back, Remove the two bolt covers, then remove the two front seat mounting bolts with a TORX Plus 50IP Bit Socket.

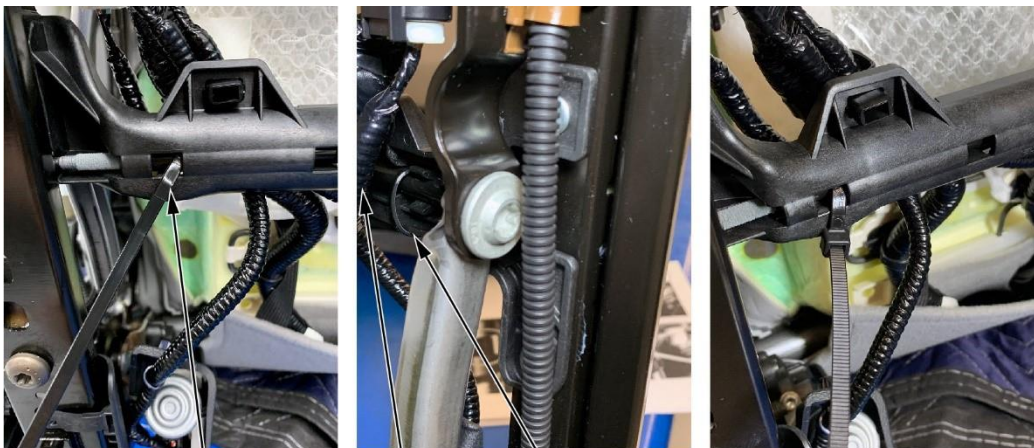
4. Route and secure the cable tie through the hole as shown. The cable tie must be above the shaft, toward the front of the vehicle, and to the right of the tab holding the rod.

Do not wrap the wire tie around the harness. Wrap it only around the flex shaft cover and the shaft.

Route the wire tie.

HARNESS

CABLE TIE

Make sure the harness is not being secured by the wire tie.

Secure the wire tie.

Install a wire tie to the flex shaft cover underneath the driver's seat.
