SERVICE BULLETIN

APPLICABILITY: 2019-20MY Forester

NUMBER: 12-299-20

SUBJECT: Driver's Seat Hinge Cover- Design Change

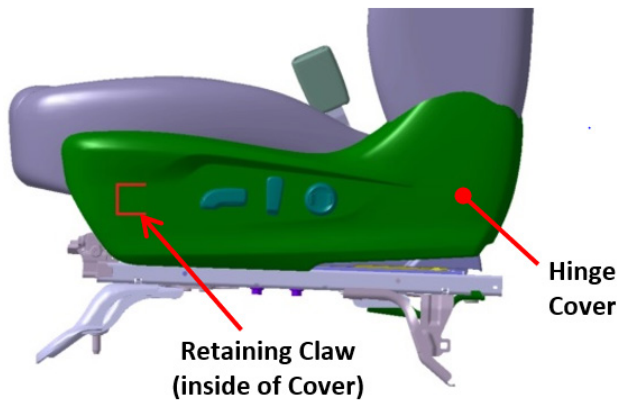
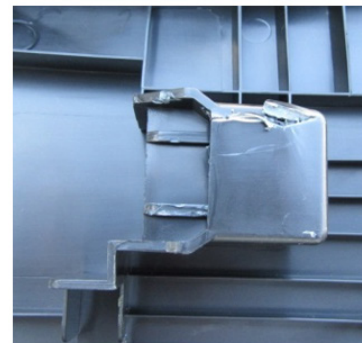
This bulletin announces a design change made to the outer hinge cover on the driver's 10-way adjustable power seat. The change has been made to address several reports about the cover coming loose over time as a result of getting into and out of the driver's seat. The retaining claw portion securing the cover to the seat frame has been changed to improve its strength and durability.

Enlarged View of Damaged Claw

The new Hinge Cover was incorporated into production starting with VIN **LH508731**.

The part number for the new Hinge Cover is **64115SJ231VH**.
