Subject: CHECK ENGINE LIGHT ON WITH P3400	Service Alert No.: SA-061/20
	Last Issued: 09/10/2020

2018-2020 Mazda6
2018-2020 CX-5
2019-2020 Mazda3
2020 CX-30

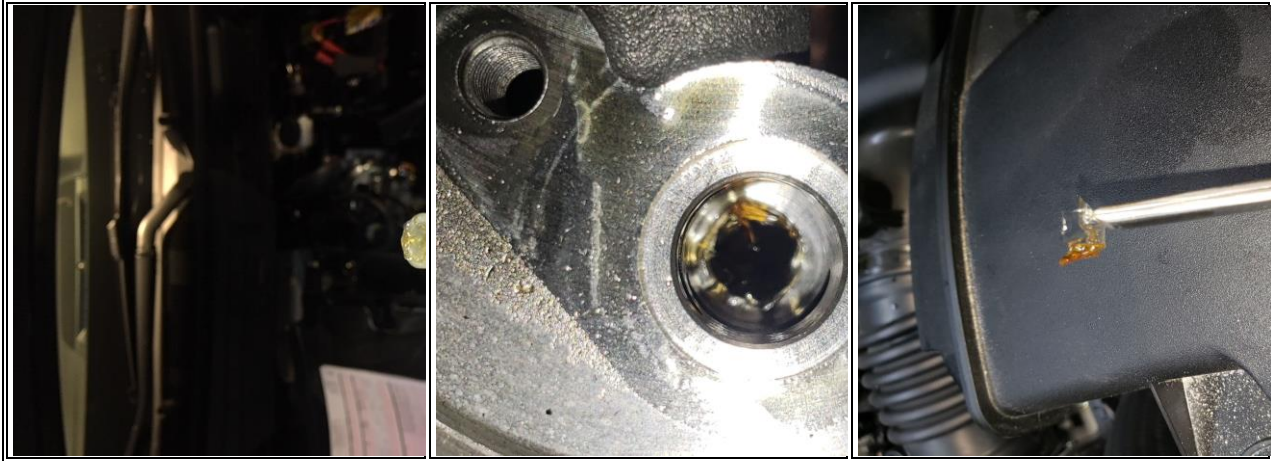
If you receive a customer concern about the CHECK IN light coming on and DTC P3400 (cylinder deactivation system malfunction) stored, **the cylinder deactivation oil control valve may be plugged with plastic debris from the oil filter wrapper. The debris may enter the center of the oil filter when poking a hole in the filter wrapper during removal, and then travel through the engine and plug the cylinder deactivation oil control valve.**

1. Verify customer concern.
2. Remove the front and rear cylinder deactivation oil control valves and inspect the oil control valves and cylinder head port for contamination or debris (see photo).

- **YES:** Inspect the oil passage for debris and clear the passage if debris is found. A vacuum device such as a brake bleeder may be helpful in removing the debris.
 - If the OCV tip filter is damaged, replace the cylinder deactivation OCV.
- **NO:** Proceed with a normal diagnosis for DTC P3400 on MGSS.
