LTB01255NAS2

# TECHNICAL BULLETIN

Oil Leak From Transmission Case

Internal porosity in the automatic transmission, allowing oil to leak between the automatic transmission and the transfer case.

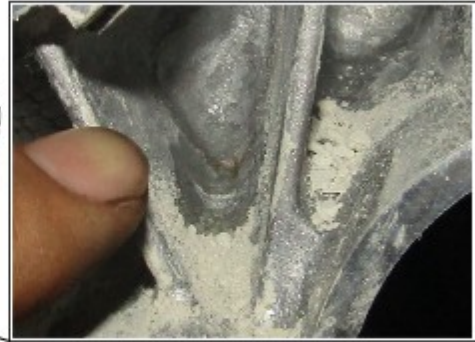
E268408

This technical bulletin only applies to vehicles installed with the 8HP45 8-speed All Wheel Drive (AWD) automatic transmission, with oil diagnosed to be leaking from the cavity highlighted in the illustration.
