Field campaign

| Topic | New Flying Spur - First Edition Badge - Facia (SC20/25) |
| Campaign number | EB67 |

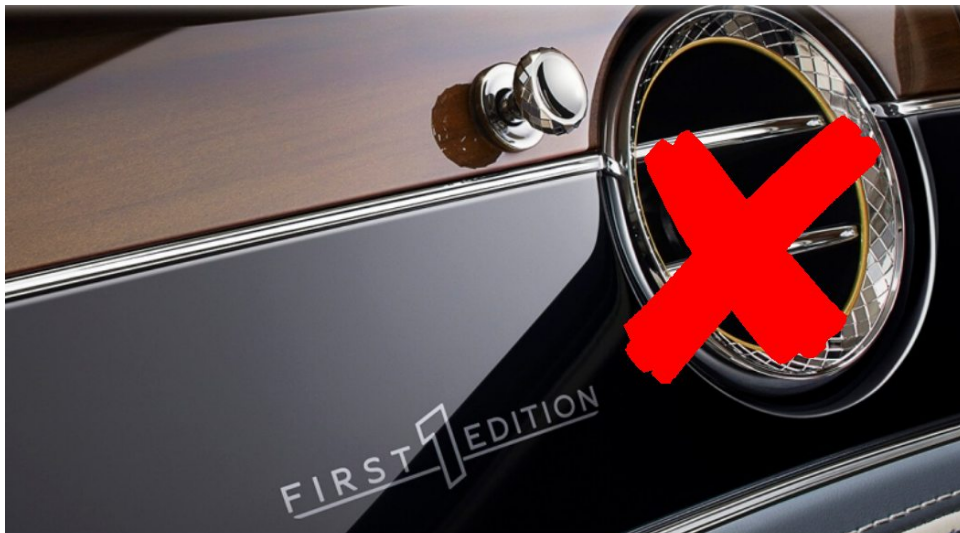
Figure 1.

A limited number of vehicles were built with an incorrect *First Edition* emblem on the Passenger facia insert, this does not match other *First Edition* emblems on the vehicle – figure 1.

Passenger facia insert with the correct *First Edition* emblem to be installed – figure 2.

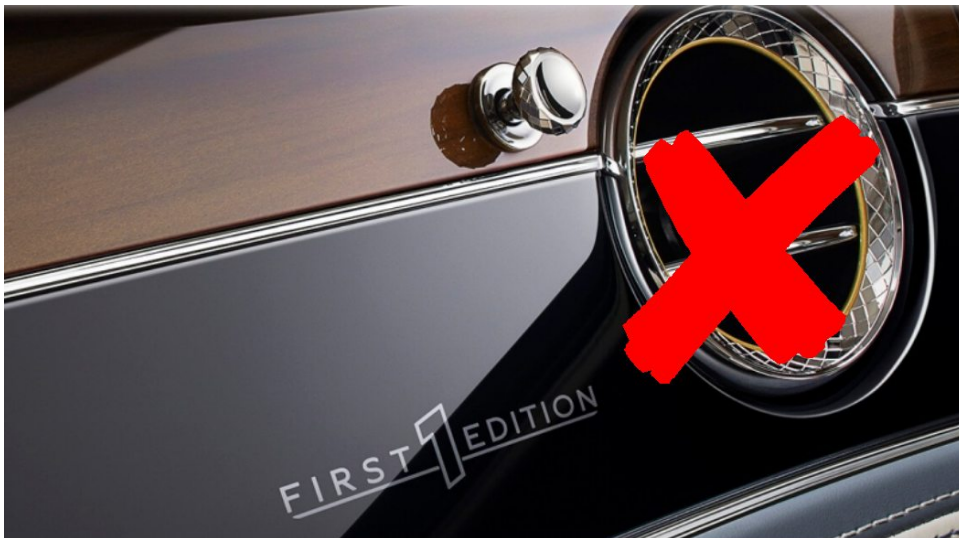
Figure 1.

A limited number of vehicles were built with an incorrect *First Edition* emblem on the Passenger facia insert, this does not match other *First Edition* emblems on the vehicle – figure 1.

The lower part of the Passenger facia insert should be replaced using an insert with the correct *First Edition* emblem – figure 2.

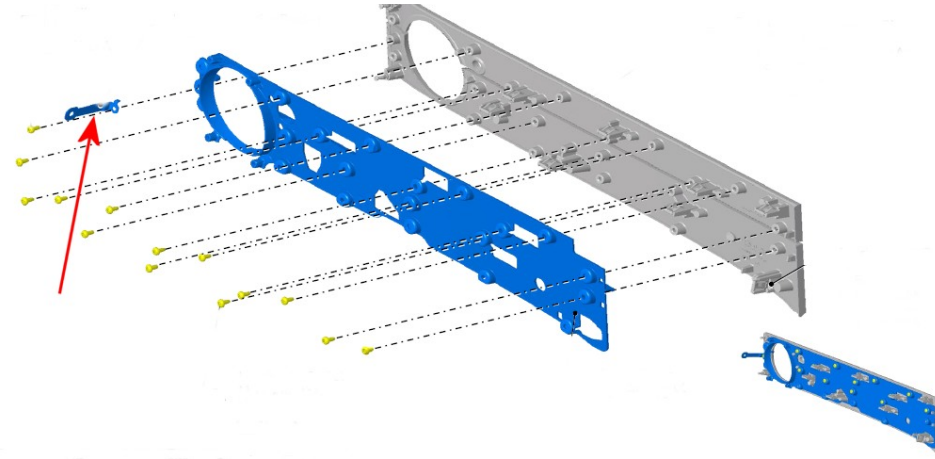
Figure 3.

- Remove the Passenger facia insert - refer to the relevant section from *Repair Group 70 Trim, noise insulation – Dashboard panels – Dashboard facia panels – To remove and fit.*
- Remove the Six M4 (2.2Nm  $\pm$  0.22) hexagon screws securing the lower part of the Passenger facia insert. Note the position of the Crash Retention Bracket and screw, arrowed in figure 3.

- Remove and discard the lower Passenger facia insert.
- Fit the new Passenger facia insert with the correct *First Edition* emblem – figure 2 - ensuring the Crash Retention Bracket and screw are fitted correctly – figure 3.

**Note:** If the lower Passenger facia insert is difficult to remove or fit it may be necessary to remove the upper Passenger facia insert and insert piece to enable correct alignment.
