## QUARANTINE NOTICE

Reference number:	QN-01-1418	Issued: 5th October, 2020
Subject:	Incorrect Installation of the Front Seat Airbags	
Model(s):	DB11, Vantage, DBS Superleggera	
VIN Range:	Refer to the separately published list of Vehicle Identification Numbers (VINs)	
Applicable to:	All Dealers	
Distribute to:	After Sales Manager Executive Manager Service Manager Sales Manager	Warranty Staff Technician(s) Parts Staff

### Reason for this Quarantine Notice

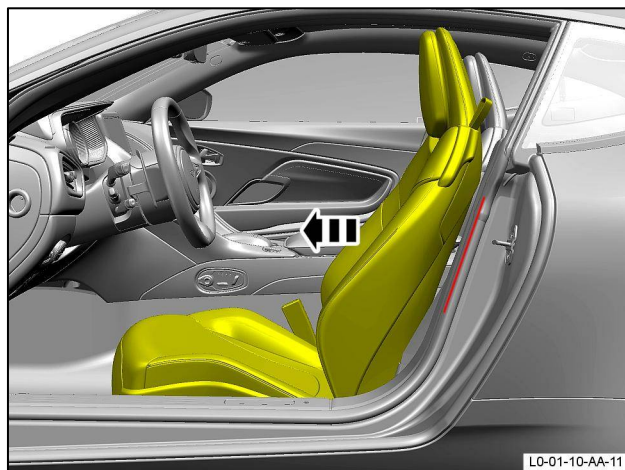
Figure 1

1. Operate the seat to its fully forward position (refer to Figure 1).

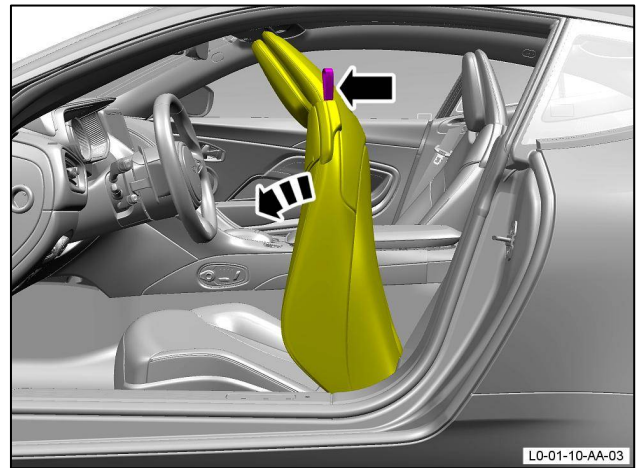
Figure 2

2. Pull the release handle to tilt the seat to its fully forward position (refer to Figure 2).

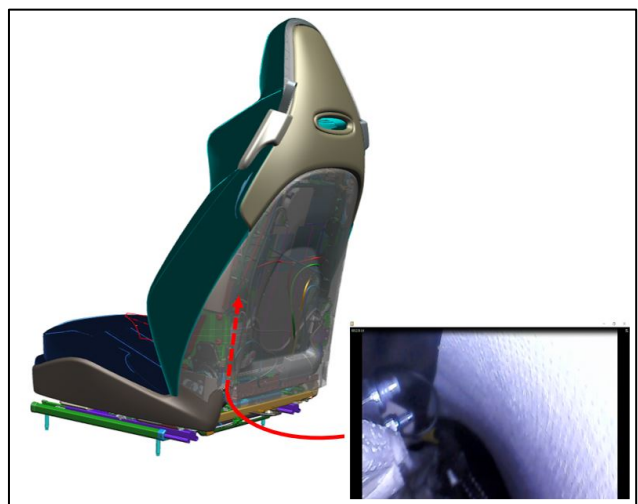
Figure 3

3. Use an endoscope on the underside of the seat to examine the two locking nuts for the seat airbag (refer to Figure 3).

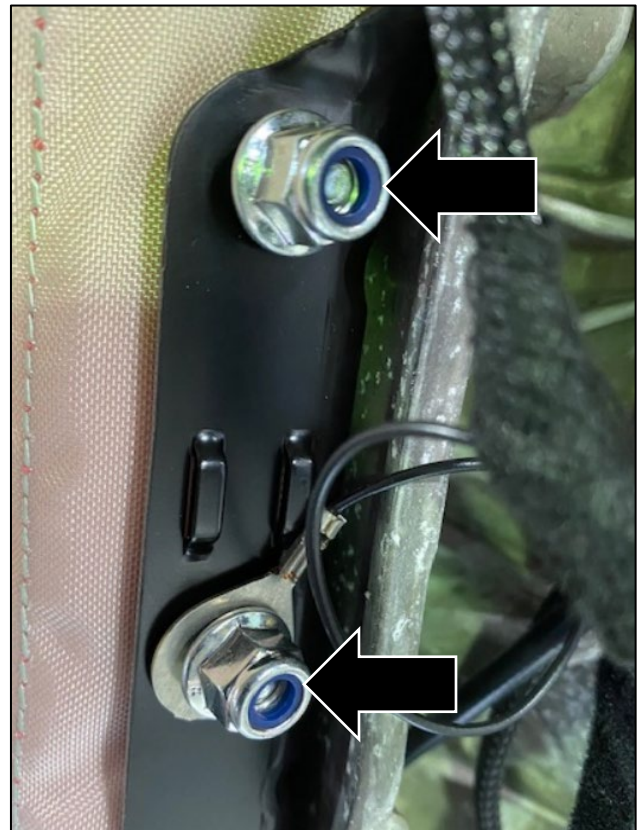
Figure 4

On the affected vehicles, it is possible the locking nuts that attach the front seat airbags to the seat are not torqued to the correct specification.

4. This image shows two locking nuts that are incorrectly installed (refer to Figure 4).

6. If any of the locking nuts are not installed correctly go to Part B: Torque the Locking Nuts to the Correct Specification.

3. Torque the two locking nuts that attach the seat airbag to the seat to 5.5 Nm. Align the ground eyelet to the bracket.
4. Install the seat back shell to the seat (refer to Workshop Manual Procedures 01.10.DU for the left side seat and 01.10.DR for the right side seat).
5. Install the seat assembly to the vehicle (refer to Workshop Manual Procedures 01.10.AA for the left side seat and 01.10.AB for the right side seat).

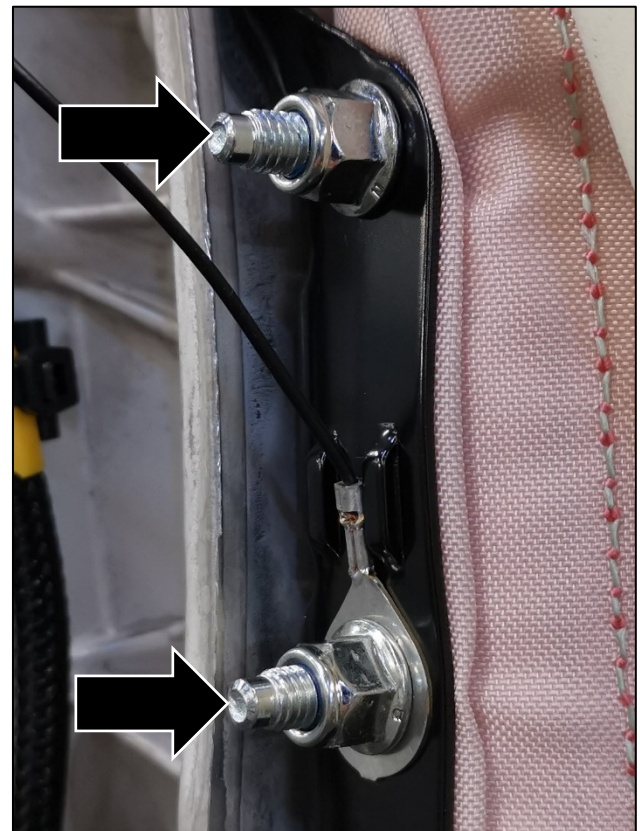
Figure 5

5. The lower fixing that clamps the ground eyelet must show a minimum of 4 visible threads. The upper fixing must show a minimum of 5 threads (refer to Figure 5).

**Note:** *This image shows two locking nuts that are correctly installed with the ground eyelet correctly aligned.*
