## BONDED KITCHEN WINDOW (2100271) FORK REPLACEMENT INSTRUCTIONS

<b>Bulletin Type:</b>	SRP	<b>Publication Date:</b>	October 2020
<b>Bulletin #(s):</b>	20-029	<b>Make(s):</b>	Jayco Class A Entegra Class A
<b>Job Code(s):</b>		<b>Model(s):</b>	Cornerstone, Anthem, Aspire, Reatta XL, Reatta, Embark
<b>Flat Rate(s):</b>	.75	<b>Model Year(s):</b>	MY2021

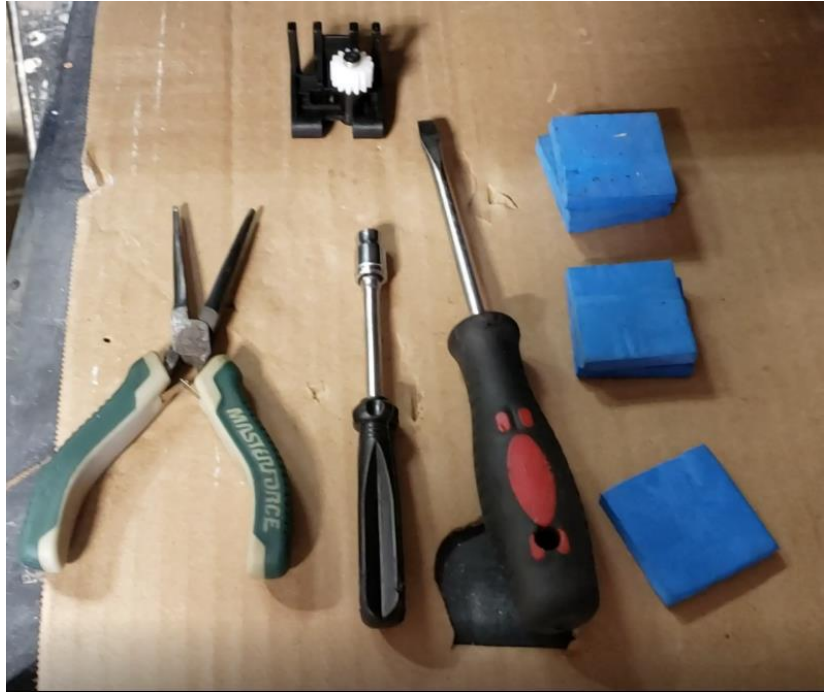
Tools required for this repair are as shown.

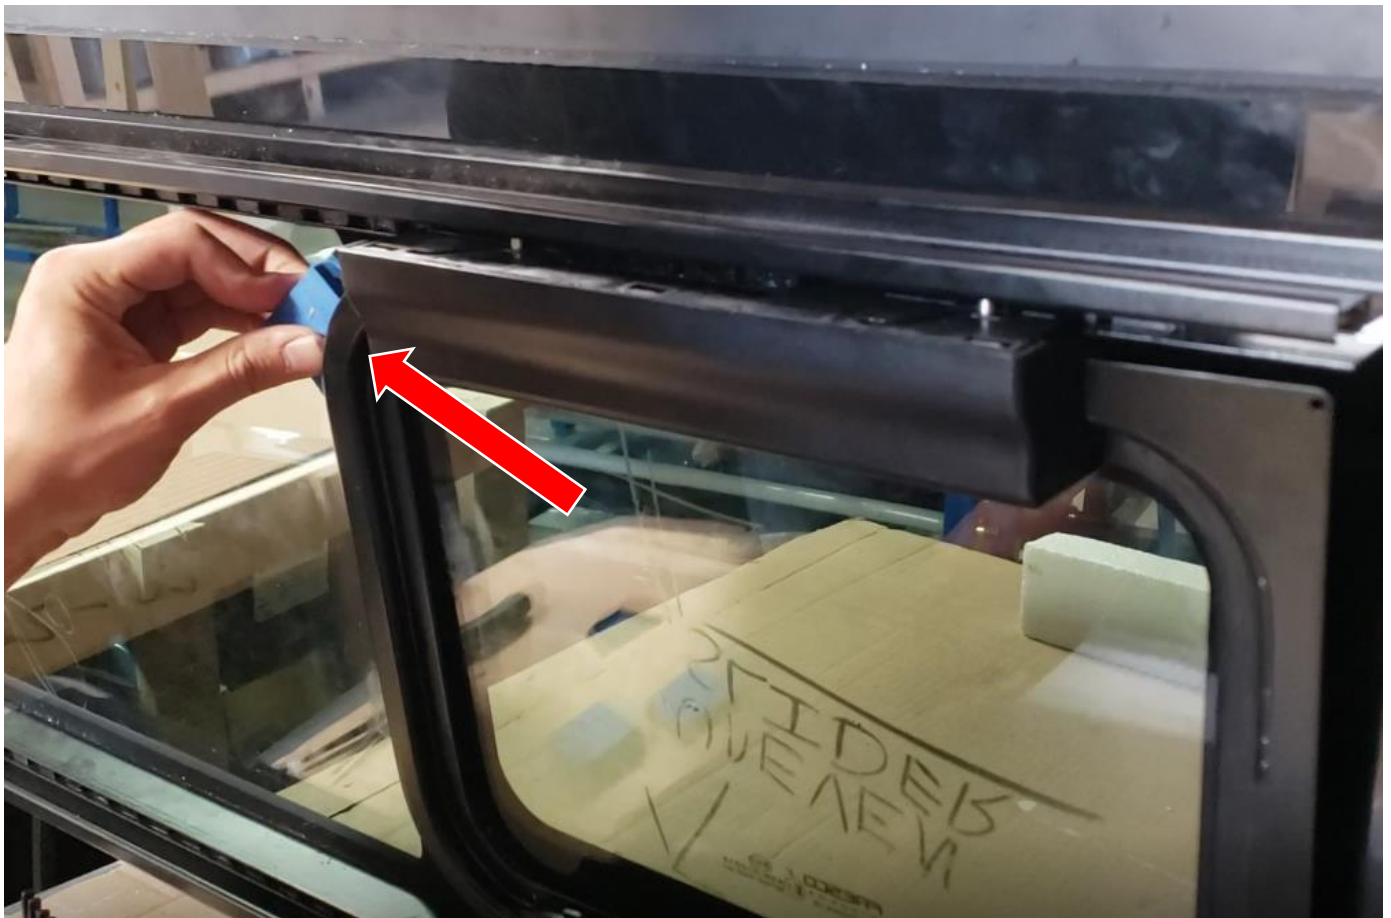
3. Compress the latch mechanism by squeezing latch handle towards the left side of the latch assembly to bring top of sliding window frame outward towards user. Place a stack of 3-square spacer blocks (15mm total) between rear window pane and sliding window frame at user's top left corner of the sliding window frame as shown below.

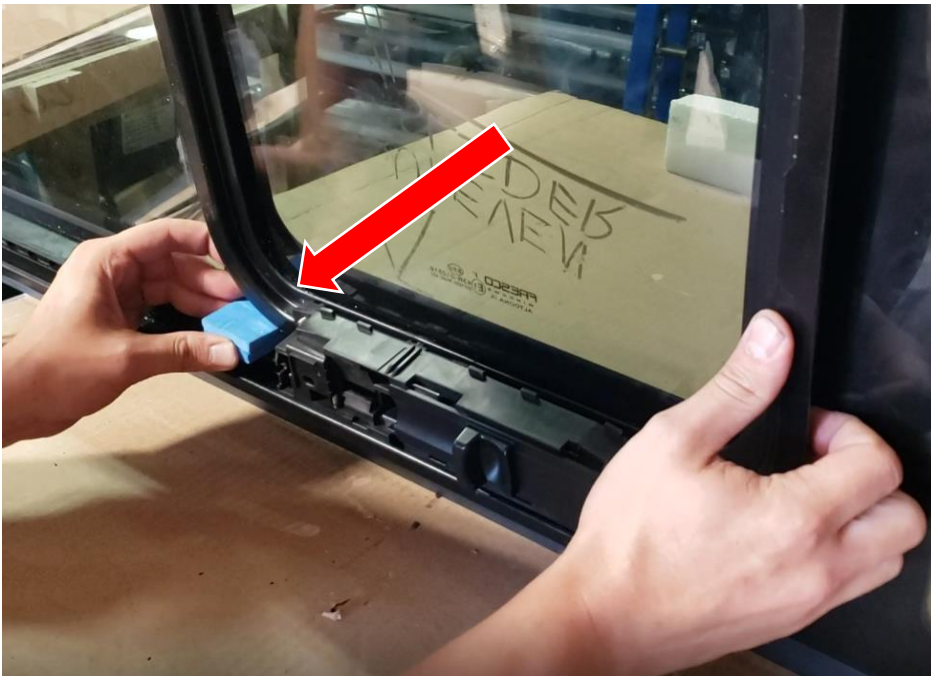
4. Place a stack of 2-square spacer blocks (10mm total) under sliding window frame between the window frame and the bottom track at user's left side of the window frame as shown in the picture to the left.

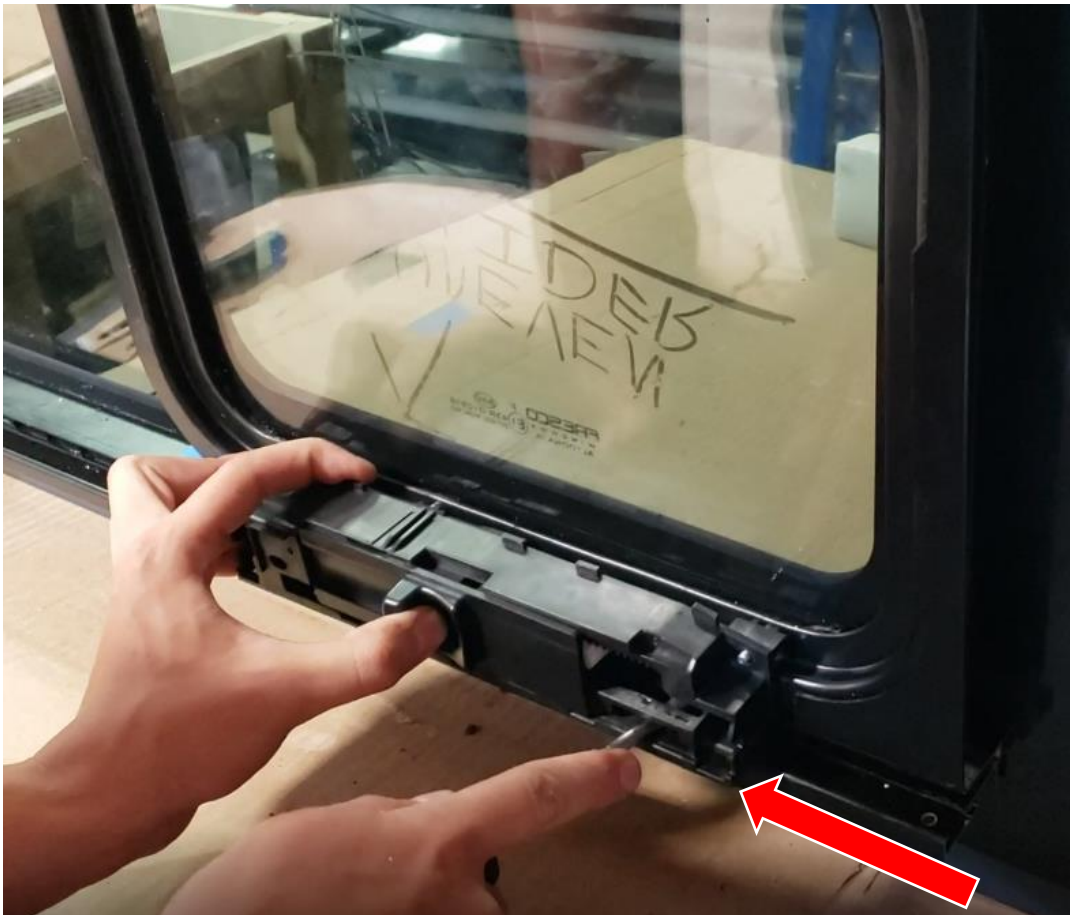
5. At this point, the sliding window frame should be able to pull outward toward user and the bottom latch assembly should separate from the bottom track. Screwdriver may be required to disengage the latch assembly from the track system for appropriate separation.

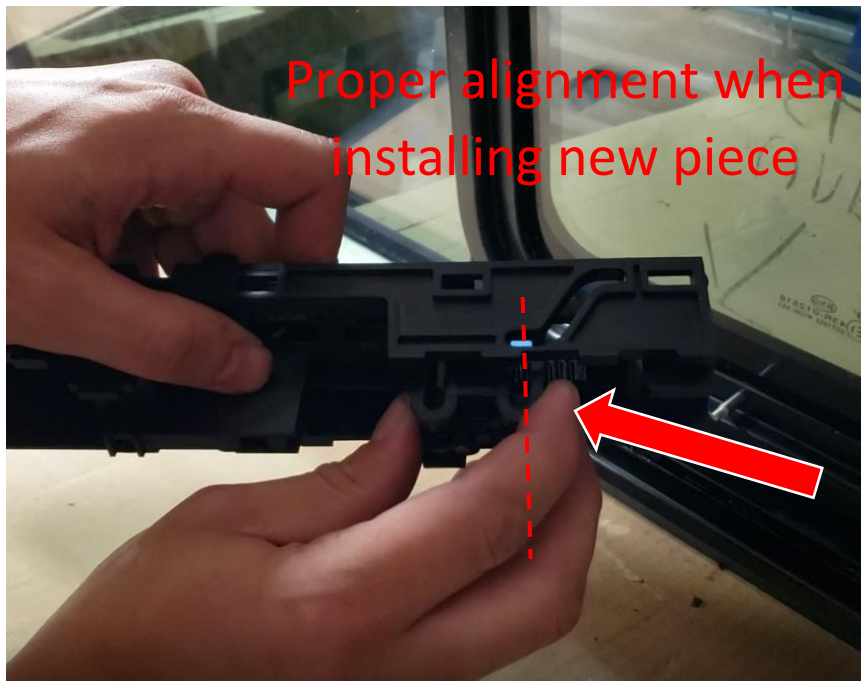
11. With fork piece removed, slide the handle all the way left (referencing previous direction/orientation when latch assembly installed on window frame) and place gear wheel of new fork piece between gear tracks inside of latch assembly with the right fork slot aligned with the left side of cam slot ("S" slot).

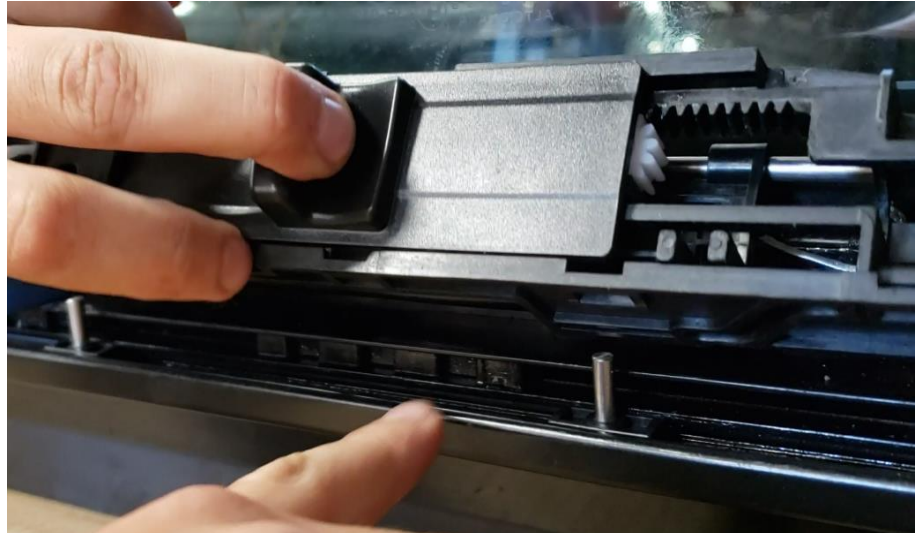
14. With the latch handle completely compressed, reposition bottom latch assembly towards the mounting location and over the top of the bottom track system. Align both pins in the bottom track system with cam/"S" slots on bottom face of latch assembly. The Right pin in the track system must be passing through cam slot AND the right fork slot of the new fork piece.
