Technical Service Bulletin

50 Threaded opening for the front towing loop is missing

50 20 01 2060825/1 October 6, 2020.

Model(s)	Year	VIN Range	Vehicle-Specific Equipment
A4, A4 allroad, A5, A5 Cabriolet, and A5 Sportback	2020 - 2021	All	Not Applicable

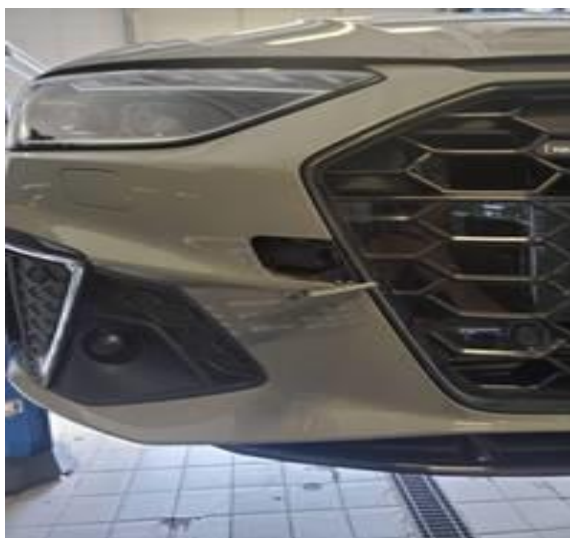
- The threaded opening for the front towing loop is not visible after removing the cover for the threaded opening for the front towing loop (Figure 1).

Figure 1. Cover for threaded opening for front towing loop removed.

None. The omission of the threaded opening for the front towing loop is intentional.

Make no repairs to the vehicle as this is an intended change.

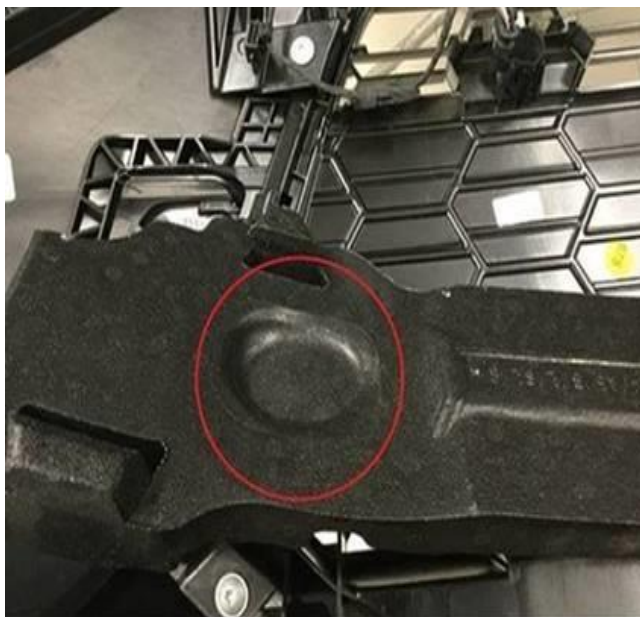
- There is no opening in the bumper foam insert where the threaded receiver was located (Figure 2).

Figure 2. Opening in front bumper foam insert no longer present.

The threaded opening for the towing loop in the front of the vehicle is no longer installed as of the PI version of the A4 and A5 platforms. The threaded opening for the towing loop in the rear of the vehicle remains present as in the past.

Making an opening in the bumper foam insert in this area or any modification of the foam bumper insert is not permitted.
