GLOBAL SAFETY FIELD INVESTIGATIONS
DCS5511
URGENT - DISTRIBUTE IMMEDIATELY

Date: September 21, 2020
Subject: N202313410 - Service Update
Engine Wiring Harness Clip
Models: 2020 Chevrolet Malibu
To: All General Motors Dealers

N202313410 Engine Wiring Harness Clip

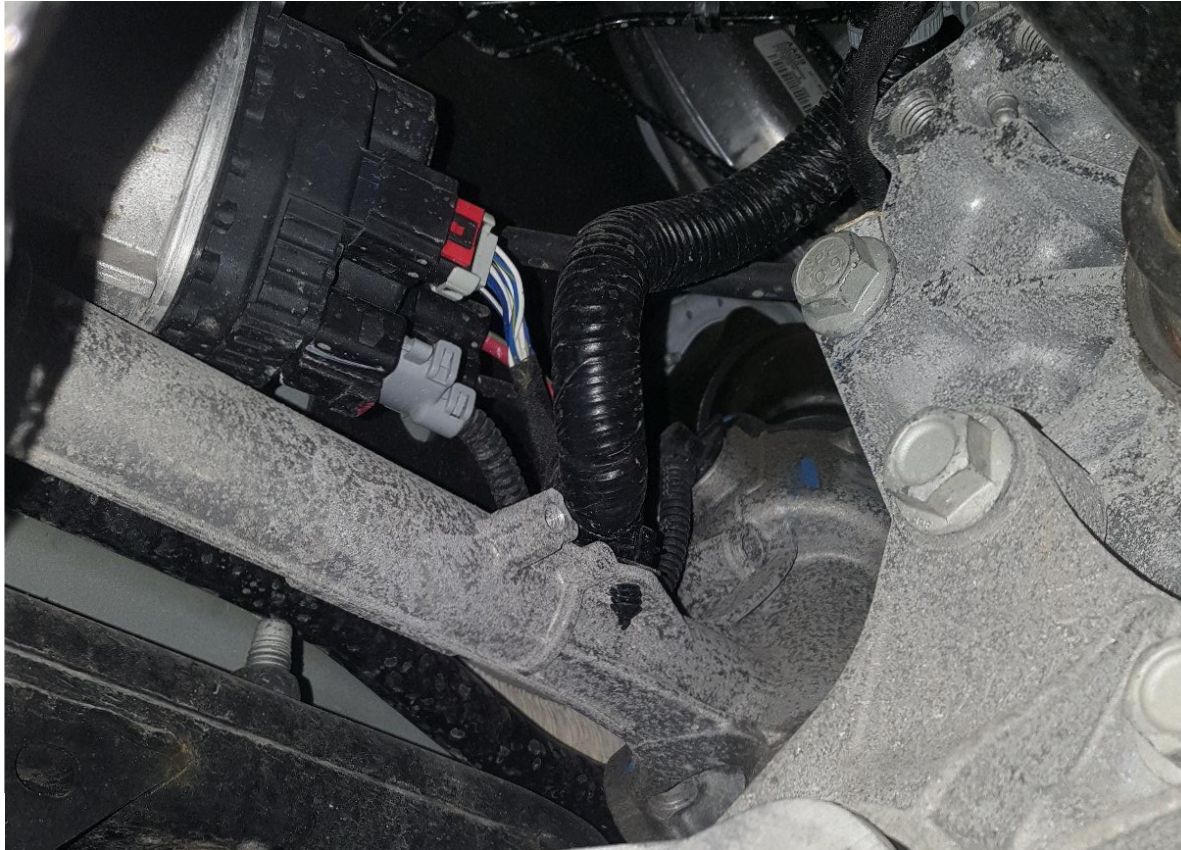
5651923

Condition	Certain 2020 model year Chevrolet Malibu vehicles may have a condition where the engine wiring harness clip may not be secured to the power steering gear housing.
Correction	Dealers are to secure the harness clip at the power steering gear.

2. Inspect the engine harness branch where it clips into the Power Steering rack as shown.
 - If the engine harness is clipped into the rack, no further action is required.
 - If the engine harness is not clipped into the rack, secure the harness to the rack using the push pin fastener attached to the harness as shown.
3. Lower the vehicle. Refer to *Lifting and Jacking the Vehicle* in SI.
