**JOB AID
FOR
SPECIAL SERVICE CAMPAIGN K0B
MILLIMETER WAVE RADAR SENSOR**

**CERTAIN:
2018 – 2019 TACOMA
2018 – 2019 TUNDRA**

VEHICLES WITH MODIFICATIONS

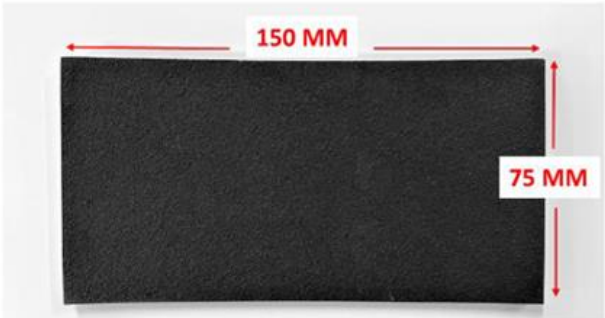
Part Number	Part Description	Quantity
88278-0C010	Cushion, Skid control Computer (EPT Sealer Repair A: 75 mm x 150 mm, t = 5 mm)	1
214182323	K0B Modified Vehicle Label*	1

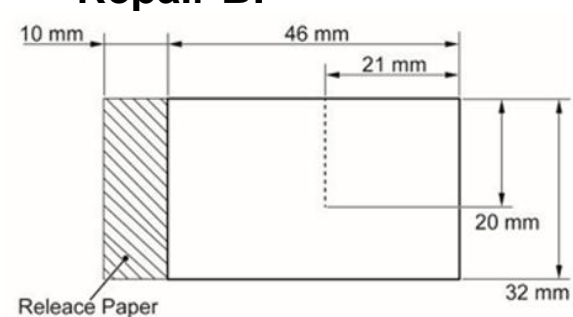
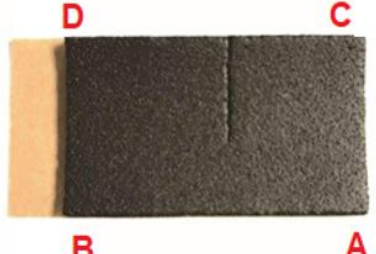
Part Number	Part Description	Quantity
88278-0C020	Cushion, Skid control Computer (EPT Sealer Repair B: 46 mm x 32 mm, t = 3 mm)	1
214182323	K0B Modified Vehicle Label*	1

Recommended temperature for adhesion is 50° F and above.
Keep stock at room temperature.

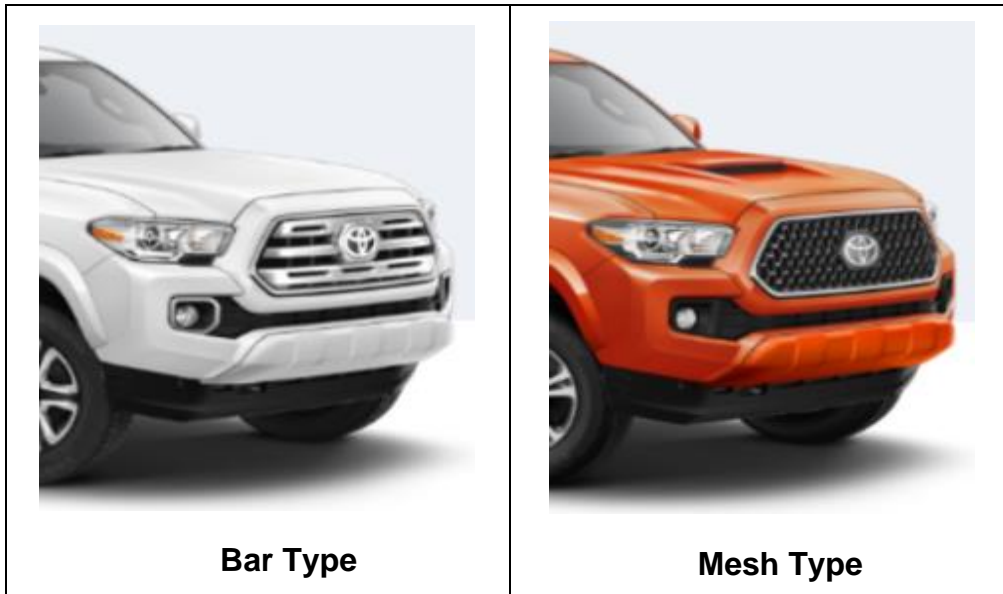
TACOMA - Repair A vehicles will have radiator grilles of these designs:

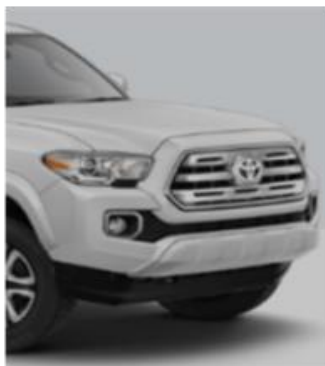
This process is only for Tacoma's with the Bar type grille:

Note: This application will use P/N **88278-0C010**. (75mm x 150mm x 5mm)

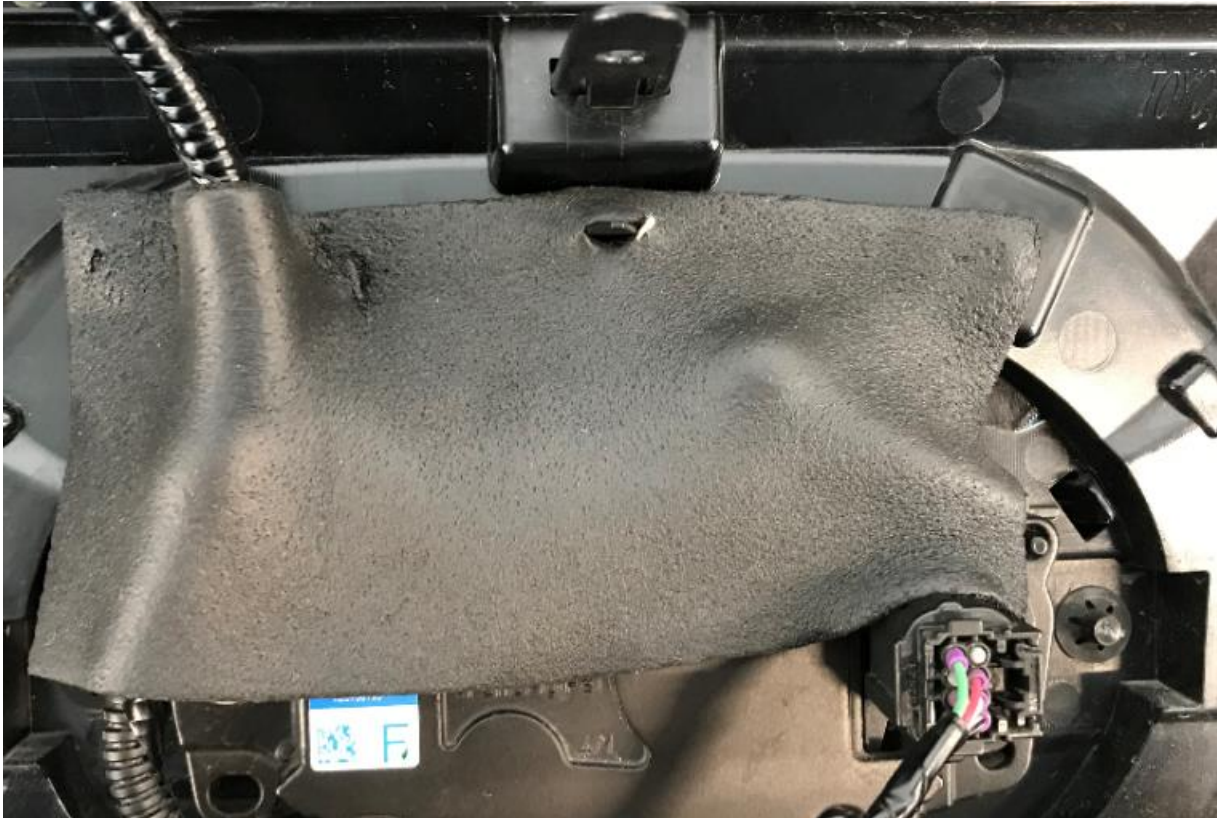
- a. Apply the EPT Sealer to the back side of the MWRS in the position shown below:
- Start applying the EPT Sealer sheet to the vertical surface of the radiator grille, just above the MWRS.
 - It will be necessary to push the EPT Sealer into the plastic tab at the top, creating a hole in the sealer.
 - Wrap the EPT Sealer around the wire harness, as shown.
 - Using heavy finger pressure, thoroughly press the entire surface of the EPT sealer to securely adhere it to all contact surfaces of the MWRS and grille.

Recommended temperature for adhesion is 50° F and above.
Keep stock at room temperature.

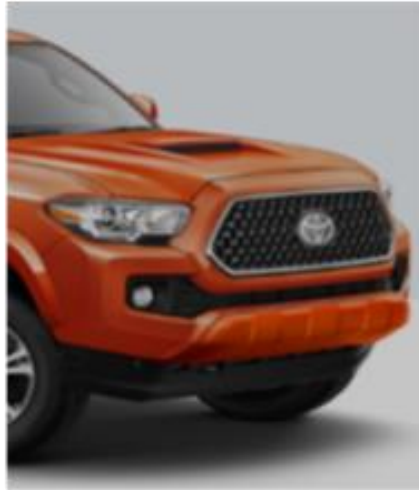
This process is only for Tacoma's with the Mesh type grille:

Note: This application will use P/N **88278-0C010**. (75mm x 150mm x 5mm)

a. Apply the EPT Sealer to the back side of the MWRS in the position shown below:

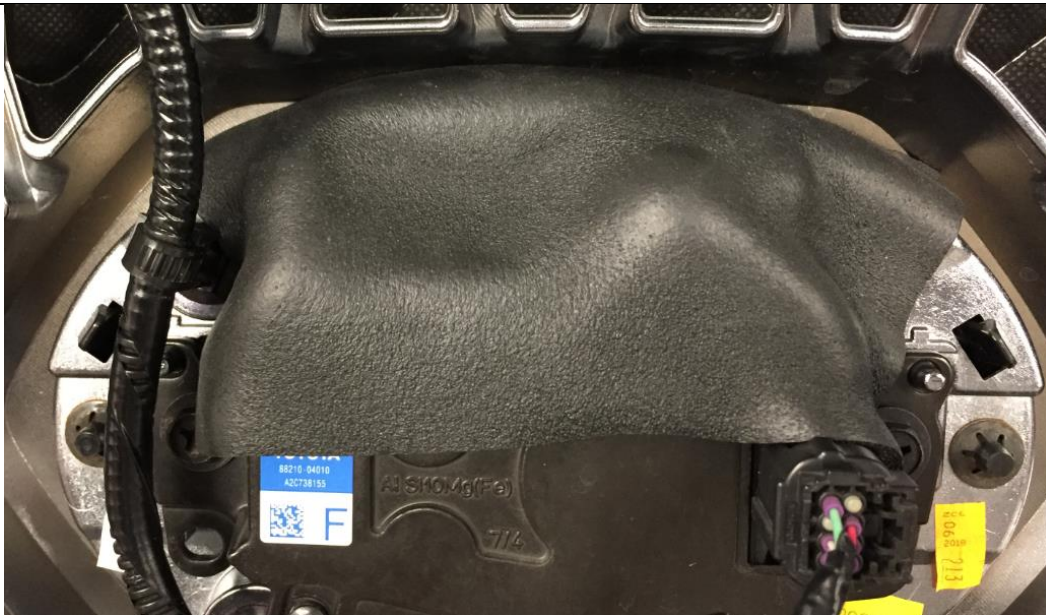
- Start applying the EPT Sealer sheet to the horizontal lip of the radiator grille to create a waterproof shield over the top of the sensor.
- Using heavy finger pressure, thoroughly press the entire surface of the EPT sealer to securely adhere it to all contact surfaces of the MWRS.

Recommended temperature for adhesion is 50° F and above.
Keep stock at room temperature.

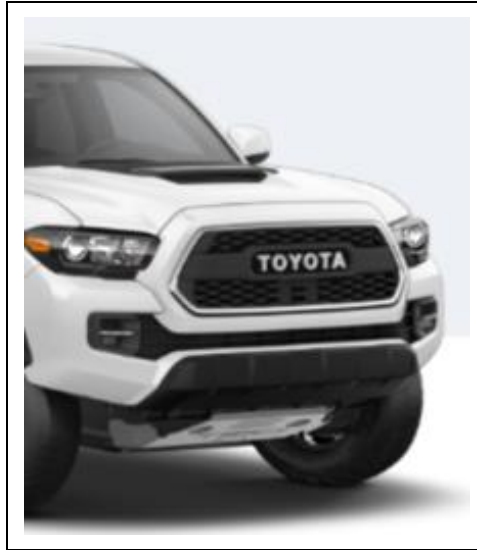
TACOMA Repair B vehicles will have a radiator grille of this design:

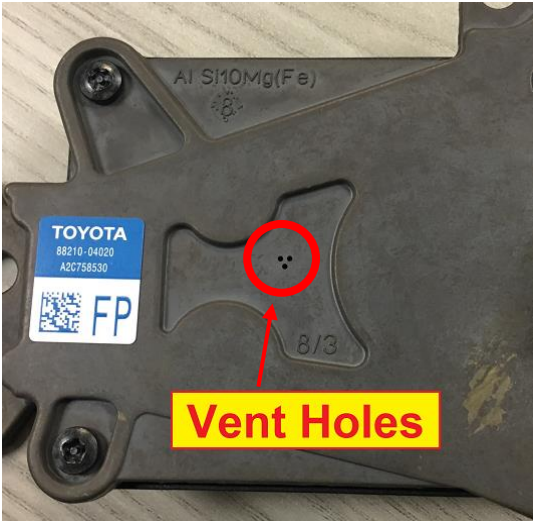
Does the NEW MWRS have vent holes on the back cover?

NO → EPT-Sealer will be necessary. Proceed to Step #5. on p. 17

Yes → EPT-Sealer WILL NOT be necessary. Proceed to Step #9 on p. 20

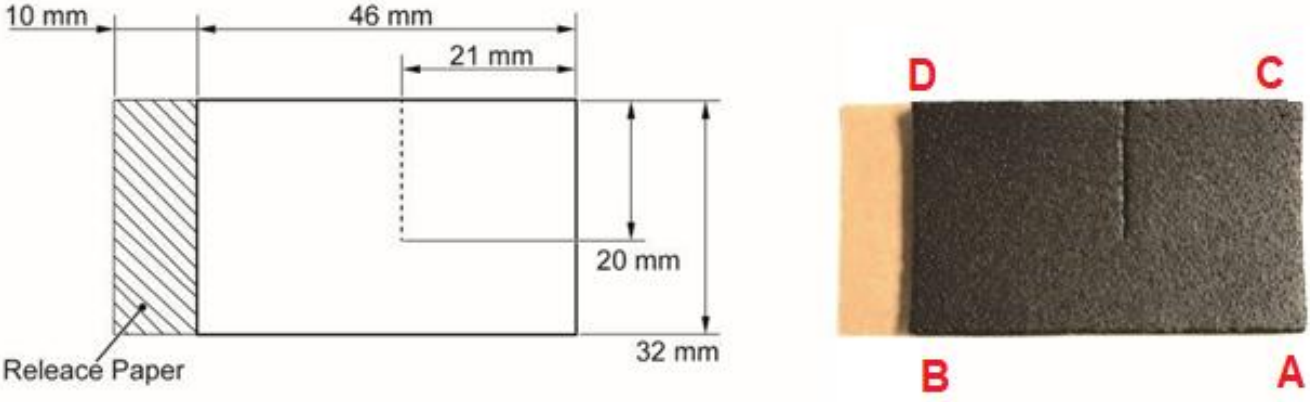
Note: This application will use P/N **88278-0C020**. (46mm x 32mm x 5mm)

The EPT-Sealer will be applied in a specific way, using the following points for orientation. Please note the arrangement of corners A, B, C, D.

Recommended temperature for adhesion is 50° F and above.
Keep stock at room temperature.

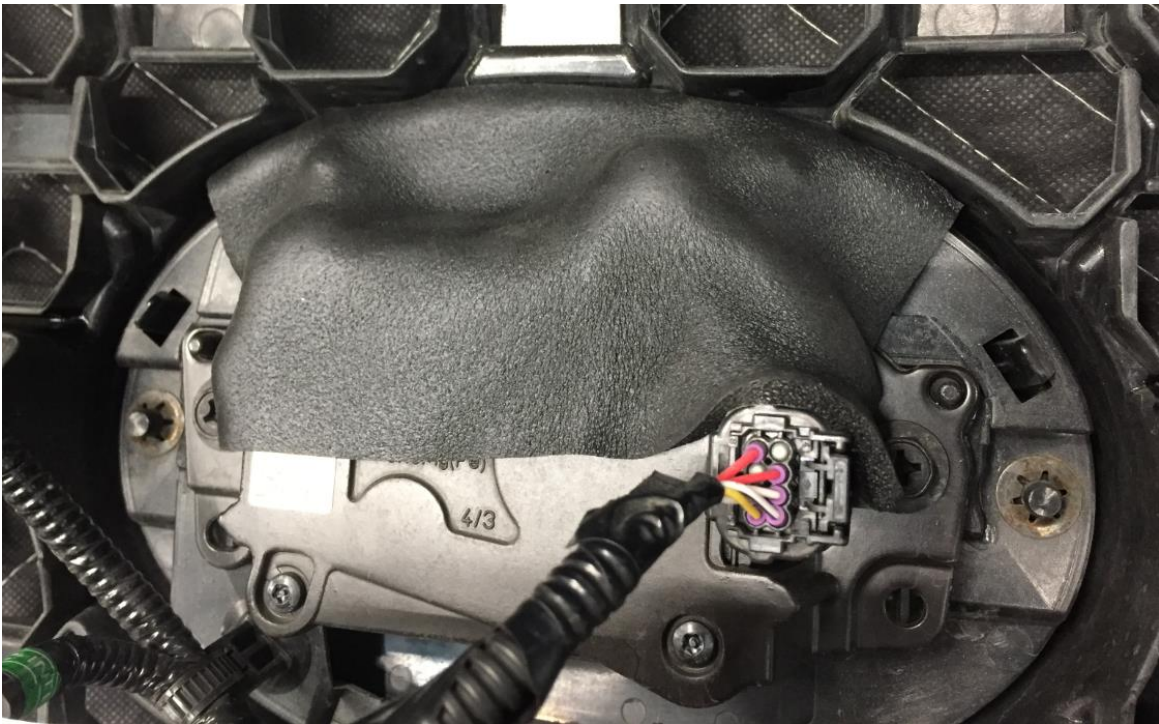
Note: This application will use P/N **88278-0C010**. (75mm x 150mm x 5mm)

- a. Apply the EPT Sealer to the back face of the MWRS in the position shown below.
- b. Roll the EPT sealer onto the inside lip of the radiator grille to create a waterproof shield over the top of the sensor.
- c. Using finger pressure, thoroughly press the entire surface of the EPT sealer to securely adhere it to all contact surfaces.

Recommended temperature for adhesion is 50° F and above.
Keep stock at room temperature.

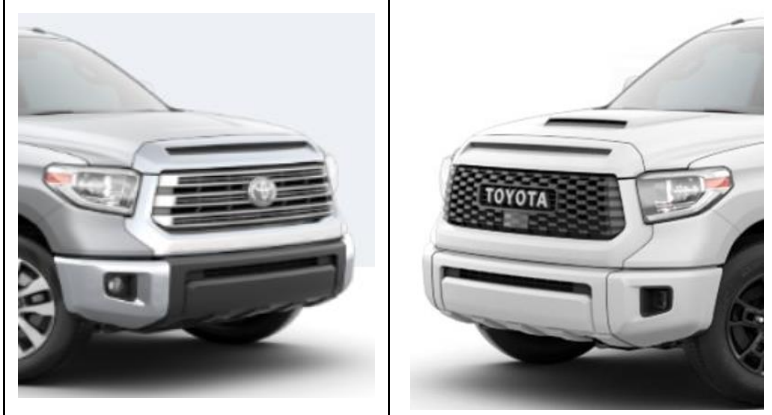
TUNDRA Repair B vehicles will have radiator grilles of these designs:

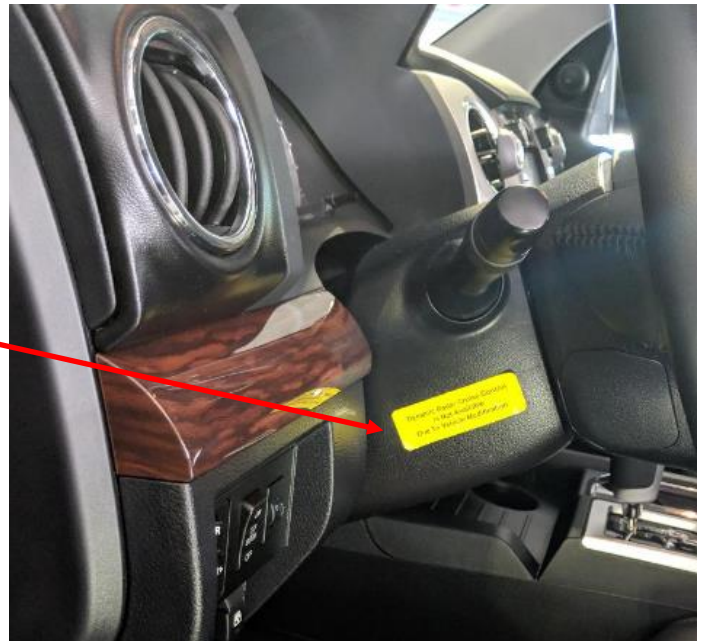
Apply the K0B Modified Vehicle Label to the left side of the steering column
