Technical Service Bulletin

87 Air conditioning does not cool and/or the compressor is noisy

87 20 10 2038023/9 October 22, 2020. Supersedes Technical Service Bulletin Group 87 number 16-74 dated June 30, 2016 for reasons listed below.

Model(s)	Year	VIN Range	Vehicle-Specific Equipment
A3, A3 Cabriolet	2015	000001 - 106816	Not Applicable

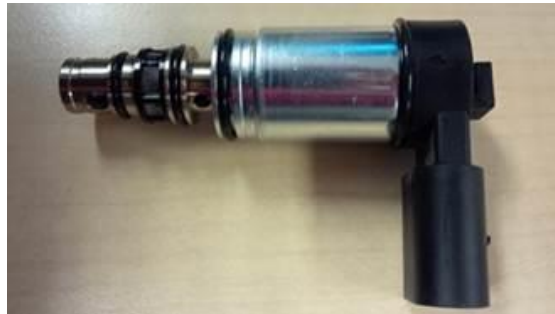
This condition is most likely caused by a faulty N280 valve (Figure 1). The internal components of the valve can be obstructed and incapable of full function. This loss of refrigerant regulation from N280 can cause noise from the A/C compressor and/or affect the HVAC cooling.

Figure 1. N280 Refrigerant Regulating Valve.

An improved N280 valve for the Sanden A/C compressor is now available as a replacement part (5Q0 260 839 A). Replacement of the entire A/C compressor is not necessary in most cases.

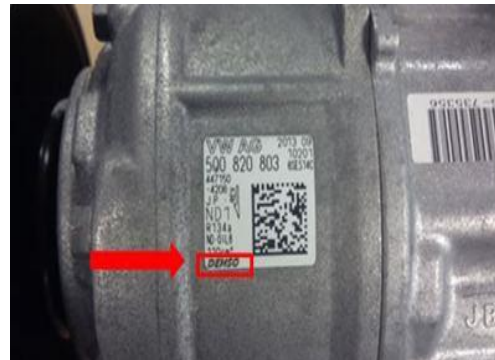
Denso A/C compressors are currently being installed in production (Figures 2 - 3).

Figure 2. Denso compressor identification tag.

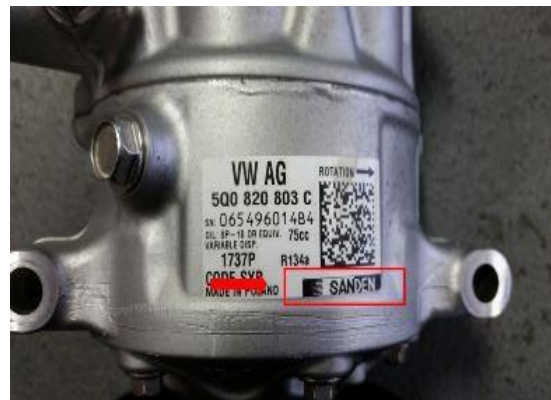
Figure 3. Sanden compressor identification tag.

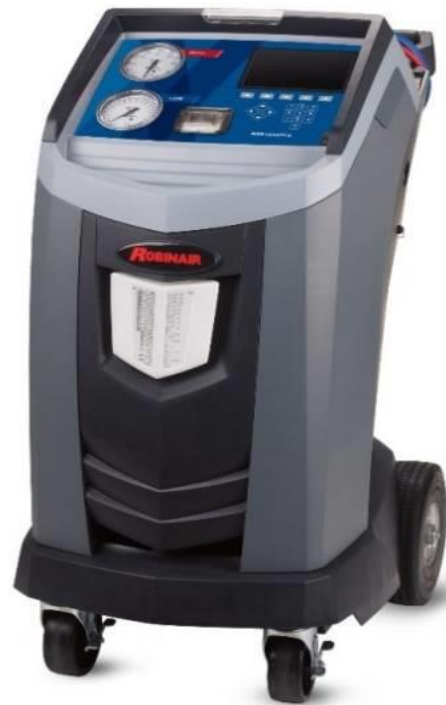
1. Connect both the refrigerant service station (Figure 4) and the diagnostic tester to the vehicle.

Figure 4. Robinair A/C Service Unit.

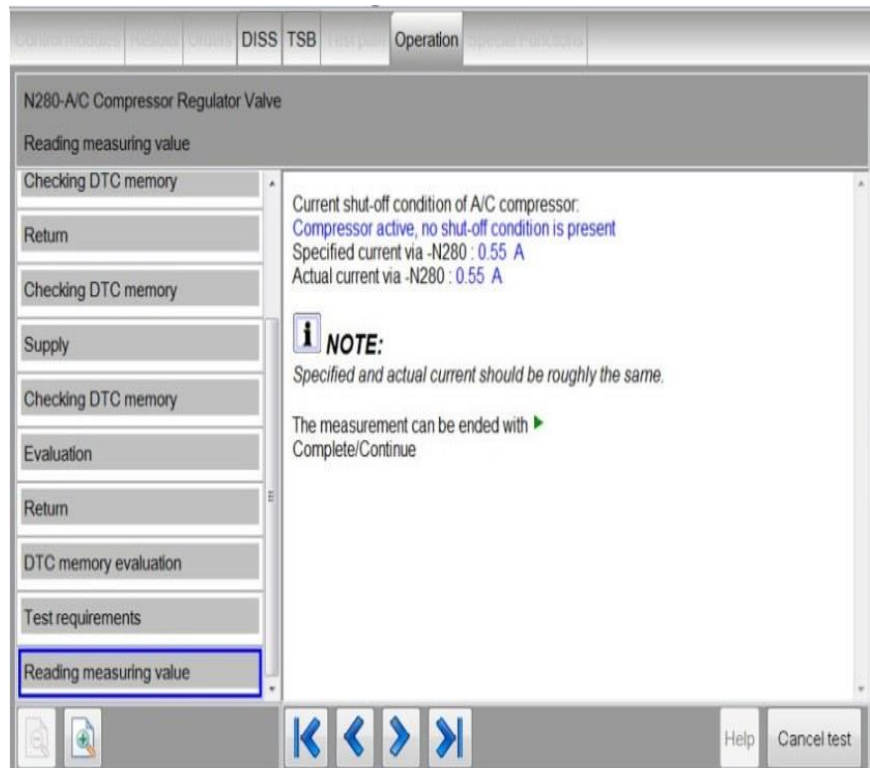
1. With the engine at idle, switch the climate control unit to full cold and full fan.
2. Using the diagnostic tester, go to Guided Functions.
3. Monitor the measuring value for the air conditioner compressor regulating valve N280 signal (Figure 5).

The actual and specified values will be plausible and will show a normal regulating range of current for the cooling request (0.400 A – 0.680 A).

However, there will be equalized pressure readings on the high and low sides of the circuit (no pressure generation from the compressor).

Figure 5. Checking N280 signal value Measuring Value Block.

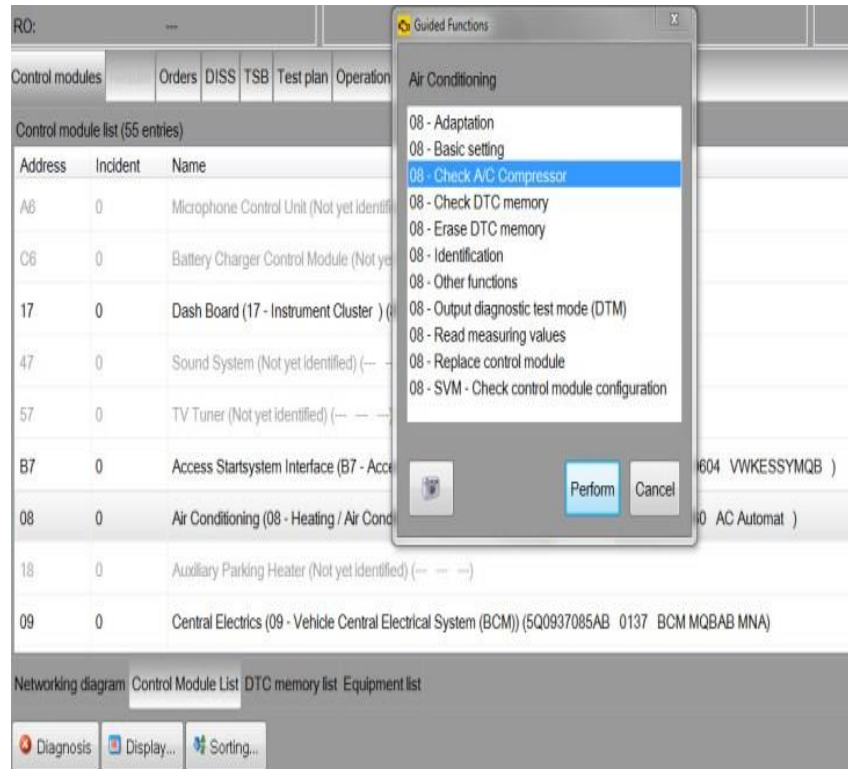
4. Continuing in Guided Functions, select the test plan for “Check A/C Compressor” (Figure 6).

Figure 6. Selecting the test plan for “Check A/C Compressor”.

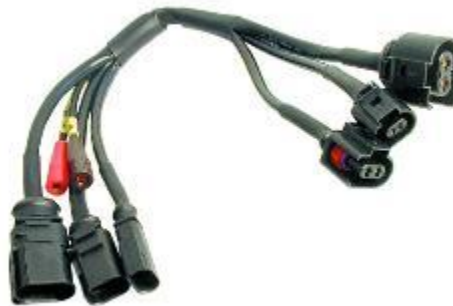
5. Shut off the engine. Connect the breakout harness VAS 5256 (Figure 7) between the N280 valve and its connector.

Figure 7. VAS 5256 breakout harness.

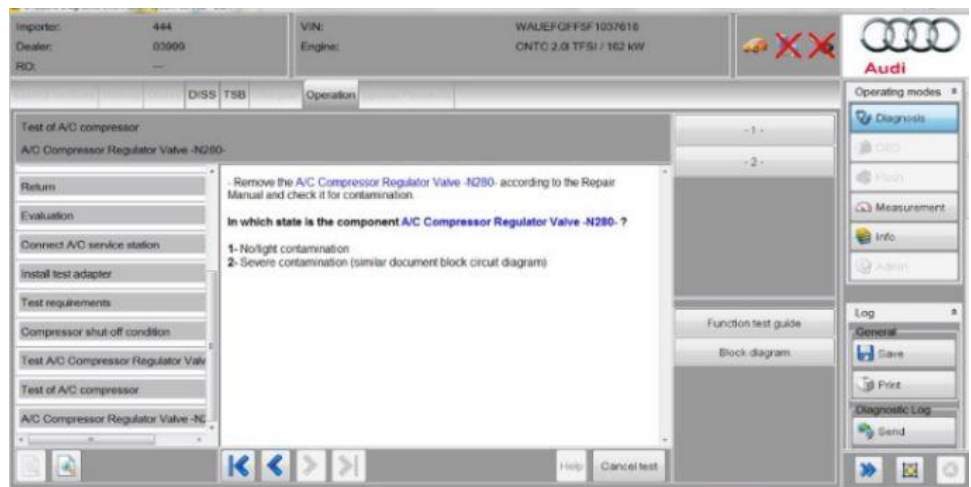
7. If the waveform signal is good, the mechanical integrity of the N280 valve will be inspected next (Figure 9).

Figure 9. Checking for N280 valve contamination.

8. Recover the refrigerant from the system. Remove the N280 valve using the procedure in the Elsa Repair Manual.

Warning: With the refrigerant circuit charged the N280 valve is under pressure. Be certain that the refrigerant circuit is completely discharged before removing the N280 valve.

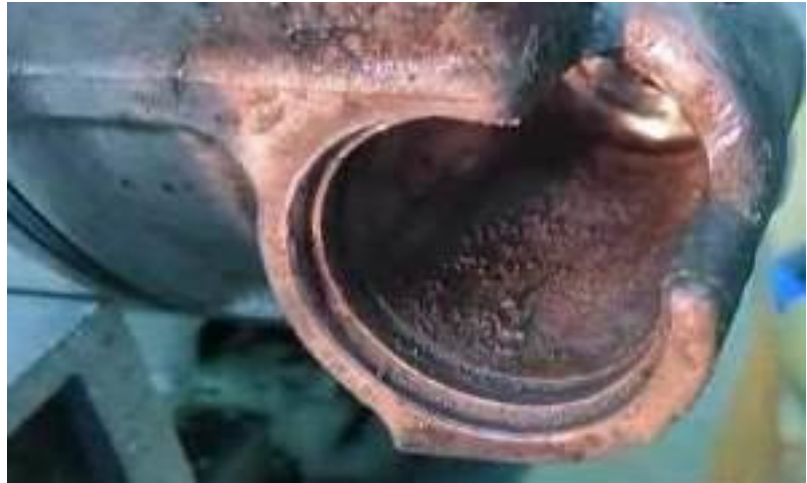
9. Assess the condition of the N280 valve bore and the valve filter screen (Figure 10). If severe contamination or corrosion is found in the valve bore there is a risk of damaging the replacement valve on installation. In these cases, the A/C compressor must be replaced. A slight amount of debris or corrosion does not present a risk and does not justify the replacement of the A/C compressor.

Figure 10. Corrosion in the N280 valve bore.

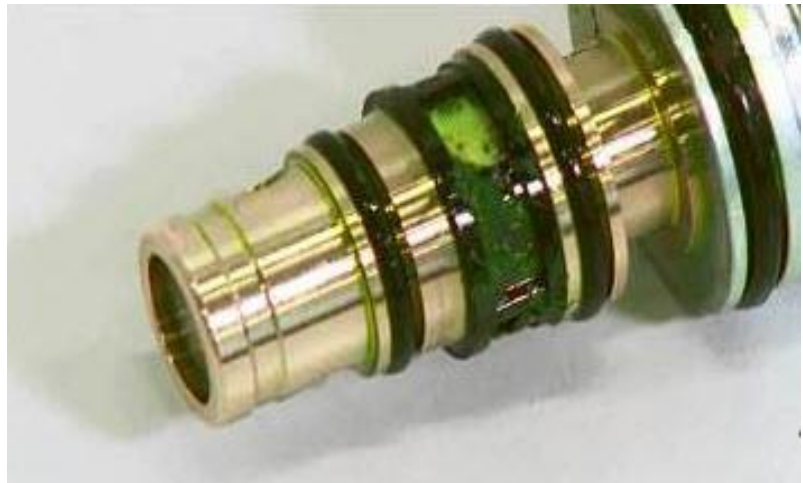
10. Should severe contamination be found at the valve filter screen (Figure 11) and A/C compressor replacement becomes necessary, ensure that the refrigerant circuit is flushed in the course of repair. The presence of small random particles on the filter screen does not constitute 'severe' contamination and does not justify the replacement of the A/C compressor.

Figure 11. Severe contamination at the N280 valve filter screen.

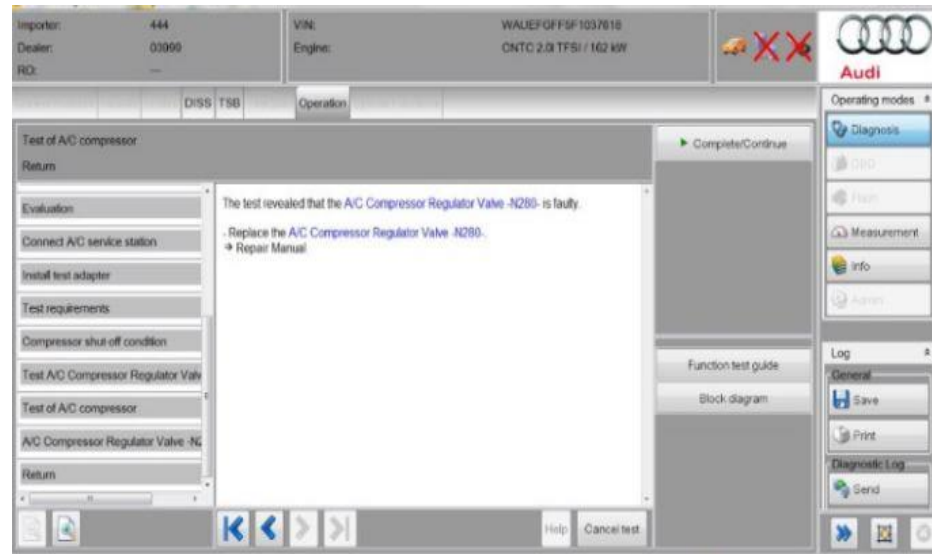
11. If little or no contamination is found, the test plan will direct to replace the N280 regulating valve (Figure 12). Replace the valve using the instructions in the Elsa Repair Manual.

Figure 12. Test plan confirming that the N280 is faulty.

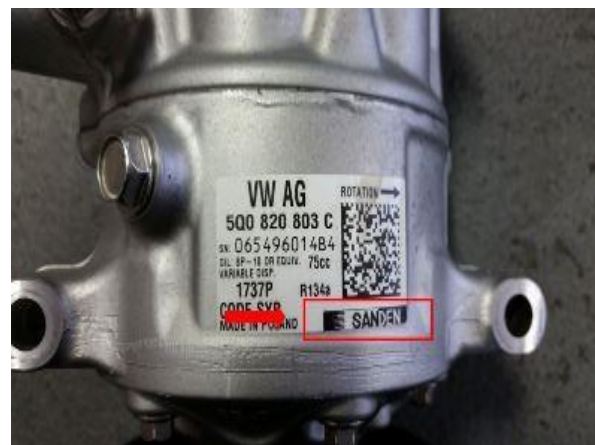
1. As mentioned in the *Technical Background*, the originally-installed compressor on the MY 2015 A3 is manufactured by Sanden (Figure 13). The replacement compressor is manufactured by Denso (Figure 14).

When replacing the original Sanden compressor with a Denso compressor, be aware that while the refrigerant volume is the same regardless of the compressor installed, the PAG oil type and volume is not. Sanden and Denso compressors have specific PAG oils that must be used.

Figure 13. Sanden compressor identification tag.

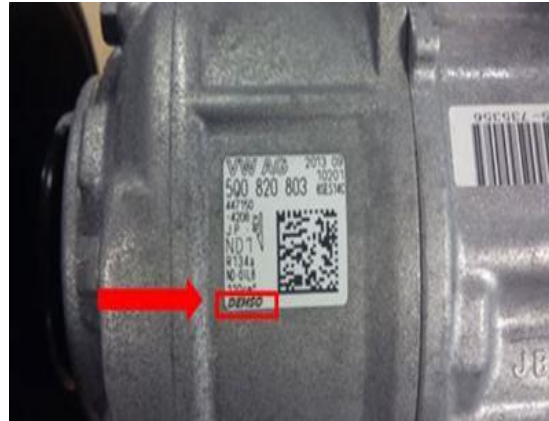
Figure 14. Denso compressor identification tag.

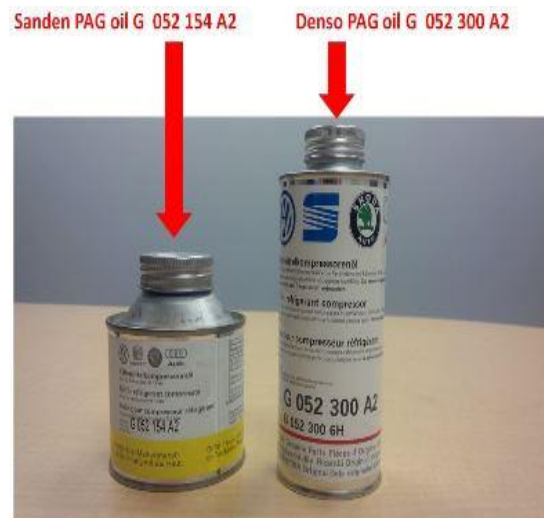
3. The replacement compressor will come with the specified type of PAG oil for the compressor (Figure 15). The amount of PAG oil supplied with the replacement compressor may not be the exact amount required to replenish the refrigerant circuit. Drain and measure the PAG oil in the replacement compressor to determine the required amount. If the amount needs to be adjusted, do so using the correct type of PAG oil specified in ETKA. Refer to Elsa for the correct oil capacity for the compressor being installed.

Figure 15. Compressor manufacturer-specific PAG oils.

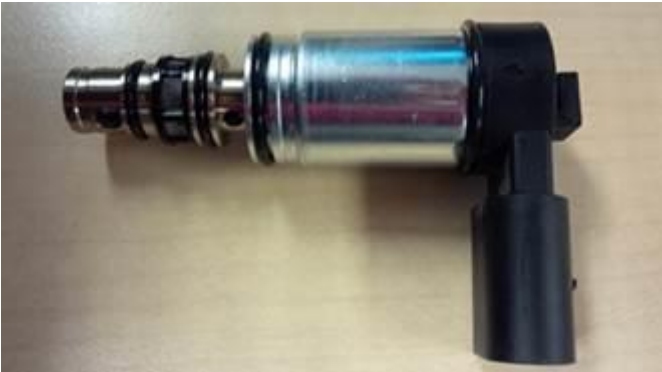
N280 Refrigerant Regulating Valve	01
G 052300A2

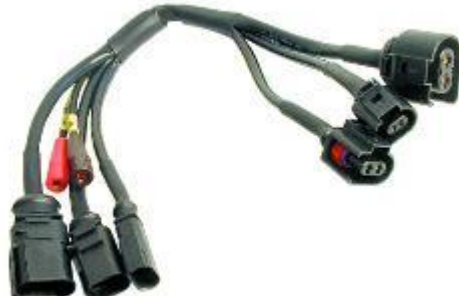
Tool Number	Tool Description
VAS5256 or equivalent

<p data-bbox="519 1291 730 1323">Breakout Harness</p>

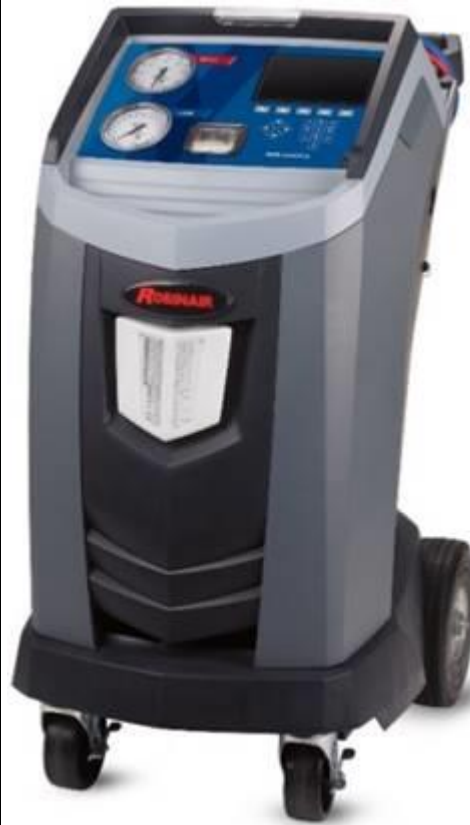
ROB134APF or
ROB134APFX

Robinair A/C Service Unit

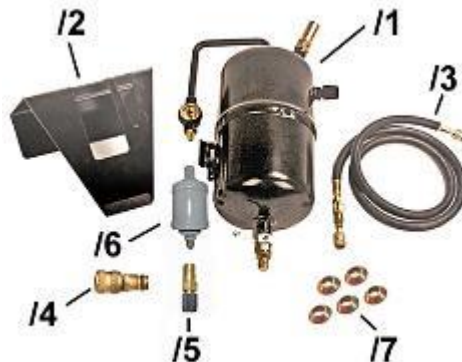
17707

Air Conditioning Flush Tool

2. The original PAG oil that will be in the refrigerant circuit must be flushed out completely with the air conditioning service station with flushing equipment, as specified in the Elsa Repair Manual.
