TECHNICAL SERVICE BULLETIN

Technical Service Bulletin: 03-1240

Forest River is alerting you to an issue involving certain 2019 through 2020 – Sierra and Sandpiper fifth-wheel travel trailer recreational vehicles. Please see the information below which describes the issue and provides you with details on the steps you should take to have your vehicle repaired.

The installed control panel may allow the slide-rooms to retract without operator command.

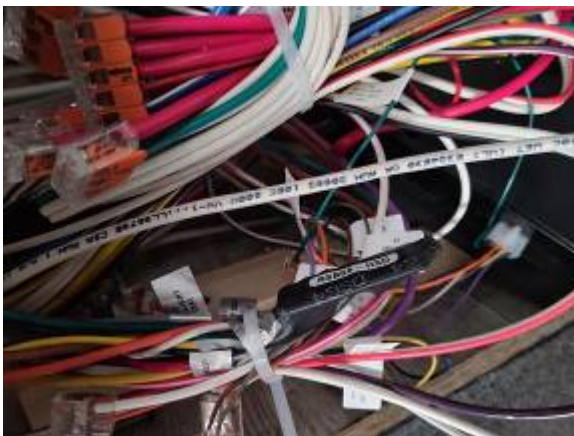
FIGURE 3

FIND THE BUNDLE OF WIRES, WHICH WILL HAVE EITHER A **RSB68-HSR** OR A **RSB68-HSD** (FIGURE 3 AND FIGURE 4);

IF THE VEHICLE HAS A **RSB68-HSD**, CLAIM THE INSPECTION CODE AND DO NOT PROCEED.

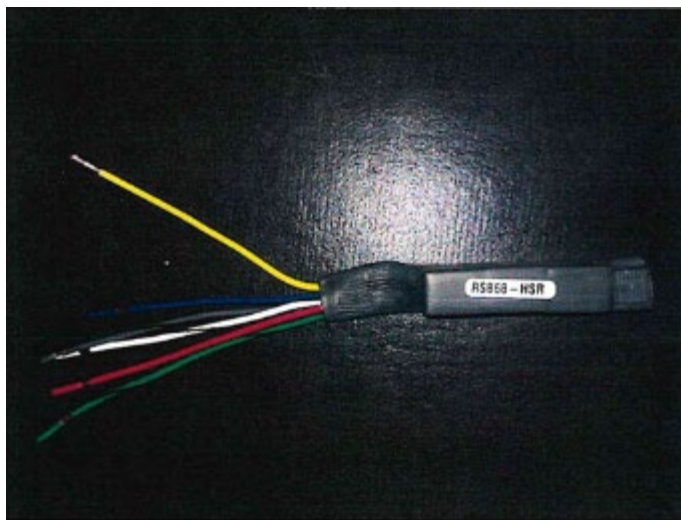
RSB68-HSR WIRES	
RSB68-HSR WIRE COLOR	CONNECTS TO:
RED WIRE	OUR RED WIRE FROM PLUG 1, PLUG 2 (AND PLUG 3 IF USED) WHICH GOES TO THE BLACK W/ WHITE STRIPE, 10 GA. WIRE ROUTED TO AND CONNECTS TO A MINI-BREAKER FOR POWER.
GREEN W/ WHITE STRIPE	OUR BLACK W/ WHITE STRIPE 14 GA.; ZIP WIRE TO THE REV. TANG ON THE TROMBETTA.
BLUE WIRE	MAIN ROOM OUT + (POS.); WHITE WIRE ON PLUG 1
GREY W/ BLACK STRIPE	OUR ORANGE 12 GA. WIRE ROUTED TO THE VALVE MAGNET FOR THE HYDRAULIC SLIDES.
WHITE W/ BLACK STRIPE	OUR WHITE WIRE 14 GA.; ZIP WIRE ABOVE AND ROUTES TO THE FWD TANG ON THE TROMBETTA.
YELLOW WIRE	MAIN ROOM OUT - (NEG.); ORANGE WIRE ON PLUG 1

When replacing an RSB68-HSR with an RSB68-HSD, ENSURE TO WIRE IT CORRECTLY.

The HSR red wire wired goes to hot, and the HSD red wired goes to the one tang on the Valve Magnet for Hydraulic Slides. So when replacing the HSR with the HSD you will need to remove the red wire on the HSR from the WAGO connector and re-close the WAGO connector.

The Green & White wires from the HSR need to be reversed on the HSD. See below for the HSR and the HSD wires breakdown.

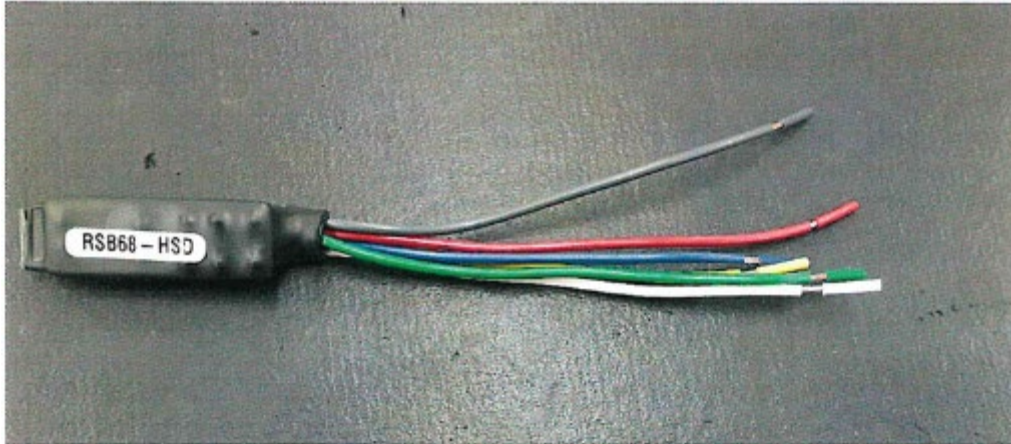
RSB68-HSD WIRE	
RSB68-HSD WIRE COLOR	CONNECTS TO:
RED WIRE	OUR WHITE 14 GA. WIRE THAT GOES TO ONE OF THE TANGS ON THE VALVE MAGNET FOR HYDRAULIC SLIDES.
GREEN W/ WHITE STRIPE	OUR WHITE 14 GAUGE ZIP WIRE THAT GOES TO THE FWD TANK ON THE TROMBETTA.
BLUE WIRE	MAIN ROOM OUT + (POS.) WHITE WIRE ON PLUG 1
GREY W/ BLACK STRIPE	OUR ORANGE 12 GA. WIRE GOING TO THE VALVE MAGNET FOR HYDRAULIC SLIDES.
WHITE W/ BLACK STRIPE	OUR BLACK W/ WHITE STRIPE 14 GA. ZIP WIRE ABOVE WHICH GOES TO THE REV. TANK ON THE TROMBETTA.
YELLOW WIRE	MAIN ROOM - (NEG.) ORANGE WIRE ON PLUG 1

Run a new 14 gauge white wire from this tang to the red wire on the new HSD.

The yellow and blue wires on the HSD will connect to the same wires as the HSR was connected to.
