IMPORTANT SAFETY RECALL NOTICE

Subject: **Can-Am® Ryker - Possible Front Wheel Loss**

WARRANTY BULLETIN SAFETY CAMPAIGN

Subject: **Possible Front Wheel Loss**

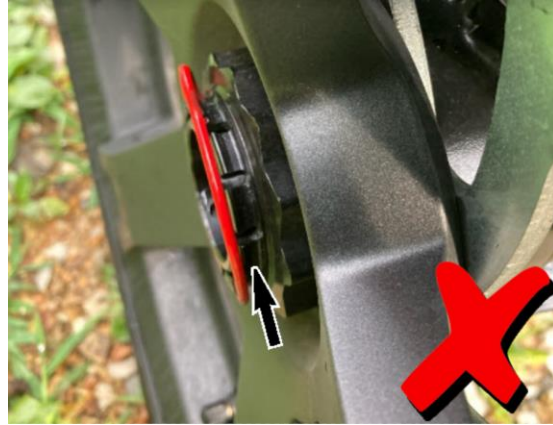
The front wheels assembly may not have been performed properly (torque application and installation of the red locking clip). In some situations, this could result in a wheel loss, increasing the risk of a crash.

RED LOCKING CLIP OUT OF THE GROOVE

Retorque the front wheel nuts and reinstall the red locking clip.

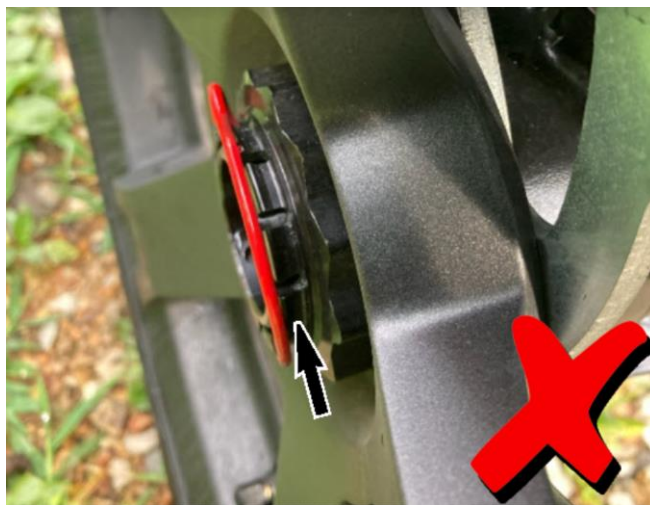
A properly installed red locking clip is sitting well into the groove all around the nut. If you see an installation like the picture below - red locking clip NOT installed properly, contact your dealer to organise transportation of your vehicle to the dealership.

RED LOCKING CLIP OUT OF THE GROOVE

If the red locking clip is NOT well installed, do not drive your vehicle as you may lose a wheel while driving.

Contact your authorized BRP Can-Am On-Road dealer and schedule an appointment to have the safety recall performed on your vehicle.
