**Subject:** Insufficient clearance between coolant hose and right-hand inner fender splash shield on some Aeromaster models.

**Condition:** Coolant reservoir hose may rub against splash shield.

**Applies To:** This bulletin applies to model year 2019-2020 Aeromaster on the Ford F59 chassis, manufactured between January 1, 2019 and July 30, 2020. Contact Utilimaster Warranty Department to verify chassis VIN.

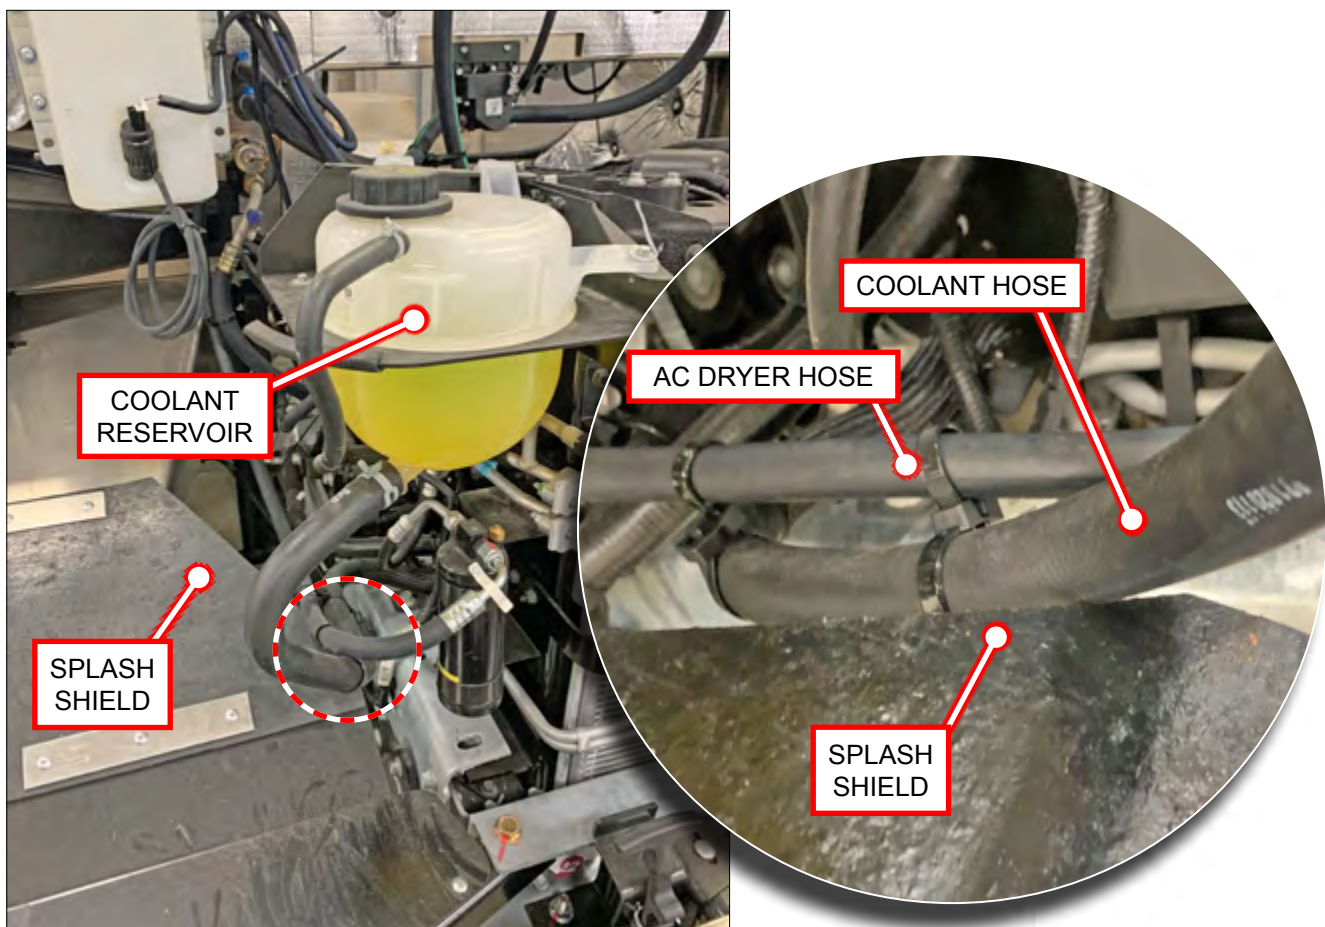
1. Read and understand all the instructions before starting the repair.
2. Raise the hood and visually inspect the lower coolant reservoir hose.
  - a. If there is at least 1" clearance between the rubber splash shield and the hoses, no further action is needed.
  - b. If coolant overflow hose has less than 1" clearance and there is no hose abrasion, proceed with Splash Shield Trim Procedure.
  - c. If coolant overflow hose shows sign of damage, proceed with Splash Shield Trim Procedure and follow the Hose Repair Procedure.

*Overview of interference between RH inner fender splash shield and hose(s)*

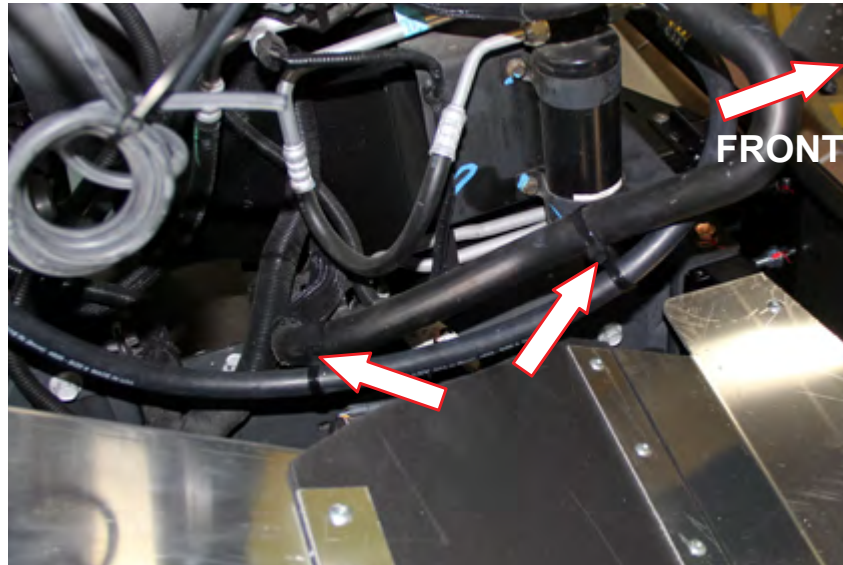
*Wire ties on coolant and AC hose*

1. Wire tie coolant hose and AC drier hose away from the splash guard.

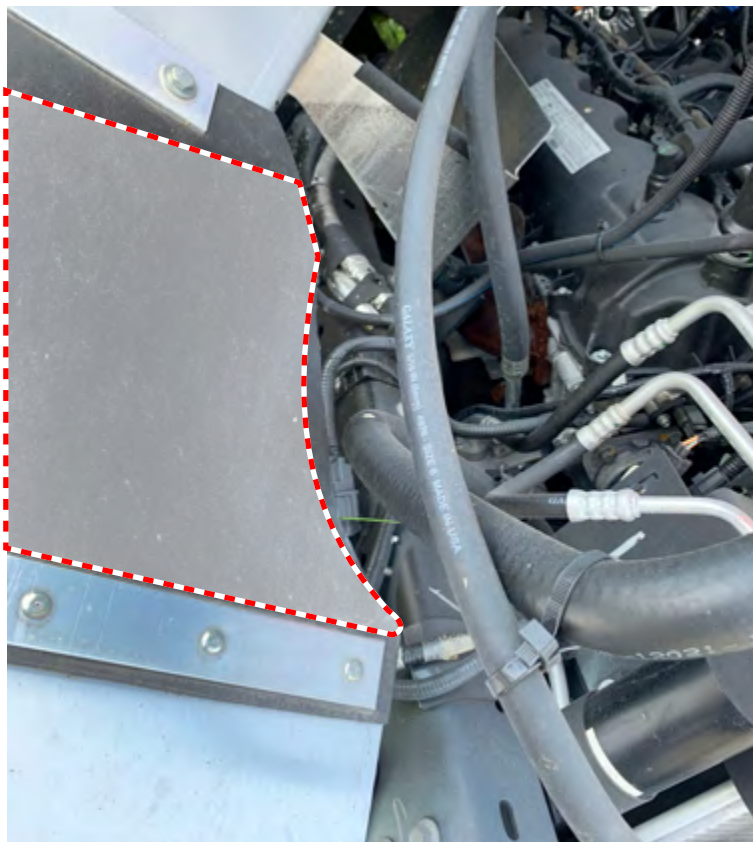
*Splash guard trimmed to provide clearance*

2. If necessary, trim the rubber material to provide at least 1" clearance.

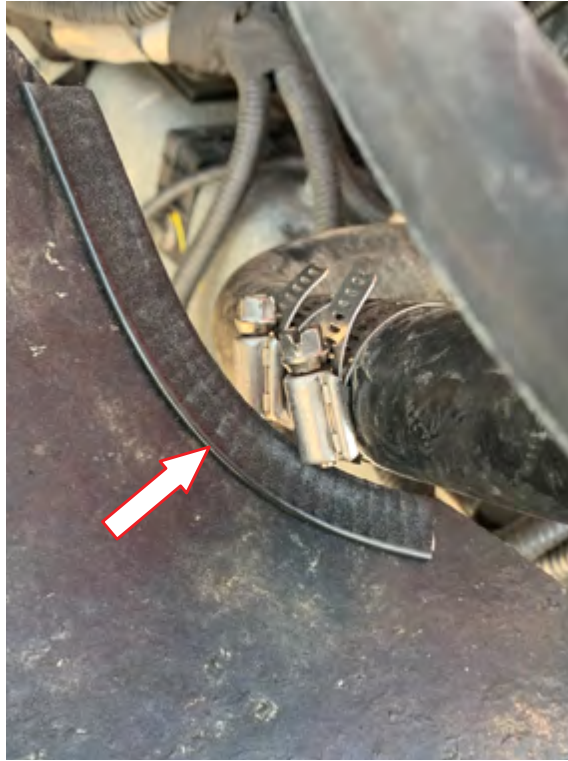
*Trim lock installed on splash shield*

3. Apply trim lock to the edge of the splash shield.

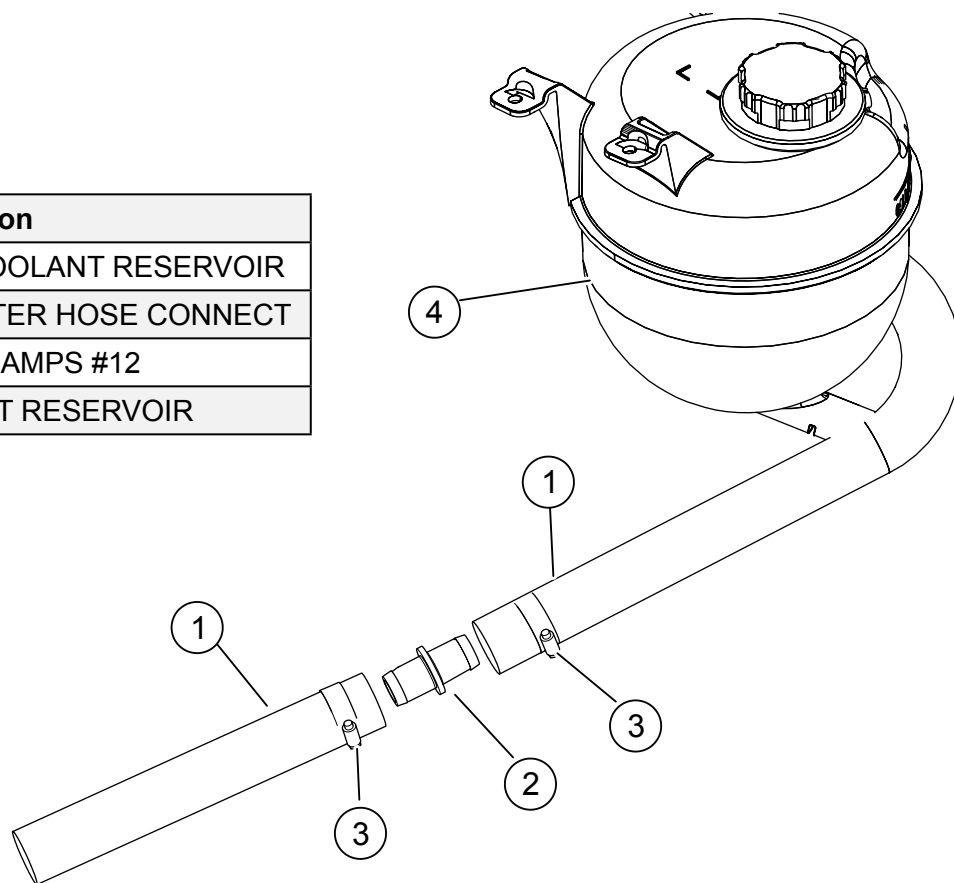
| ID | Description |
| 1 | HOSE COOLANT RESERVOIR |
| 2 | 3/4" HEATER HOSE CONNECT |
| 3 | HOSE CLAMPS #12 |
| 4 | COOLANT RESERVOIR |

*Overview of hose repair*

1. Clamp off the hose above and below the cut or abrasion.
2. Cut the hose to remove the damaged segment.
3. Insert the hose connector between the hoses and secure with (2) #12 hose clamps.
4. Torque clamps to 50–60 in•lb.
5. Add coolant if the level is below MIN mark on the coolant reservoir.

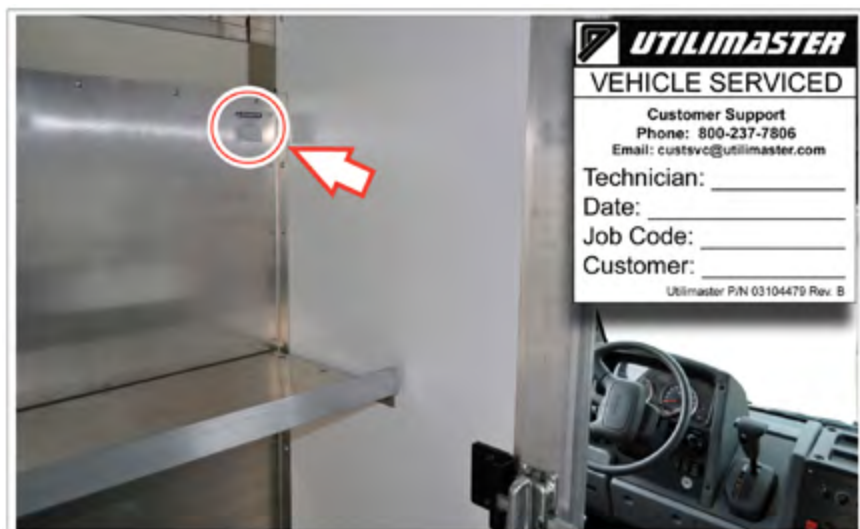
Service decal on driver's door pocket (cargo side)

6. Use the applicable Job Code from this document to complete the SERVICED decal.
7. Adhere the decal to the upper right-hand corner of the driver's door pocket panel or sidewall next to the bulkhead wall. Do NOT cover any previously applied decals.
