SERVICE INFORMATION BULLETIN

APPLICABILITY: All Models with FA and FB Series Engines **NUMBER:** 14-26-20
SUBJECT: FA / FB Front Timing Chain Cover Removal Tool Announcement **DATE:** 10/07/20

INTRODUCTION:

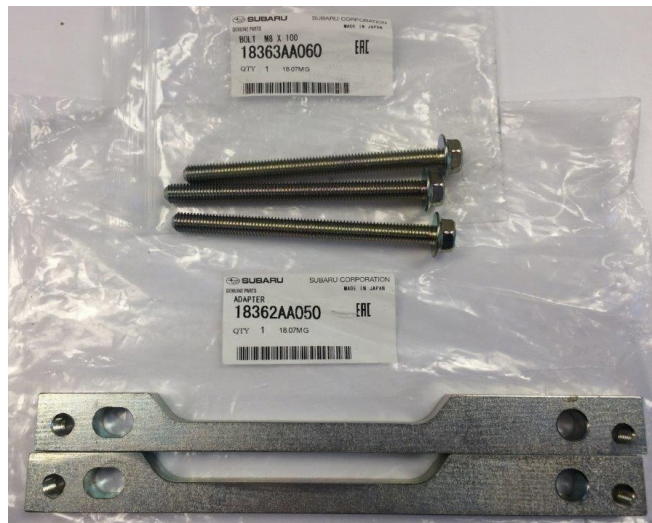
The kit consists of two “Adapters” and three M8-1.25 x 100 removal bolts which when installed into the adapters, will press against specific areas to separate / “push” the timing chain cover away from it’s mating surfaces on the crankcase and camshaft carriers. A photo of the kit contents is supplied below.

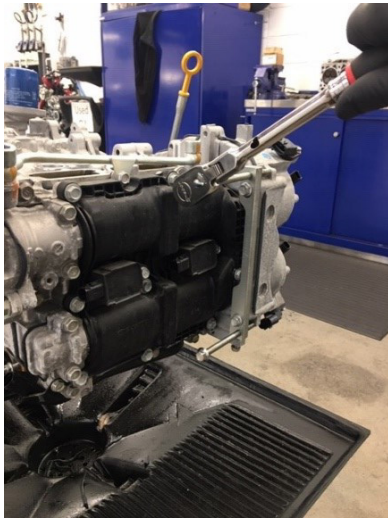
3) **USING HAND TOOLS ONLY**, begin to **SLOWLY** turn the removal bolts **ONE HALF A TURN AT A TIME** while alternating from left to right, upper and lower until the chain cover begins to separate from the engine. **NEVER** use any power tools when performing this procedure.

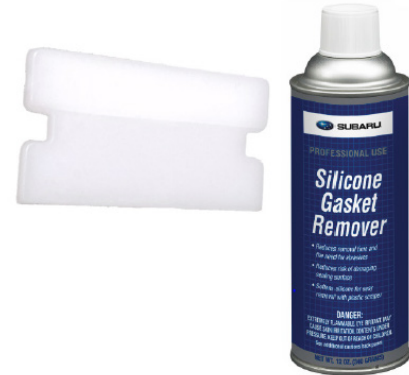
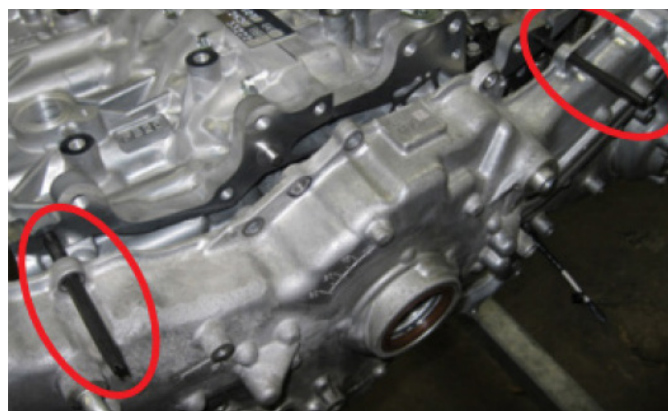
- Whenever re-installing the chain cover assembly, be very careful to not allow it to contact the timing sprockets. If contact does occur, it is almost a guarantee the fresh sealant beads applied to the chain cover will be disturbed and can potentially cause a post-repair oil leak. To minimize the possibility of this, **ALWAYS** use the alignment pins shown below to “guide” the chain cover into proper position without disturbing the freshly applied sealer. The Subaru Special Tool Kit number is **J-51972**. Each kit includes 2 alignment pins.
