Outside Door Handle Cracks/Breaks

Model	Model Year	Model Type	VIN Range	Vehicle-Specific Equipment
Macan	2015-2021	95B	N/A	M Number 4F6 K keyless Entry

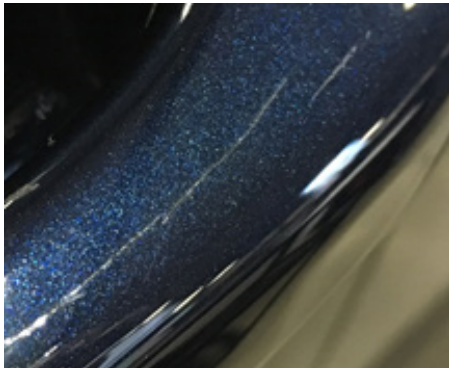
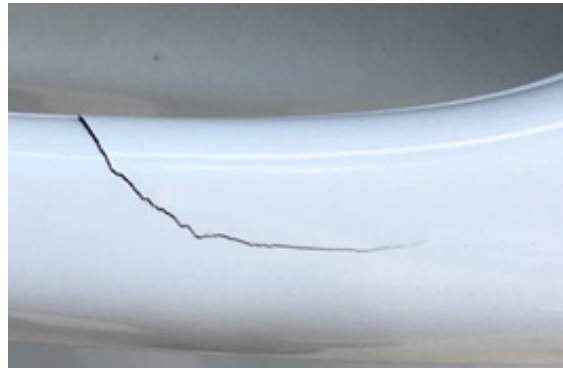
The outside door handle may crack and break. It initially looks like the paint is cracking, but will grow to larger size cracks.

A material incompatibility in the handle itself has been found to cause this issue.

The door handle should only be replaced, if the crack has become more than a hairline crack like the photo on the right.

95B.837.205.C G2X

95B.837.206.C G2X
