### Outside Door Handle Cracks/Breaks

Model	Model Year	Model Type	VIN Range	Vehicle-Specific Equipment
Cayenne	2019-2021	9YA/ 9YB	N/A	M Number 4F2, 4F6 Keyless Entry

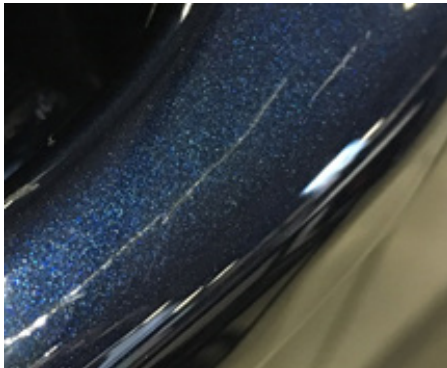
The outside door handle may crack and break. It initially looks like the paint is cracking, but will grow to larger size cracks.

A material incompatibility in the handle itself has been found to cause this issue.

The door handle should only be replaced, if the crack has become more than a hairline crack like the photo on the right.
