**Symptom in Vehicle Interior - Center Console Operator Control Unit Discolored at the Edges (SY 154/20)**

Model Line: **Cayenne (9YA)**

Model Year: **As of 2019 up to 2020**

Subject: **Center console operator control unit**

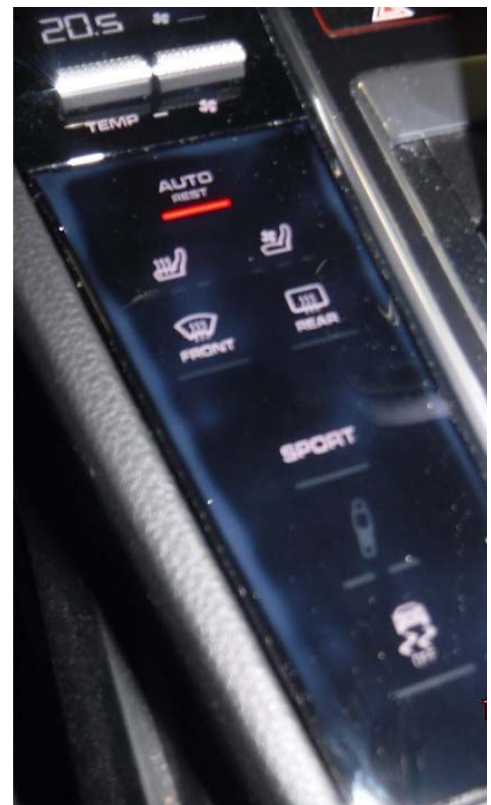
Symptom: The center console operator control unit may become discolored at the edges.

*Center console operator control unit discolored at the edges*

Optimized center console operator control units have been used in production since 26 April, 2019.

Remedial Action: In the event of a customer complaint, replace the center console operator control unit, see ⇒ *Workshop Manual '962719 Removing and installing centre console operator control unit (front)'*
