Technical product information

Topic	Rotating Display - Fault Diagnosis
Market area	Bentley: worldwide (2WBE),Hongkong-Macau (5HK)
Brand	Bentley
Transaction No.	2055580/4
Level	EH
Status	Released for publishing
Release date	22-Oct-2020

New Continental GT

Various rotating display operational complaints or noises.

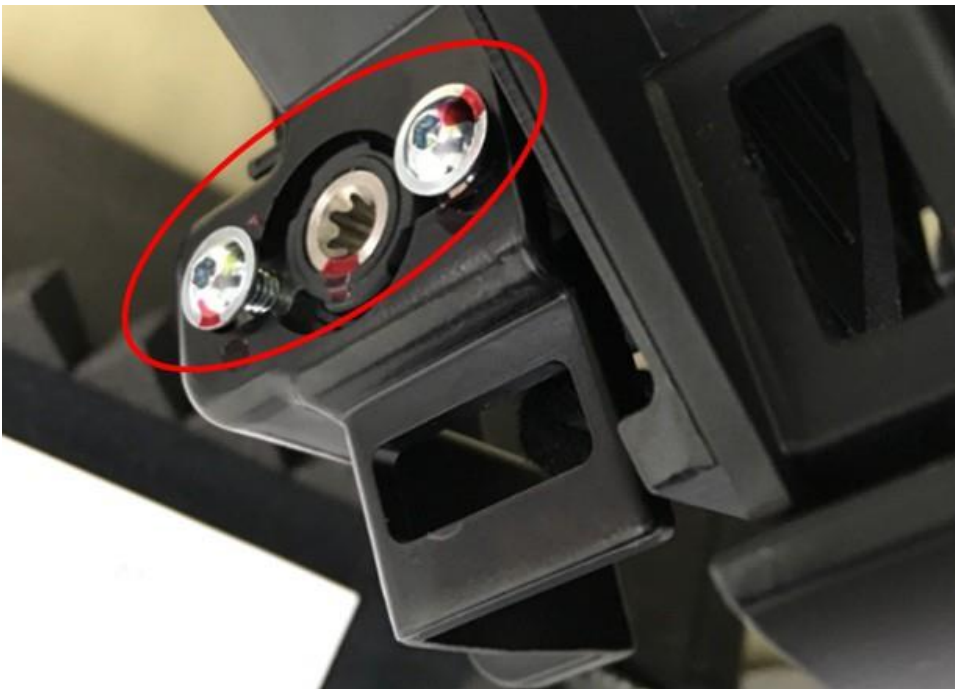
Figure 5

Check the tightness of the fixing screws highlighted (Figure 5), there are 8 fixing screws in total. Check and retighten where necessary (3 Nm).

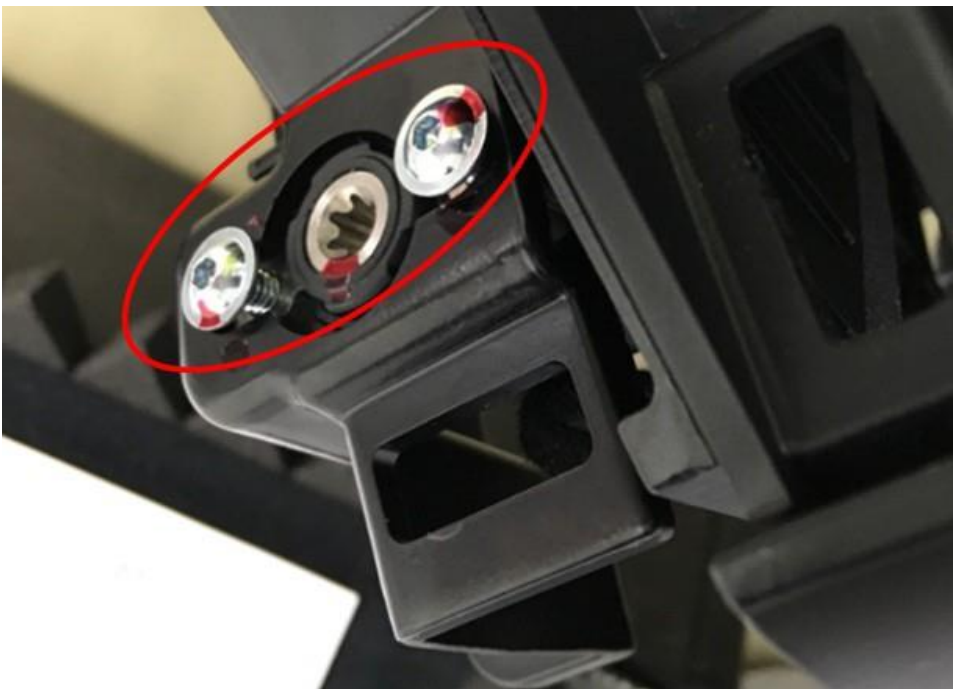
Figure 9

1. Remove rotating display then check and if necessary tighten fixing screws highlighted (Figure 9), there are 8 fixing screws in total. Check and retighten where necessary (3 Nm).

2. Refit the rotating display to a state that it can be tested then carry out re-initialisation and retest.
