Technical product information

Topic	Fluid leak from front air spring
Market area	Bentley: worldwide (2WBE),Hongkong-Macau (5HK)
Brand	Bentley
Transaction No.	2054635/5
Level	EH
Status	Released for publishing
Release date	22-Oct-2020

New Continental GT and New Continental GTC

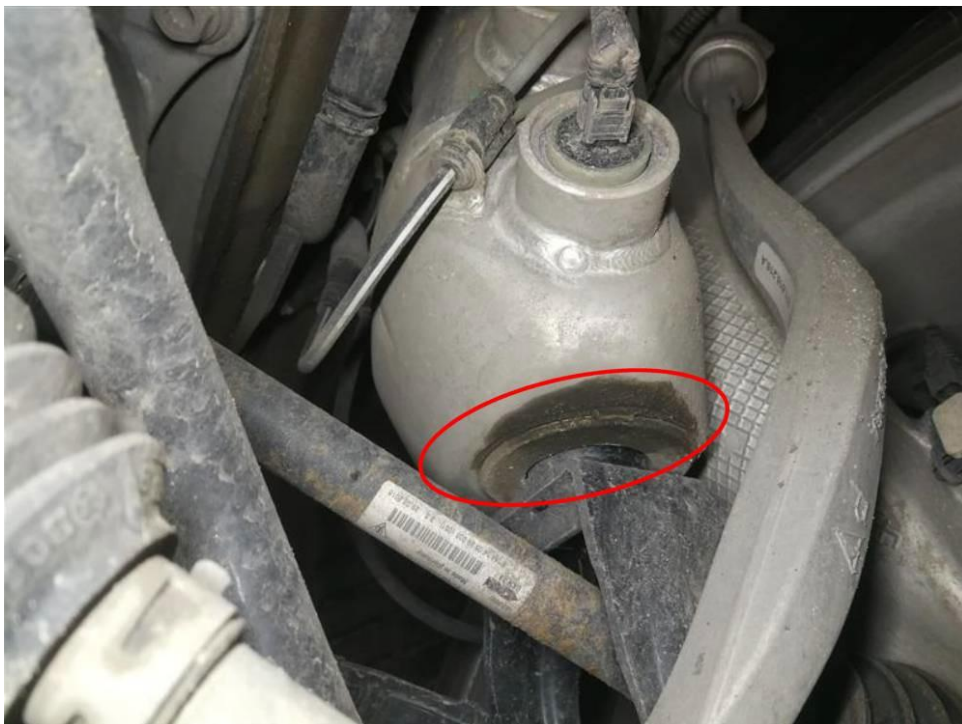
Figure 1

- Fluid leak from the base (Figure 1) and/or the top (Figure 2) of the front air spring/s

The fluid shown in Figures 1 and 2 is assembly fluid residue. The fluid is applied to various internal components of the air spring during manufacture.

1) Take a photograph of the applicable air spring in which the residue is evident

- Clean the residue from the air spring

2) Conduct a road test

3) On return from road test - Conduct a further inspection to check/confirm the residue is no longer evident

- Should the residue no longer be evident – No further action is required, parts must not be replaced for this concern
- Should the residue be evident on return from the road test – Raise a DISS query and await feedback before carrying out any further work
NOTE: Please ensure photographs of the residue are attached within the DISS query clearly showing the residue prior to cleaning/road test and post road test
