Technical Service Bulletin

GROUP	NUMBER
AUTOMATIC TRANSMISSION	20-AT-005H-1
DATE	MODEL
OCTOBER, 2020	SONATA (LFa) SANTA FE (TMa) PALISADE (LX2) SONATA (DN8)

AUTOMATIC TRANSAXLE SOLENOID DTC P074100, P074300, P074800, P075300, P075800, P076300, P076800, P077300 & P270900

This TSB supersedes TSB 20-AT-005H to revise the Parts Information.

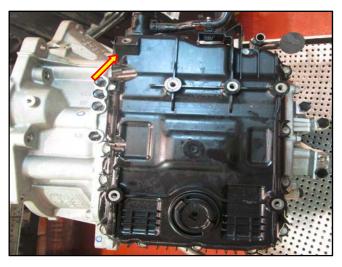
9. Remove 14 oil pan bolts and remove the pan.

Use a rubber hammer to tap the oil pan cover on a corner until the cover is loose.

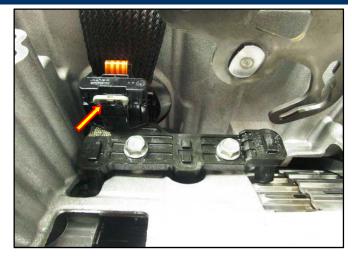
13. Pull the gray tab up and then press the tab to disconnect the harness from the input speed sensor.

Remove the harness and install a new harness.

Reconnect the new harness to the input speed sensor.

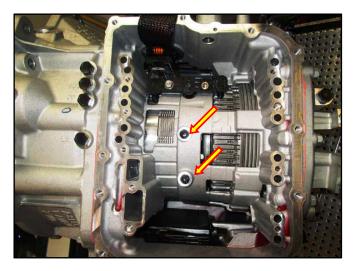
18. Confirm two O-rings are installed correctly in the case.

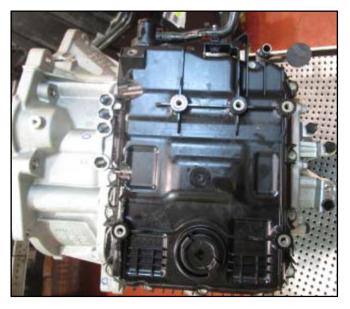
23. Install a new gasket to the oil pan and reinstall the pan.

Install 14 bolts to the pan and tighten the bolts to specification.

Torque: 8~10 lb.ft (1.2~1.4 kgf.m/12~13 N.m)
