<b>HYUNDAI</b> <b>Technical Service Bulletin</b>	GROUP <b>Body</b>	NUMBER <b>20-BD-018H</b>
	DATE <b>October, 2020</b>	MODEL(S) <b>Palisade (LX2)</b>
<b>SUBJECT: HEADREST ODOR SERVICE PROCEDURE</b>

**Description:** This bulletin describes the procedure to service certain Palisade (LX2) vehicles that may have odor emitting from the headrest(s).

**Applicable Vehicles:** Certain 2020-2021MY Palisade (LX2) vehicles equipped with Nappa leather

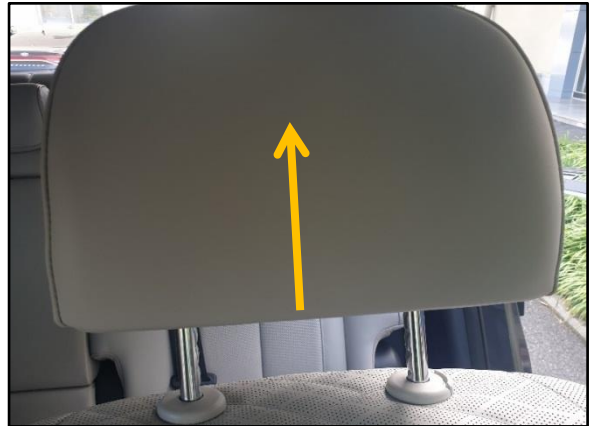
1. Remove all affected headrests.

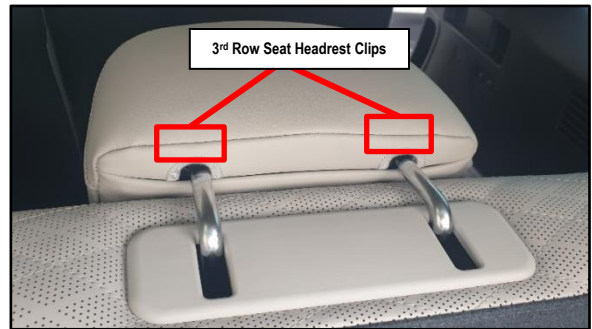
The headrests located on the third row of the vehicle are secured by clips. Press down on the clip locations to remove the headrests.

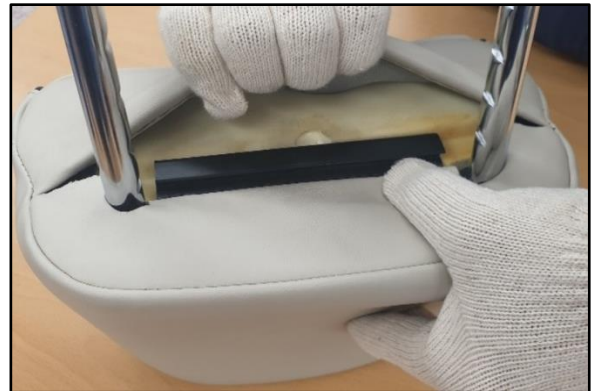
2. Open each headrest leather cover to expose the foam pad.

Do not fully remove the leather cover from the foam pad. Removal can damage the leather cover stitching.

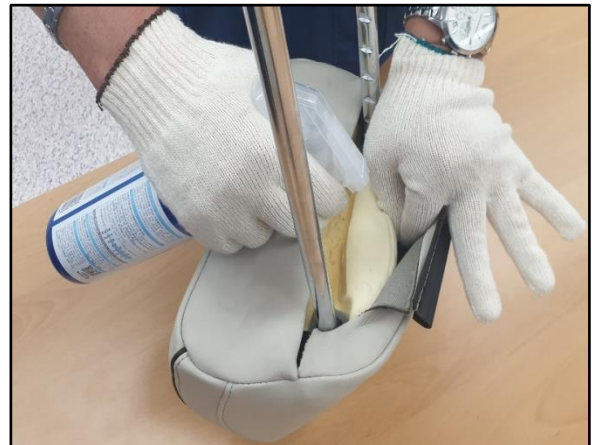
3. Soak the foam pad with the odor eliminator product, and squeeze the foam pad to absorb the liquid.

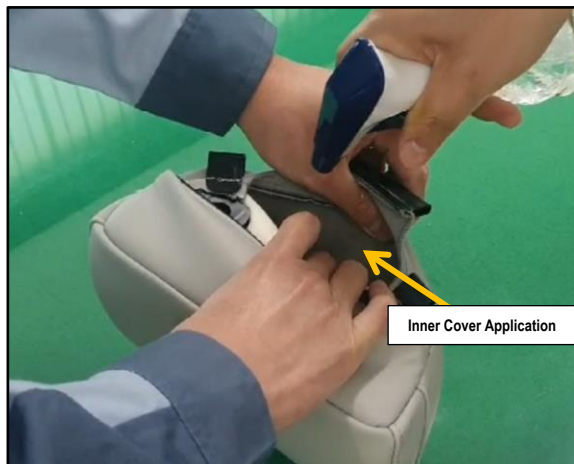
4. Apply a second application of the odor eliminator product to the inside fabric of the leather cover(s).

Do not spray onto the outside of the leather cover(s).

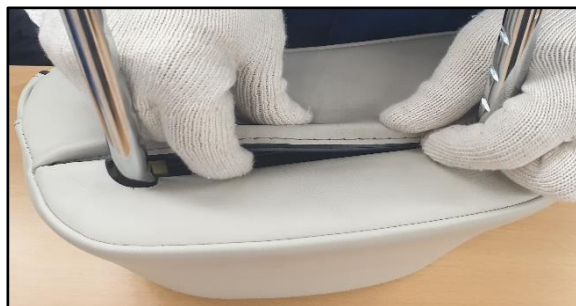
5. Close the headrest cover(s).

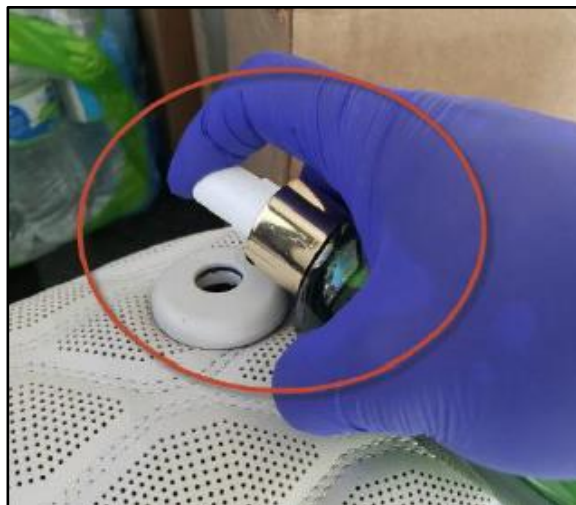
6. Apply the odor eliminator product to the headrest mounting holes on the top of each seat.
