Technical product information

Topic	Continental Series and Flying Spur - Luggage Compartment Lid - Check and Setting Guide
Market area	Bentley: worldwide (2WBE)
Brand	Bentley
Transaction No.	2059884/1
Level	EH
Status	Approval
Release date

Luggage Compartment Lid (Boot Lid) has sporadic functionality, fails to latch when closing, bounces back when closing or fails to open or close fully.

This Technical Product Information (TPI) document has been developed to resolve various boot lid concerns, it provides a series of checks and updates to ensure robust boot lid operation.

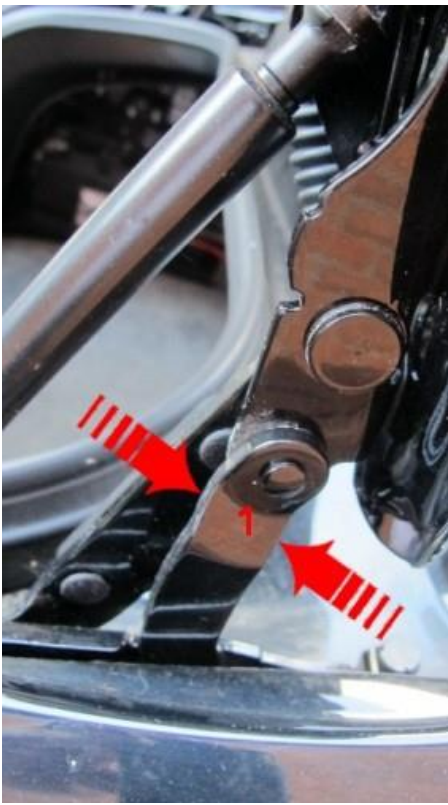
Figure 1

Prior to continuing with this document, ensure the right hand hinge (motor driven hinge – item 1) is serviceable, manipulate the open hinge whilst checking for excessive play. Ensure the hinge function is uncompromised and no misalignment exists in the hinge elements, replace the driven hinge where necessary - *Figure 1*.

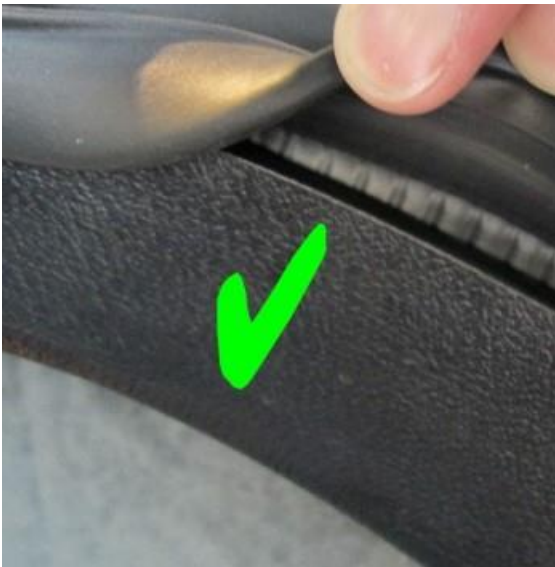
Figure 2

Ensure the boot lid seal is correctly fitted - *Figure 2* – specifically, the knock-on strip element of the seal must be fully engaged on the lip of the boot aperture and not as shown in *figure 3* where it is displaced by the boot trim.

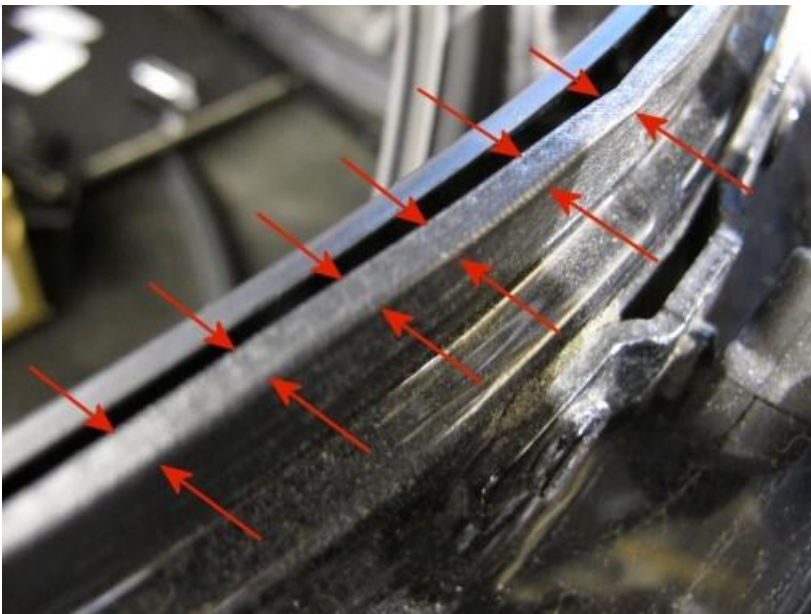
Figure 4

Ensure the obscuration tape fitted to the boot aperture flange is not restricting seal fitment - *Figure 4*.

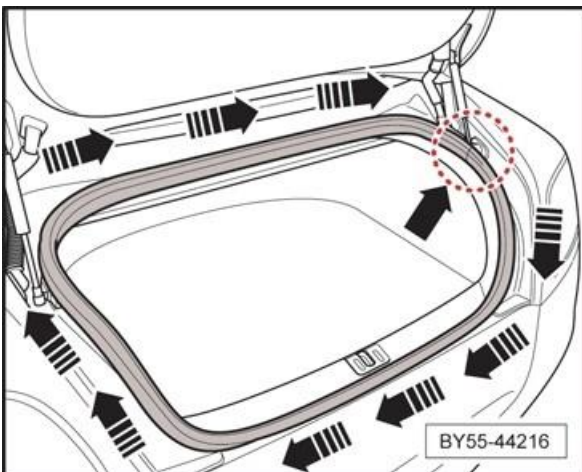
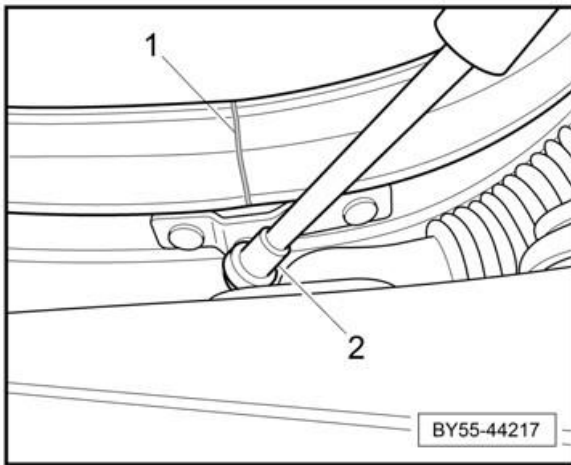
Figure 5

Check the seal is correctly orientated, the vulcanised joint -1- should be to the centre line (+/- 10mm) of the ball joint -2- on the boot lid gas strut - *Figures 5 and 6*.

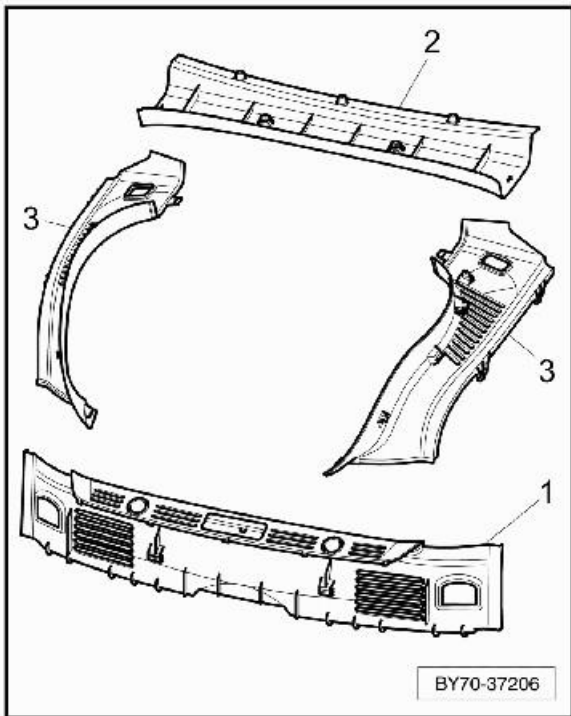
Figure 7

Ensure the boot aperture finishers are secure, correctly fitted, and not compromising boot lid seal fitment, rectify and replace damaged clips where necessary – figure 7.

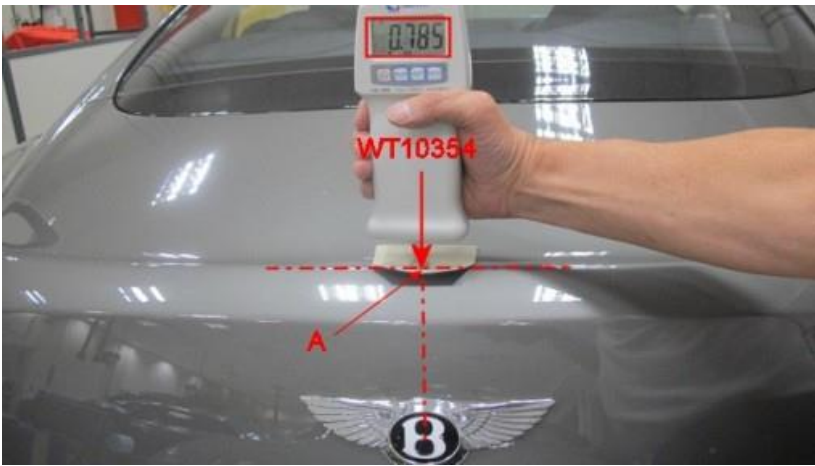
Figure 8

Carry out closing force gauge test – to perform this test the boot lid is operated to close and stopped short of closing on the power close cycle by pressing the close button again and manually catching the boot lid in the final centimetres of the close cycle, just before it engages with the striker pin. At this point the boot lid is resting on the boot lid seal, once in this state the force gauge (WT 10354) should be set in position *A on the boot lid. Apply load to the boot lid via the force gauge recording the load at which the boot lid power latched, record results - Figure 8.

Note: Position (A) for the force gauge is the intersection on the centre line of the boot lid and the rear lip of the boot lid. Place protection between the boot lid painted surface and the gauge foot at position (A) to avoid paint damage, an offcut of leather will suffice.

The load measured should be less than 1kg. If the load measured to initiate the close cycle is less than 1kg or the boot latches under its own weight and the boot successfully completed three consecutive power open and close cycles then the TPI is complete.

Carry out closing force gauge test – to perform this test the boot lid is operated to close and stopped short of closing on the power close cycle by pressing the close button again and manually catching the boot lid in the final centimetres of the close cycle, just before it engages with the striker pin. At this point the boot lid is resting on the boot lid seal, once in this state the force gauge (WT10354) should be set in position "A" on the boot lid. Apply load to the boot lid via the force gauge recording the load at which the boot lid power latched – figure 8.

Carry out closing force gauge test – To perform this test the boot lid is operated to close and stopped short of closing on the power close cycle by pressing the close button again and manually catching the boot lid in the final centimetres of the close cycle, just before it engages with the striker pin. At this point the boot lid is resting on the boot lid seal, once in this state the force gauge (WT10354) should be set in position *A on the boot lid. Apply load to the boot lid via the force gauge recording the load at which the boot lid power latched – *Figure 8*.

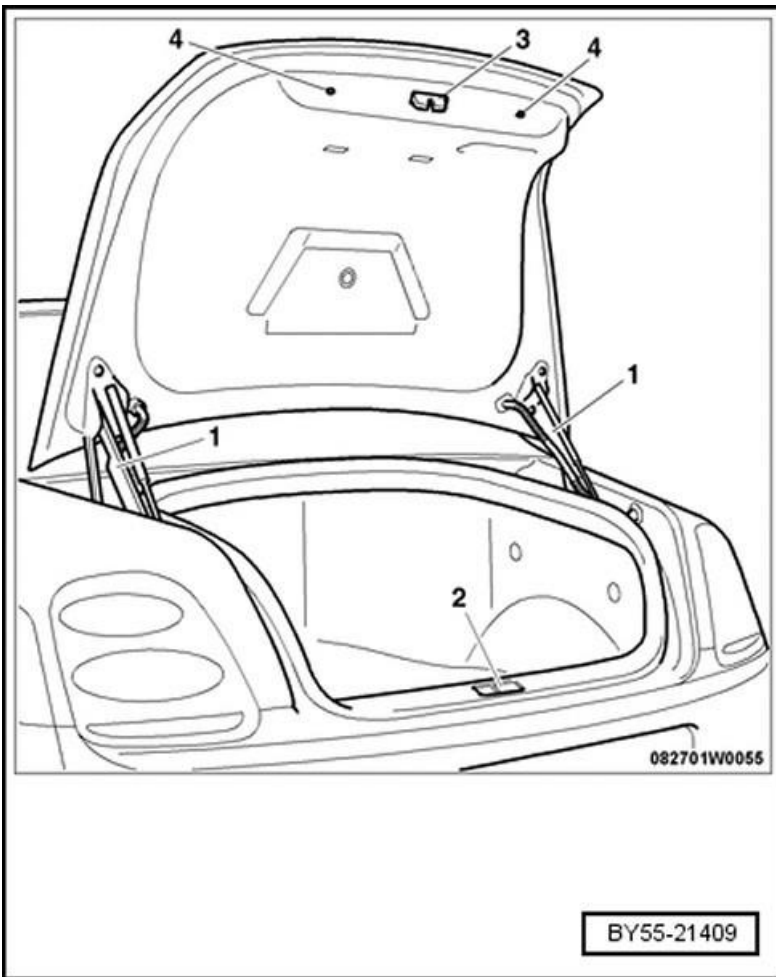
Figure 9

Prior to adjusting the boot lid hinge ensure the hinge (1) is serviceable, check for excessive play in pivots, ensure the hinge function is uncompromised and no misalignment exists in the hinge elements. Replace individual hinges where necessary – *figure 9*.

Check the striker pin (2) is serviceable, the pin surface should be undamaged and must rotate freely by hand, free off and lubricate where necessary, in extreme cases a replacement may be required – *Figure 9*.

The position of the boot lid can be set by adjusting the hinges (1) or the striker (2). The locking latch (3) is attached directly to the boot lid. It does not have slotted holes and therefore has no means of adjustment. Before any adjustments are made the car must be resting on its road wheels and on level ground. Ensure the socket used to release the fasteners is 'as new' and that it is fully engaged with the fastener. Tapping the socket with small dead blow hammer to assist the tool in *cutting into* the paint to aid engagement is recommended. Releasing the harness conduit clips from the each hinge will assist in access. When applying specific torque to fasteners ensure any adaptors or extensions used on the torque wrench are accounted for in your calculation for applied torque – *figure 9*.

- Check for signs of wear in the ball end of the gas struts.
- Ensure ball and sockets are clean and apply fresh grease where necessary (*Shell Retinax "A"*)
- Ensure ball end clips are fitted correctly and gas struts are fitted the correct way up. The main body of the gas strut connects to the boot lid with the rod end connecting to the car body - Figure 9.
- Check correct gas strut part number and hand of use is fitted:

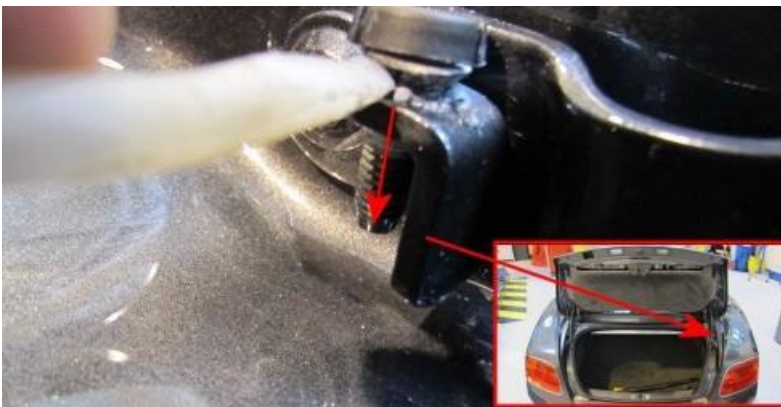
Figure 10

Remove the plastic caps and wind down the bootlid hinge bump stops located on each hinge assembly, these are adjusted back after the setting procedure – figure 10.

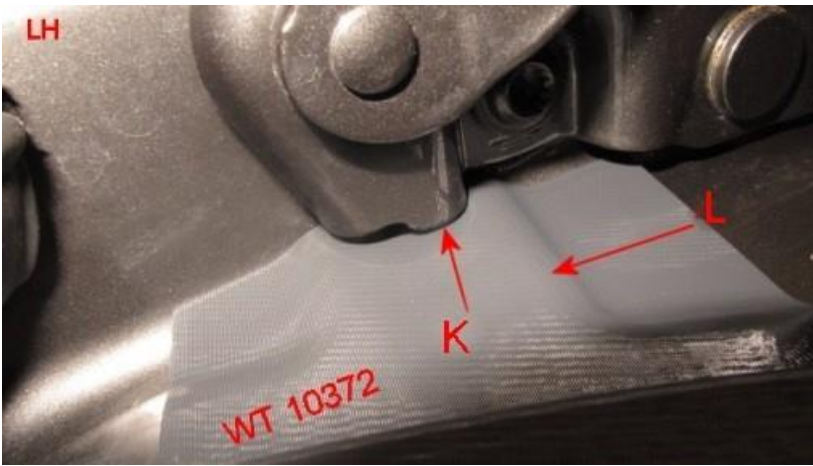
Figure 11

For New Continental GT – use gauge part number WT10372 left hand or WT10373 right hand - Gauge setting hinge. Clean the drain channel to ensure the gauge will fully engage with the channel surface.

The gauge is loaded into the drain channel from the front of the hinge in direction L. With the gauge correctly positioned the full length of the gauge will be in contact with both vertical sides of the drain channel whilst sitting on the channel bottom – figure 11.

In this position the rearward section of hinge should be touching the gauge at point K. If the gauge is tight, loose or not touching at K then slacken both fasteners and adjust hinges to achieve the base setting at K. The gauge adjustment at K is achieved at the hinge rear mounting bolt, therefore, although the front mounting bolt has to be slackened, the hinge should only rotate at the front bolt with the vertical adjustment performed at the rear bolt. Re-tighten the fasteners - figure 11.

Note: New Continental GT torque figure of 28Nm + 2 is critical.

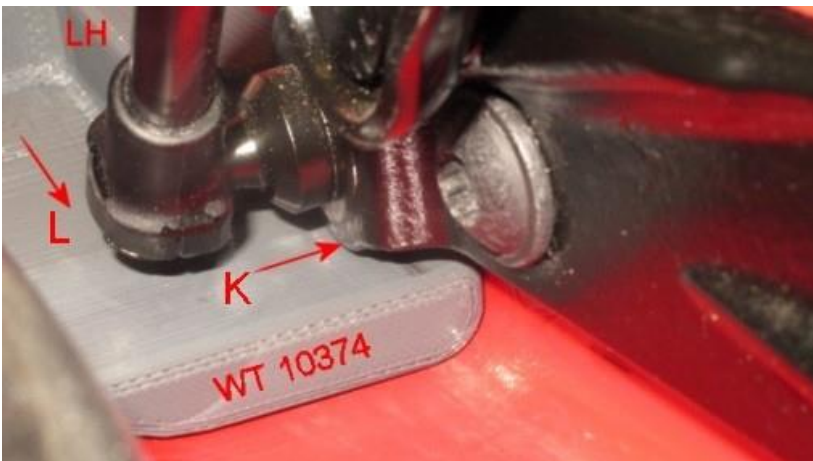
Figure 12

For New Continental GT Convertible – use gauge part number WT10374 left hand or WT10375 right hand - Gauge setting hinge. Clean the drain channel to ensure the gauge will fully engage with the channel surface.

The gauge is loaded into the drain channel from the rear of the hinge in direction L. With the gauge correctly positioned the full length of the gauge will be in contact with both vertical sides of the drain channel whilst sitting on the channel bottom – figure 12.

In this position the rearward section of hinge should be touching the gauge at point K. If the gauge is tight, loose or not touching at K then slacken both fasteners and adjust hinges to achieve the base setting at K. The gauge adjustment at K is achieved at the hinge rear mounting bolt – figure 12.

Note: For New Continental GT Convertible - new bolts (increased length) must be fitted and the torque for these bolts is [http://bymccrsh0122/aspshr02/VAOC/5.TPI.requests/2020/KW36/Rotating display rattle/steves vid.mp4](http://bymccrsh0122/aspshr02/VAOC/5.TPI.requests/2020/KW36/Rotating%20display%20rattle/steves%20vid.mp4) critical at 20Nm + angle 45° new bolt part number is N.910.097.01 x 4 off.

– (H) Adjustment in height profile adjacent to the rear screen is achieved at the forward, nearest the rear screen, part of the hinge, slacken both hinge fasteners but make adjustments primarily around fastener (C) to raise or lower at point (H) – figure 14. Re-check hinge to maintain gauge setting - figure 12 (GT) figure 13 (GTC)

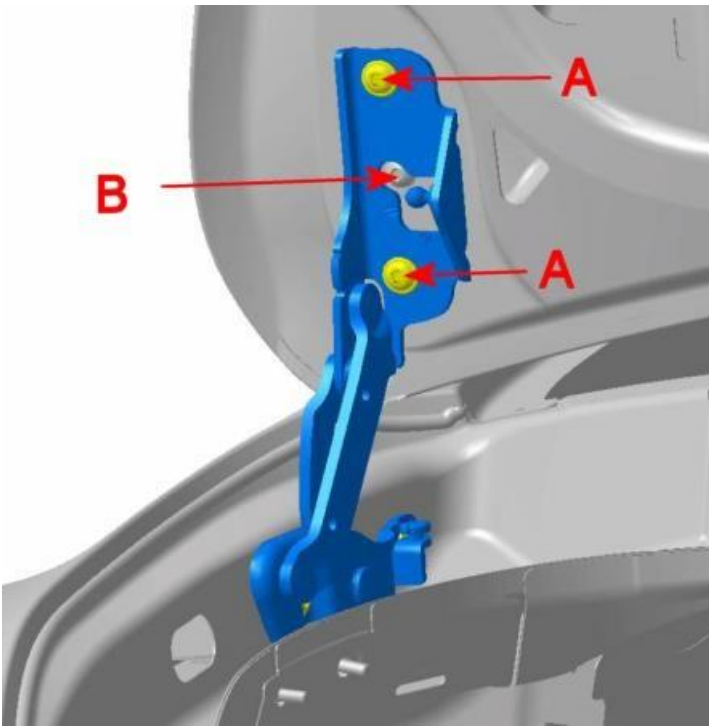
Figure 13

All Cars - Slacken the fasteners (A) securing the boot lid - figure 13.

Note: Do not slacken fastener B at this time. Allow the hinges to “float” ensuring that left and right hinges are not working against each other and operate in same plane without undue resistance. Re-tighten the four fasteners (A) 20Nm + 2 – figure 13.

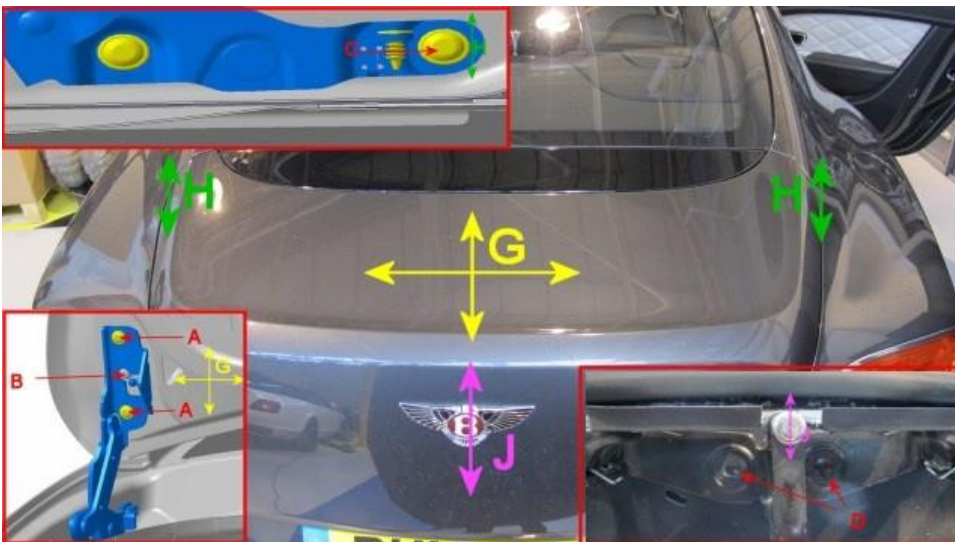
Boot Adjustments - Reference Figure 14

– (J) Adjustment in height profile at the rear of the boot lid is achieved at the striker plate, slacken both fasteners (D) then raise or lower at point (J) – figure 14.

– (G) To achieve panel gaps the boot lid surface can be moved in both axis at the hinge / boot lid connection, slacken fastener (B) and fasteners (A) to release the captive plate to allow adjustment – figure 14.

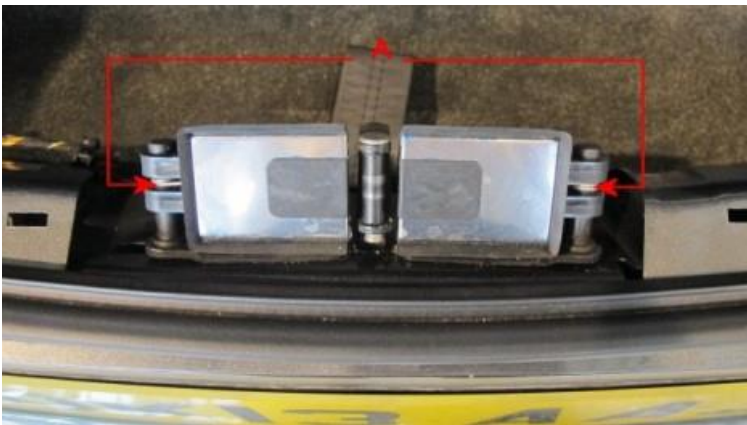
Figure 15

Replace both boot lid striker door springs (A). First replace the left hand spring using the right hand as a reference – *figure 15*.

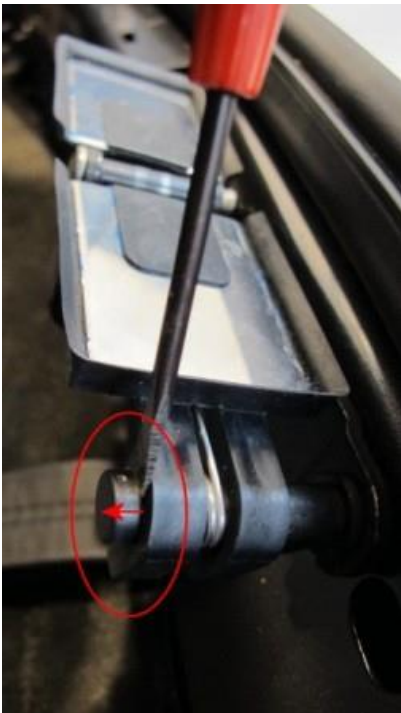
Figure 16

Detach plastic retaining cap and discard - *Figure 16*.

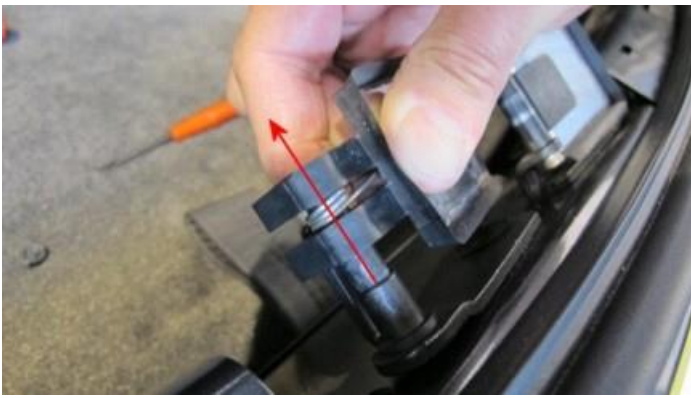
Figure 17

Slide door and spring off the bearing pin, discard the original spring - *Figure 17*.

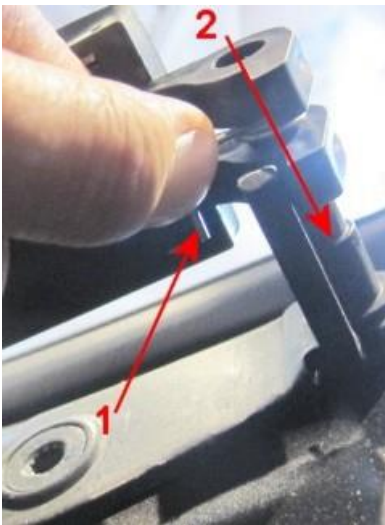
Figure 18

Position the new spring (part number 3W0827441 or 3W0827665) in the removed door. Whilst holding the spring tang back (1) partially fit door and new spring onto bearing pin - Figure 18.

Push the door and spring assembly (2) fully onto the bearing pin before releasing the spring tang (1) onto interlock - figure 18.

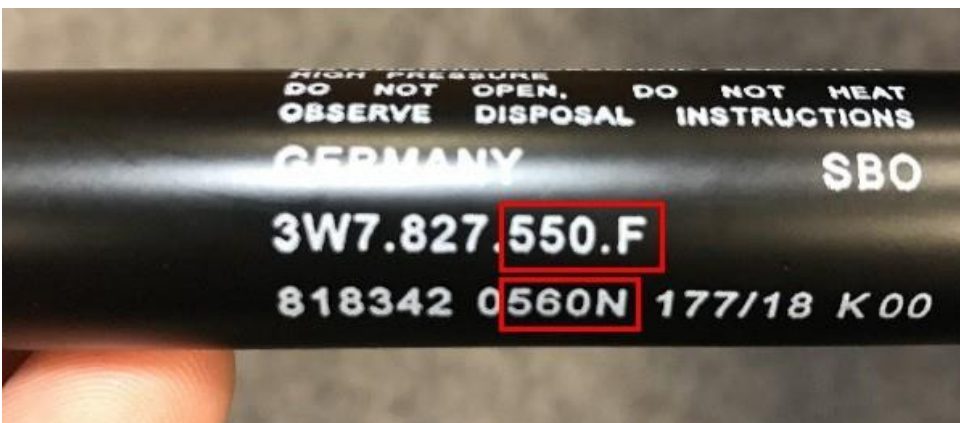
Figure 19

Correct left hand side strut 3W7827550F (560N) - marked in White writing - figure 19.

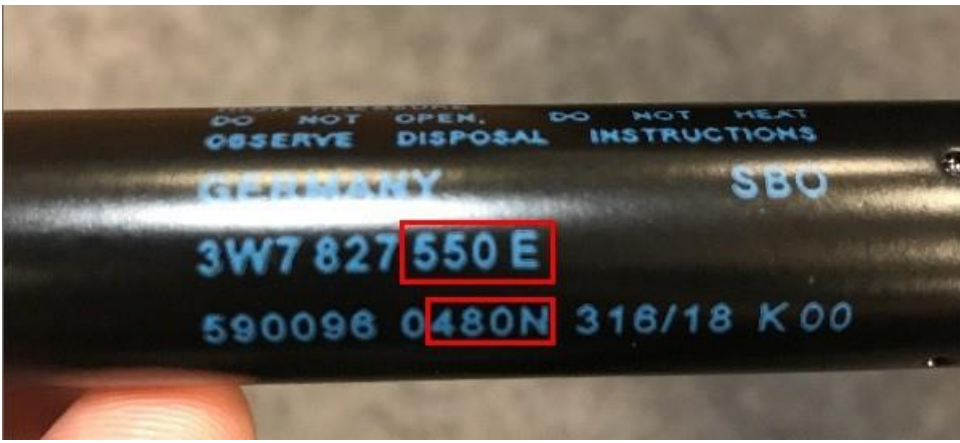
Figure 20

Correct right hand side strut 3W7827550E (480N) - marked in Blue writing - figure 20.

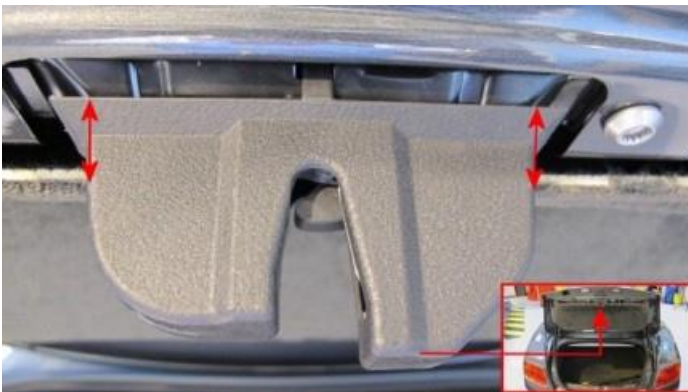
Figure 21

To replace, remove and discard latch plastic cover – *figure 21*.

Note: *Figure 21* shows the new design cover, *figure 22* shows the original cover.

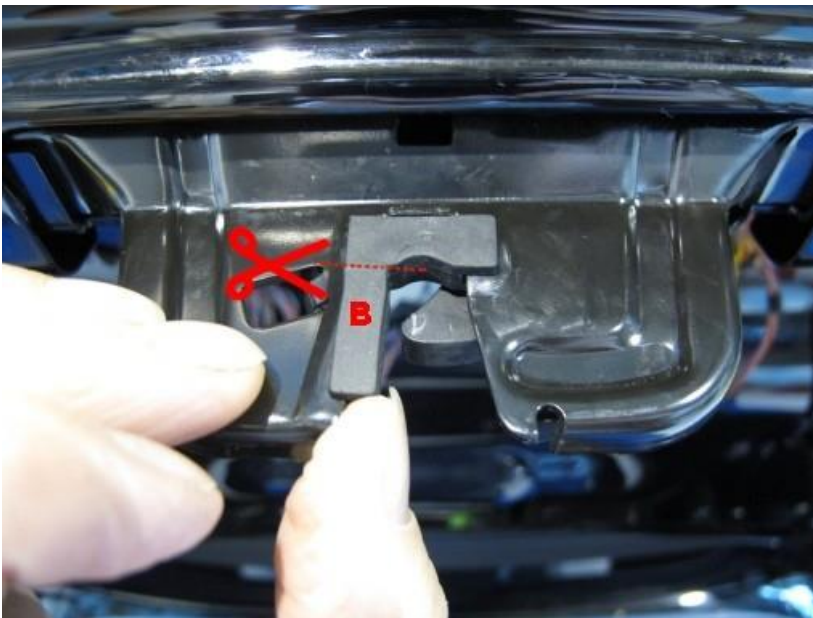
Figure 23

With the original plastic cover removed modify the latch buffer by removing section (B) shown - *figure 23*.

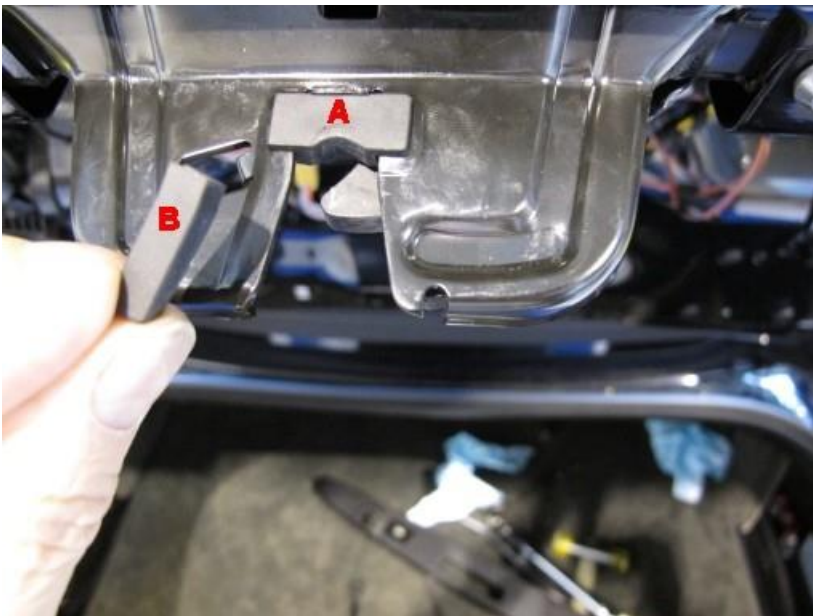
Figure 24

With section (B) cut and discarded from the main buffer to form part (A) then the new latch plastic cover (part number 3W0827520A) can be fitted – Figure 24.

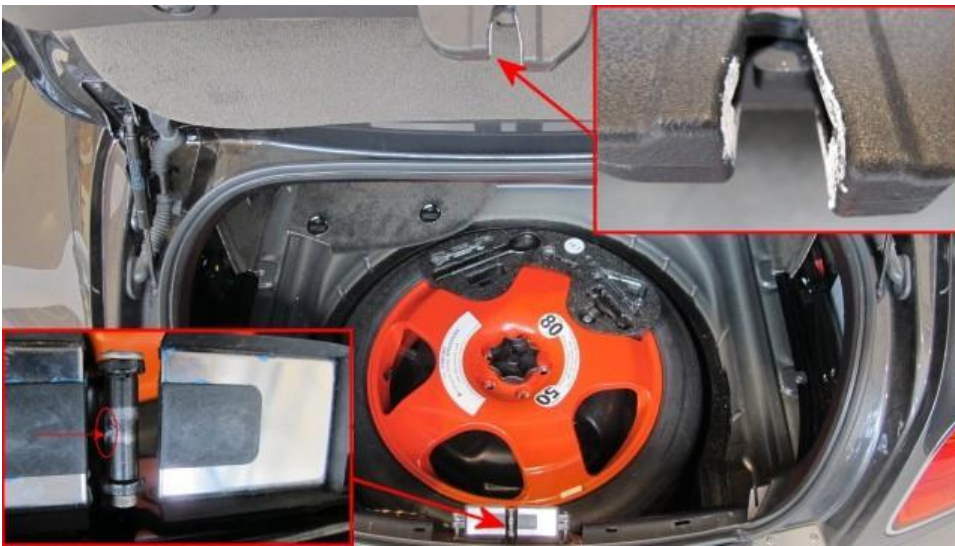
Figure 25

With the fit and profile of the boot lid set, check and if necessary adjust the striker plate to ensure it is central in the boot latch striker plastic cover. To do this, apply chalk to the boot latch striker plastic cover and operate the boot close function. If chalk is deposited on the striker pin then adjust the striker assembly to the left or right to reduce this occurrence.

In the example below the chalk is deposited on the left hand side of the pin, this would necessitate the striker assembly being adjusted 1 or 2 mm to the right – figure 25. Once set remove chalk traces.

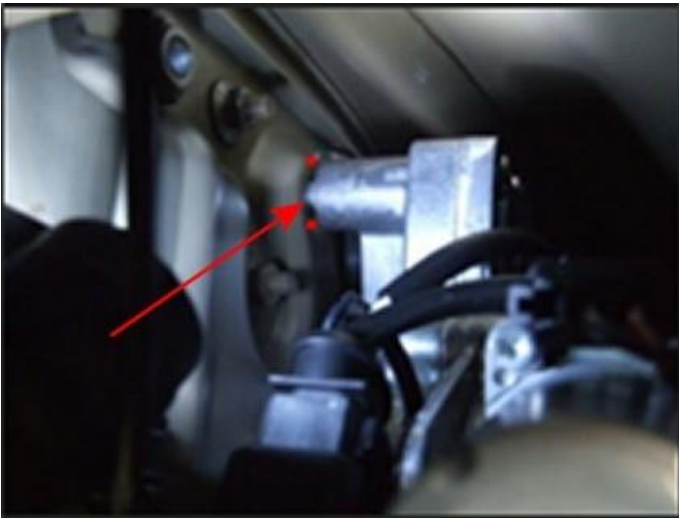
Figure 31

Check that the power boot motor is correctly aligned on to the hinge splines and that the locating peg is fully engaged in the body location and tapping plate - where necessary loosen motor and correct alignment – figure 31.

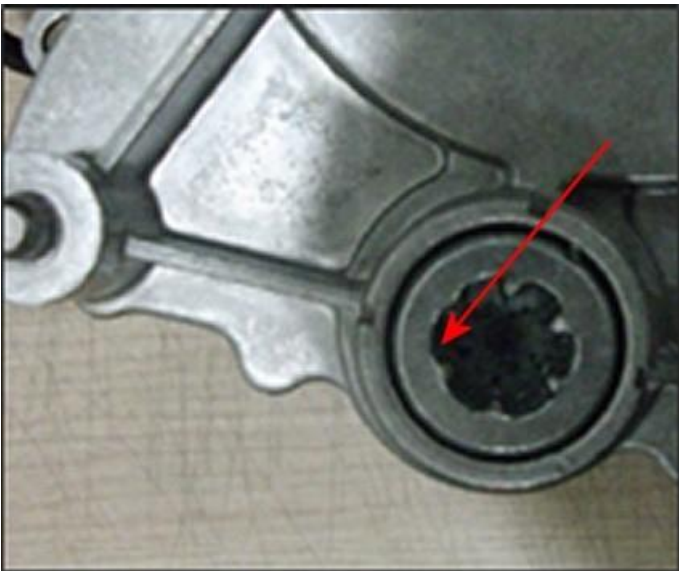
Figure 32

Remove motor and inspect motor spline drive and hinge spline for damage, replace damaged components where necessary – figure 32.
