QUARANTINE NOTICE

Reference number:	QN-23-1425	Issued: 24 October, 2020
Subject:	Incorrect Reminder for Second-Row Seatbelts	
Model(s):	DBX	
VIN range:	Refer to the separately published list of affected Vehicle Identification Numbers (VINs)	
Applicable to:	All Dealers	
Distribute to:	After Sales Manager Service Manager Sales Manager	Warranty Staff Technician(s) Parts Staff

Reason for this Quarantine Notice

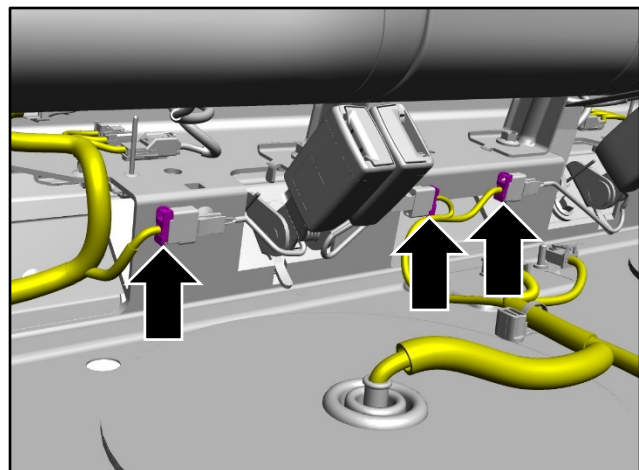
Figure 1

1. Remove the rear seat bench assembly (refer to Workshop Manual procedure 30.01.FC).
2. Disconnect the three electrical connectors (refer to Figure 1).
 - Cabin Harness – A02
 - Cabin Harness – A03
 - Cabin Harness – A04

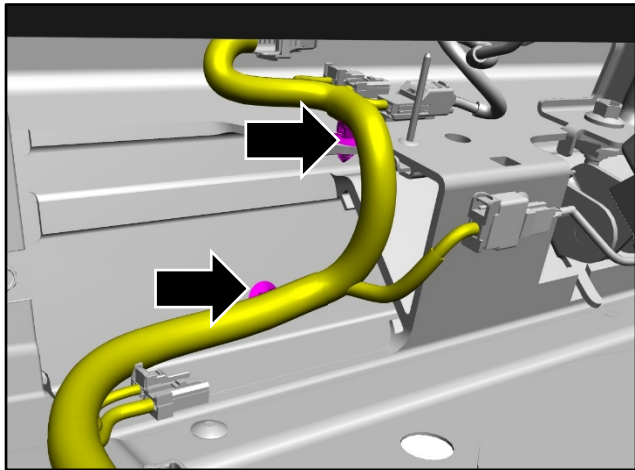
Figure 2

3. Release the wiring harness (refer to Figure 2).

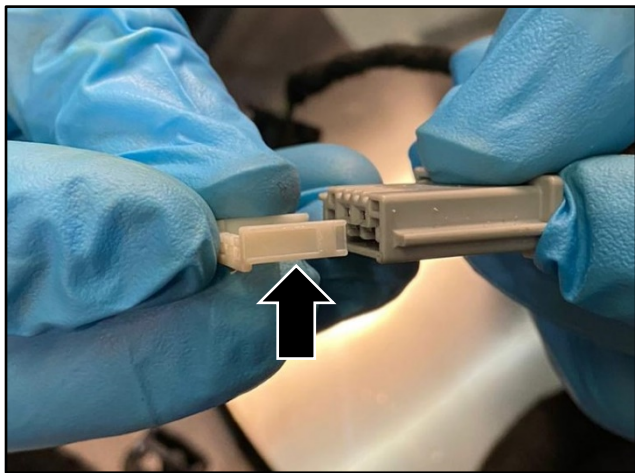
Figure 3

4. Find the electrical connector Cabin Harness – A02
5. Remove the terminal lock (refer to Figure 3).

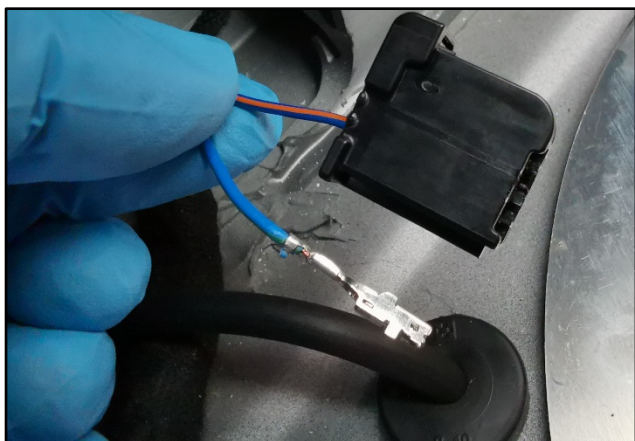
Figure 4

6. Remove the terminal from pin 1 (refer to Figure 4).

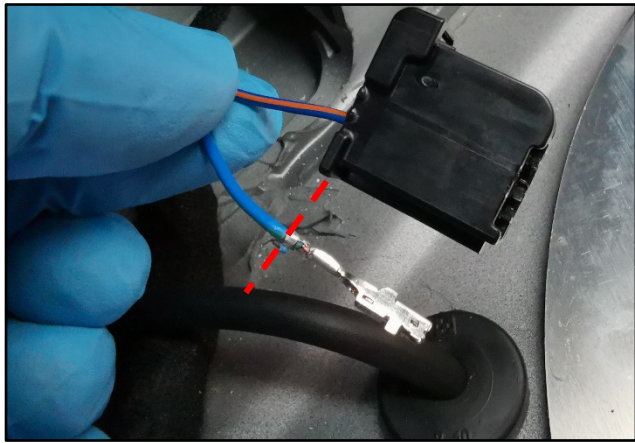
Figure 5

7. Use the applicable tool to remove the existing terminal (refer to Figure 5).

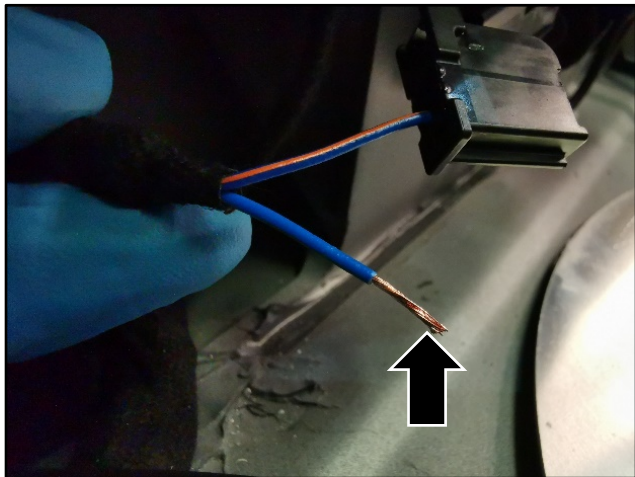
Figure 6

8. Remove approximately 5-7mm of the insulation at the end of the wire (refer to Figure 6).

CAUTION: DO NOT REMOVE MORE LENGTH THAN IS NECESSARY.

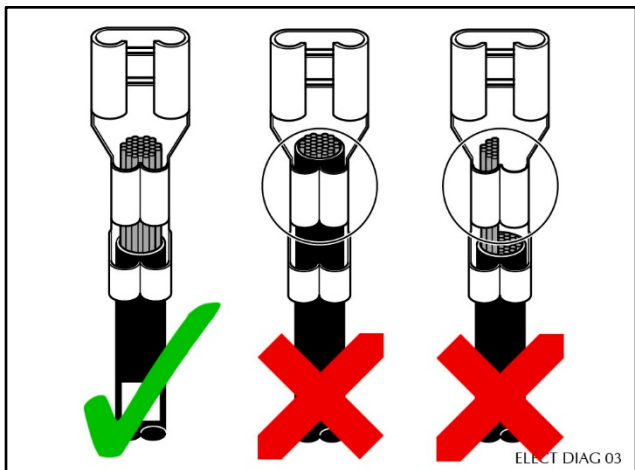
Figure 7

9. Use the applicable tool to install a new terminal onto the wire.

CAUTION: MAKE SURE TO INSTALL THE WIRE IN THE CORRECT POSITION. (REFER TO FIGURE 7)

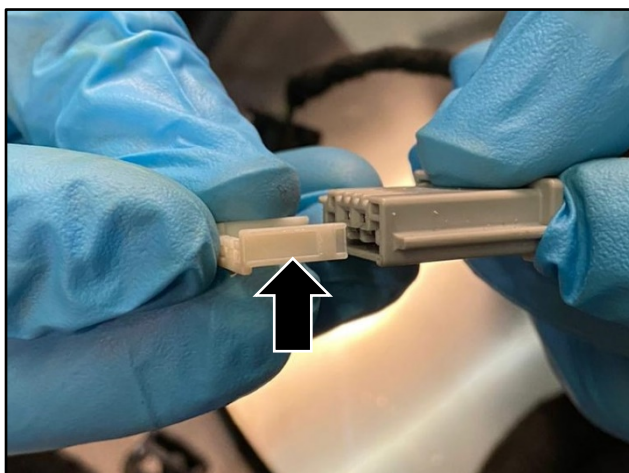
Figure 8

13. Install the terminal lock (refer to Figure 8).

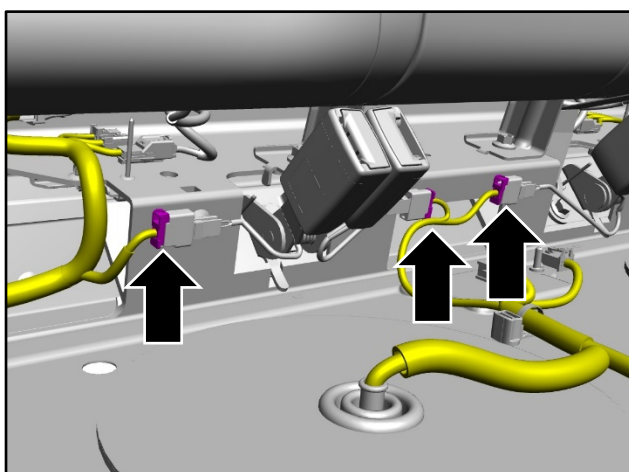
Figure 9

14. Repeat step 5 thru step 13 for electrical connector Cabin Harness – A03
15. Repeat step 5 thru step 13 for electrical connector Cabin Harness – A04
16. Connect the three electrical connectors (refer to Figure 9).

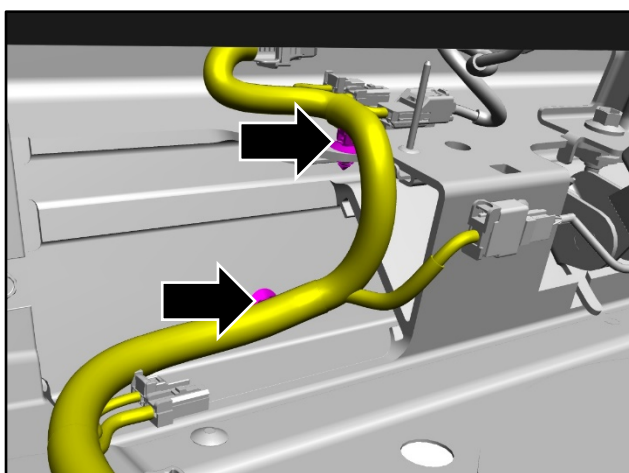
Figure 10

17. Attach the wiring harness (refer to Figure 10).
