Service Bulletin

Bulletin No.: 17-NA-216

Subject: Convertible Top Back Glass Separation from Top Cover Material

Brand:	Model:	Model Year:		Date Breakpoint:		Engine:	Transmission:
		from	to	from	to		
Buick	Cascada	2016	2019	—	—	All	All
Chevrolet	Camaro Convertible	2016	2021

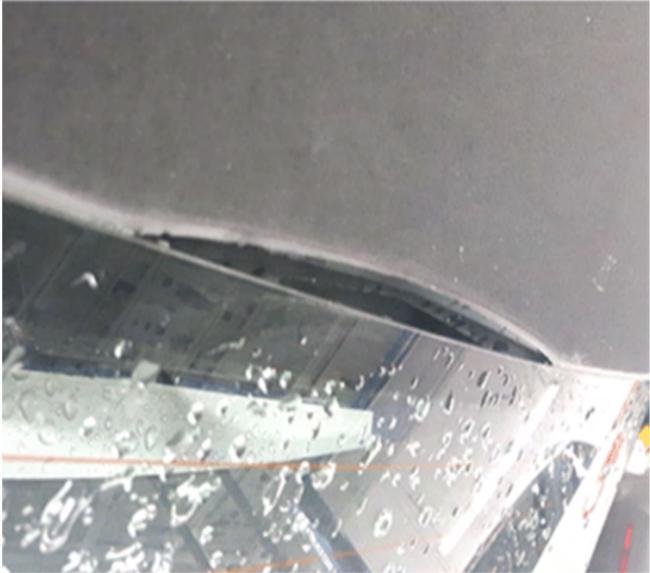
4794660

Involved Region or Country	North America, Europe, Middle East, Israel, Argentina, Brazil, Bolivia, Chile, Colombia, Ecuador, Paraguay, Peru, Uruguay, Japan
Condition 1	<p>Some customers may comment on seeing the back glass separating from the convertible top cover material.</p> <p>Several examples of the separation are shown in the graphic examples below:</p>

<p>4794112</p> <p>It will be necessary to replace the convertible top cover (1). Refer to <i>Folding Top Cover Replacement</i> in SI.</p>

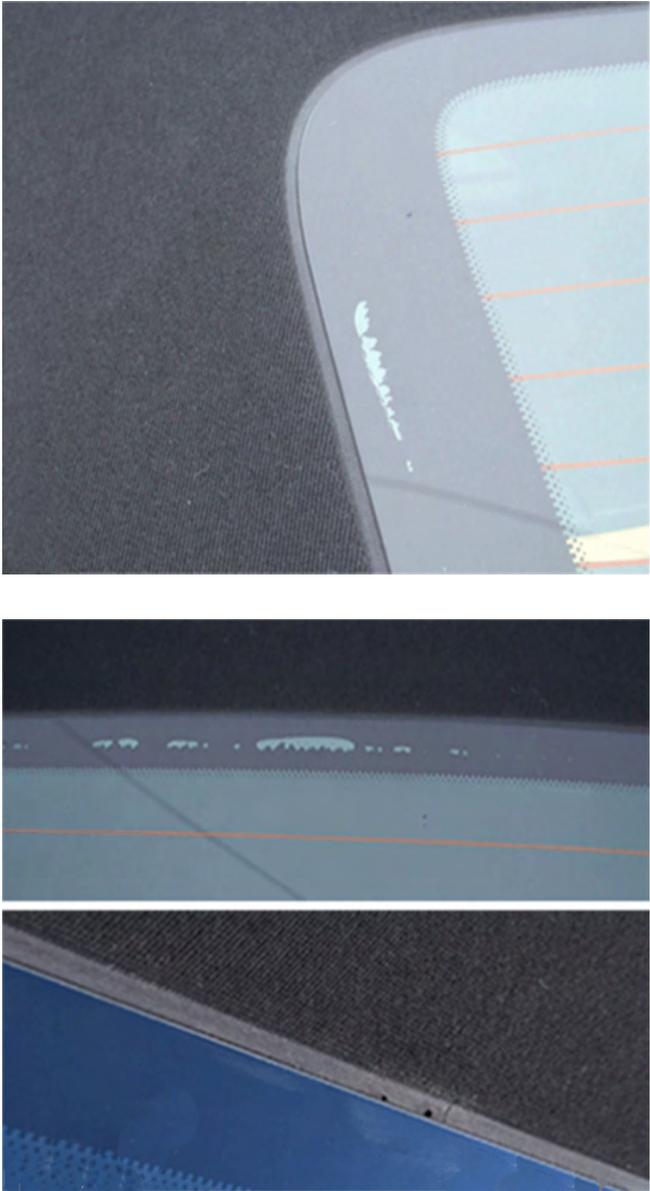
<p>4794670</p> <p>4794682</p>
<p>Cause 1</p>	<p>The cause of this condition may be an insufficient amount of primer used during the assembly process, which creates stress points allowing the material to separate from the glass.</p>

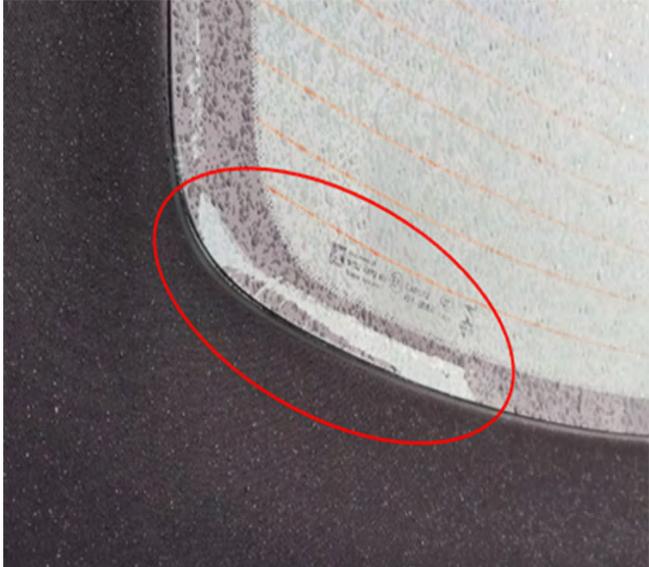
<p>5049793</p> <p>Some customers may comment that the vehicle may exhibit a condition where the back glass is separating from the top. This condition will typically start in the corner of the back glass.</p>
<p>Cause 2</p>	<p>The cause of this condition may be the back glass separating from the bond.</p>
<p>Correction</p>
