Service Bulletin

Bulletin No.: 17-NA-271

Subject: Clicking Noise from Front Wheels While Turning at Slow Speeds

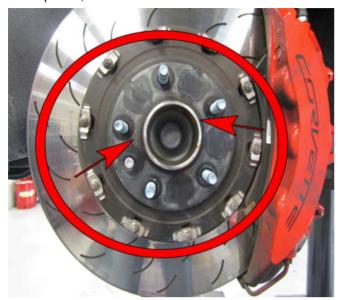
515280

Using 3M red Scotch-Brite 7447 pad or equivalent with approved brake cleaner (ex. Part number 19370705 (U.S.), 88901247 (Canada)), wipe the wheel mounting surface of the rotor (brake rotor top hat) and the wheel pilot at the center of the rotor, removing any residual grey or black material that has accumulated on the rotors.

Clean the wheel mounting surface of the brake rotors, or sometimes referred to as the brake rotor top hats, as follows:

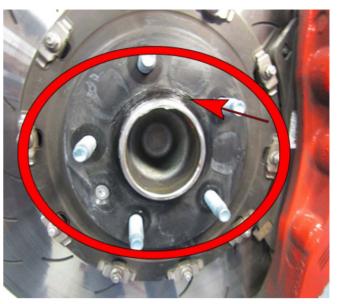
5152729

- Using Super Lube paste, P/N 12371287 (in Canada, 10953437) or equivalent, apply a light coat around the center pilot of the hub ONLY.
- 4. Reinstall both of the wheels using the original wheel nuts. Refer to *Tire and Wheel Removal and Installation* in SI.
