Service Bulletin

Bulletin No.: 19-NA-236

Subject: Binding and/or Clunking Noise Heard While Operating the Front Door Windows

Brand:	Model:	Model Year:		Breakpoint:		Engine:	Transmission:
		from	to	from	to		
Chevrolet	Express	2018	2020	-	-	-	-
GMC	Savana

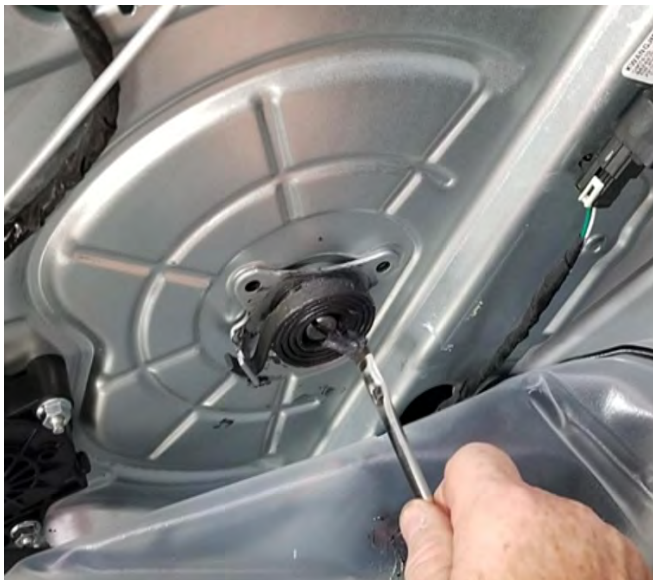
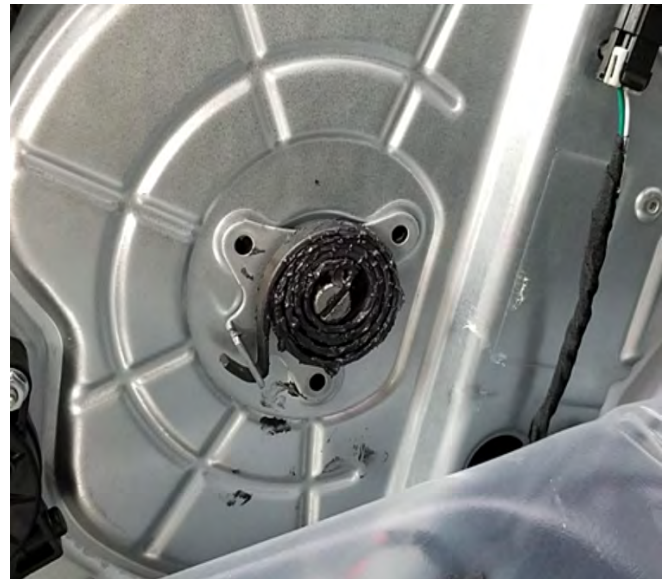
Involved Region or Country	North America, Middle East and Israel
Condition	Some customers may comment on a binding and/or clunking noise heard when operation the front door windows.
Cause	This condition may be caused by insufficient grease in the window regulator clock spring.
Correction	Apply M-77 Paste to the clock spring windings following the procedure below. Note: The updated service part does NOT have a clock spring by design.

2. Using an acid brush, apply M-77 Paste to the clock spring windings, as shown in the pictures above.

Note: It may be necessary to apply pressure to one side of the spring to open a gap for paste.

3. Test the window to ensure that the noise is gone.
4. Reinstall the front side door trim panel. Refer to *Front Side Door Trim Panel Replacement* in SI.
