## Service Campaign 70-27

**AFFECTED:** 2020 Boldt

**SUBJECT:** Water Tank Heater Pad Wiring

## Water Tank Heater Pad Wiring

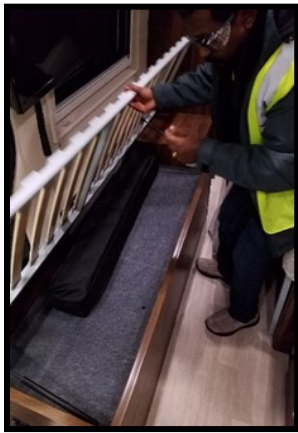
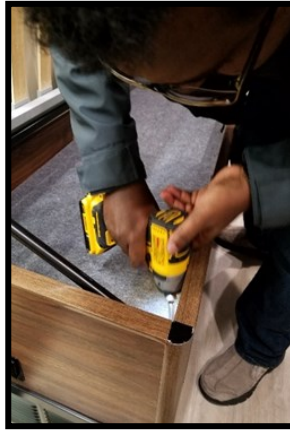
1. Lift bed rack on passenger side bed. Unscrew four screws on access cover. Remove Cover.

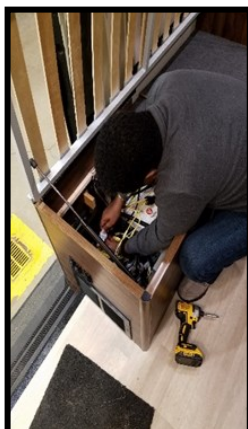
3. Use relay from original harness and install new harness.

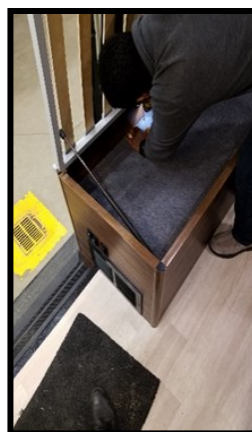
4. Reinstall access cover. Install four screws. Lower bed rack.

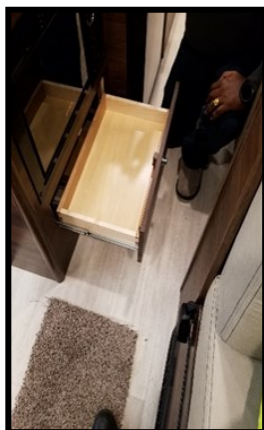
#### **Procedure for 70BL:**

1. Remove both galley drawers on passenger side of coach.
2. Locate water tank heater pad wiring harness and remove. (Description of harness noted in Step 2 of 70KL procedure)
3. Use relay from original harness and install new harness.
4. Reinstall galley drawers.
