Type: Customer Satisfaction Campaign
 Year: 2020
 System: Electrical
 Sequence: 02

MODEL: Revero GT

TITLE: Installed Radar Assembly Verification

PURPOSE: Inspection of the AFRM date code to validate part for future updates (Fig 1).

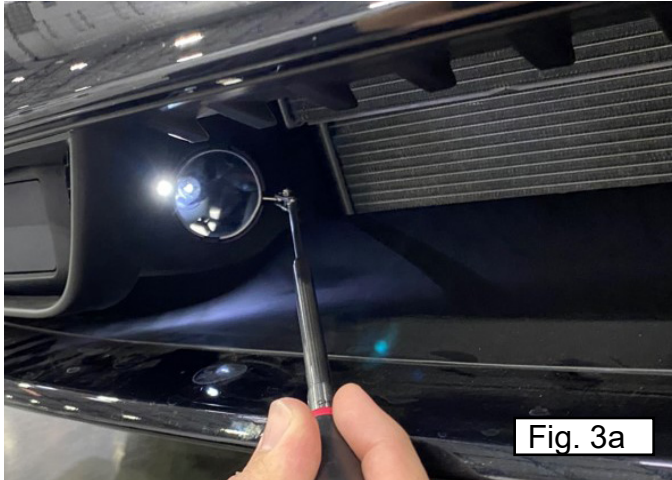
Fig. 3a

STEP 1. Using a telescopic mirror (you may also need a flashlight) and camera capture an image of the radar module (Fig 3a). this can be achieved through the lower fascia opening. Extend the mirror through the opening in the front of the fascia to the back side of the radar.

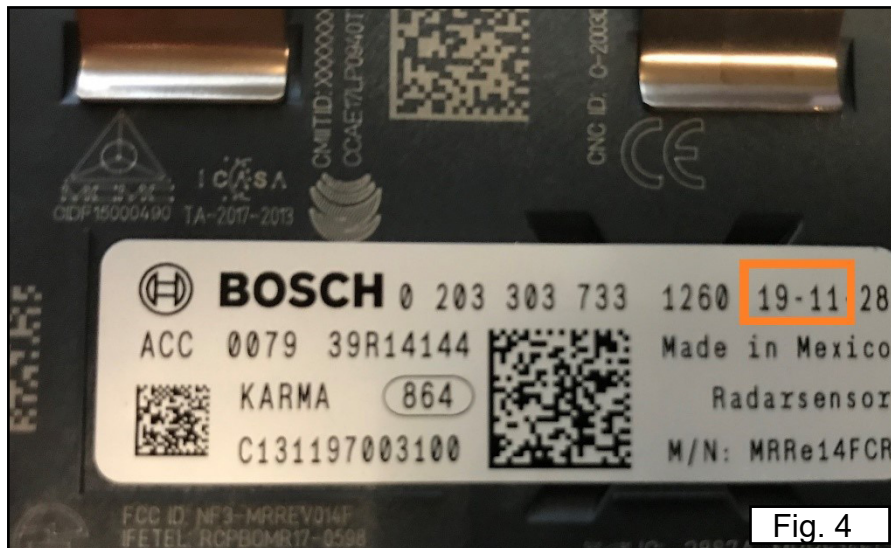
Fig. 4

This visible number is the date code (as shown in Fig 4). The value shown is “Year – Month”. Below in (Fig 4a) shows “19-11” or 2019 – November.

Any date code “19-10” or earlier will require further inspection.

Any date greater than and including “19-11” does not require further inspection. For example units with “19-11”, “19-12”, “20-01” etc. do not need further inspection and the vehicle can be returned for regular use.

Again any date earlier than and including “19-10” require inspection (go to step 2).

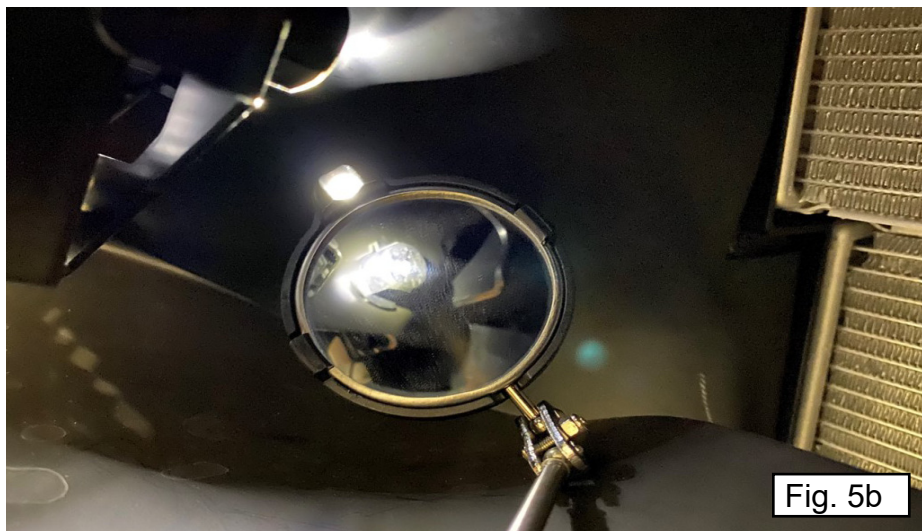
Using the same mirror, inspect each screw and retention pin for the condition, you will need to position the mirror to get the best view and make sure you have plenty of light, capturing images during this inspection is recommended for the TSS case as well. (Fig 5b)
