**HYUNDAI**

**Technical Service Bulletin**

NUMBER  
**20-BR-002H**

**SUBJECT:** BRAKE CALIPER FLUID INSPECTION

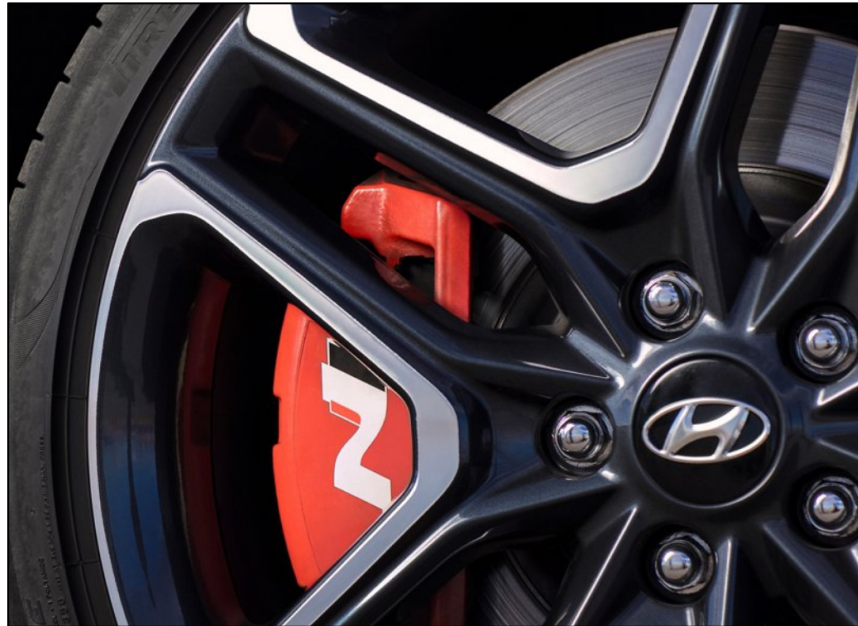
**Description:** This bulletin describes the procedure to inspect and identify fluid which may appear around the brake caliper area.

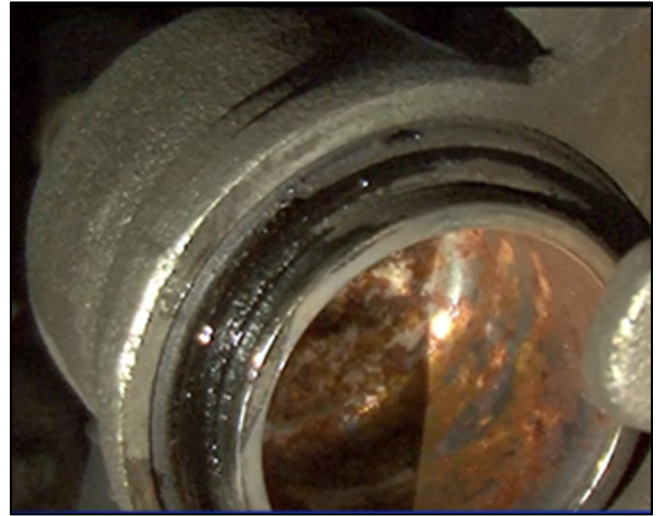
1. If oil/fluid is present on the brake caliper piston area, test the fluid to determine if it is brake fluid or assembly oil.

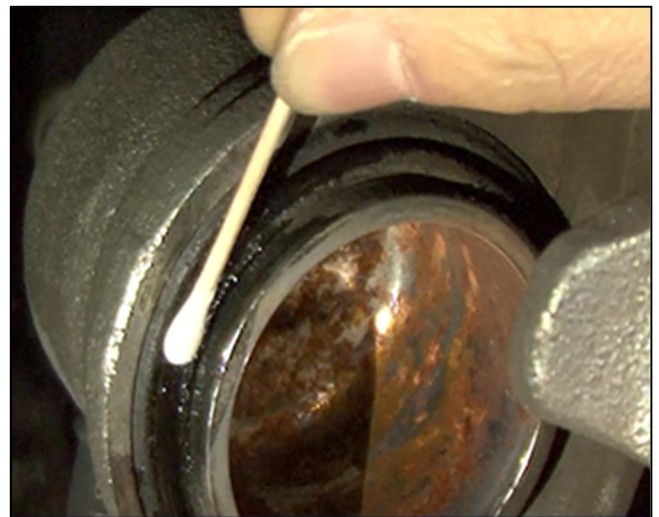
2. Use a cotton swab to carefully collect a sample of the fluid.

Do not disturb the caliper boot.

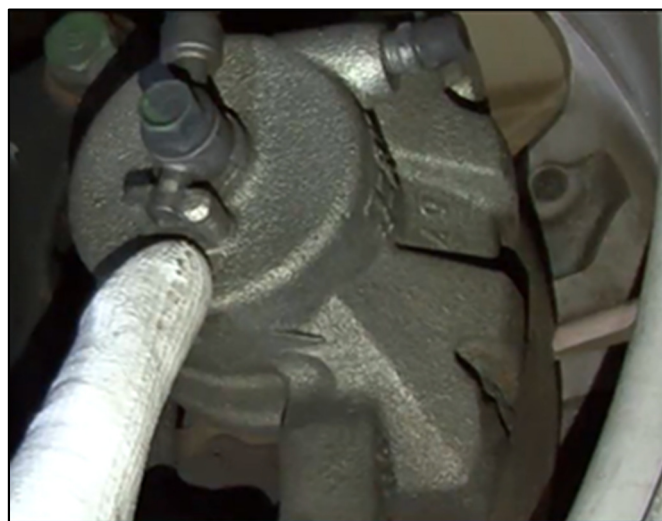
If a fluid leak is found at the banjo bolt area between the brake line and the caliper, replace the copper washers of the banjo fitting.

Follow the applicable service manual procedures to replace the washers, bleed the brake system, and inspect for brake fluid leaks.
