SERVICE BULLETIN

Classification: EL20-024a	Reference: NTB20-052a	Date: November 5, 2020
------------------------------	--------------------------	---------------------------

REAR DOOR ALERT SERVICE INFORMATION

APPLIED VEHICLES: 2021 Rogue (T33)
 2020-2021 Sentra (B18)

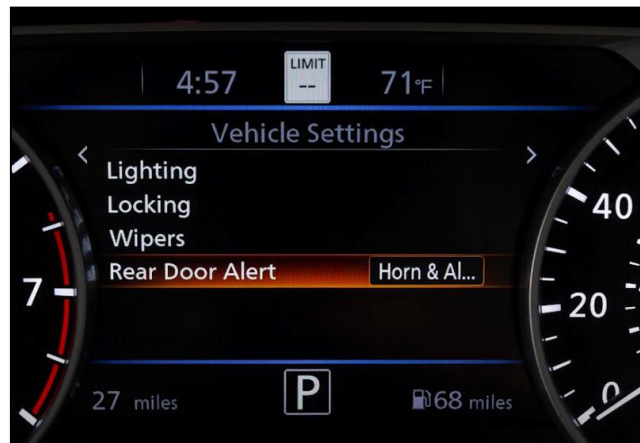
Figure 1

1. Press the left or right arrow button, on the left side of the steering wheel, until **Settings** displays.
2. Press the up or down arrow button to select **Vehicle Settings**.
3. Press the **OK** button.
4. Press the up or down arrow button to select **Rear Door Alert**.
5. Press the **OK** button.

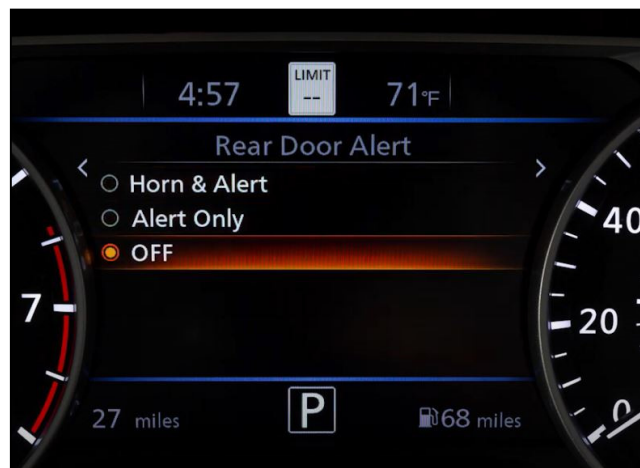
Figure 2

6. Highlight **OFF** and press the **OK** button to turn the system OFF.
7. Deselect **OFF** and press the **OK** button to turn the system ON (not shown).

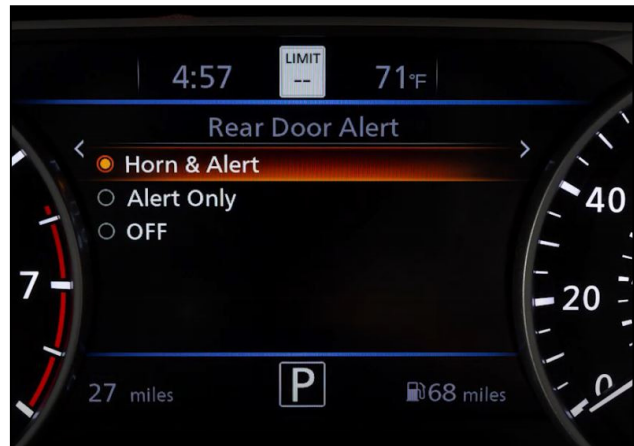
- Follow steps 1-5 on page 2 to enter the **Rear Door Alert** menu.
 - Highlight **Horn & Alert** and press the **OK** button if the horn alert function is desired.
 - Highlight **Alert Only** and press the **OK** button if the horn alert function is not desired.

NOTE: If the alert function is NOT desired, the Rear Door Alert system must be turned OFF (steps 1-6 on page 2).

- When the driver exits the vehicle, after arriving at a destination, a rear door **must be opened** within a short time to **deactivate the alert**.
 - If the driver exits the vehicle while the rear door alert is active, the message **Check Rear Seat for All Articles** will be displayed, and the horn will sound, (if selected as shown in Figure 3 on page 3).

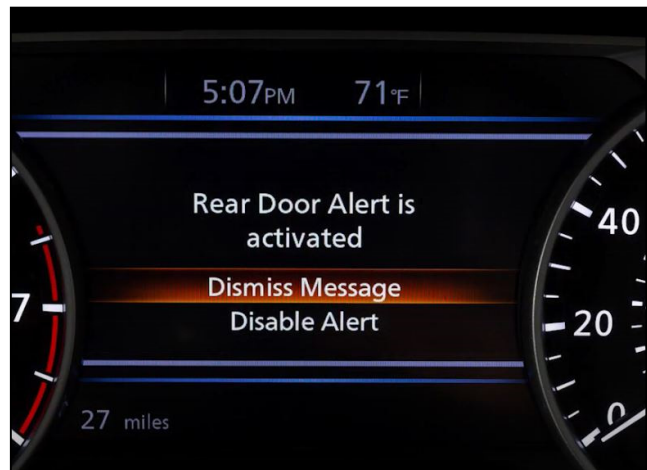
- When the rear door alert is active, the message in Figure 4 appears to remind the driver to check the rear seat.
 - If desired, **Dismiss Message** can be selected to clear the display.
 - If desired, **Disable Alert** can be selected to disable the rear door alert for the current trip.
 - If no selection is made, this message will disappear after a period of time.

- The rear door alert system is activated when the vehicle is driven within approximately 10 minutes of opening a rear door.
 - Once the system is activated, **the horn will sound (if selected) and the vehicle information display message will display on every trip UNLESS** deactivated by one of the two methods:
 - The driver opens a rear door within a short time after arriving at their destination.
 - **Disable Alert** is selected in the vehicle information display (Figure 4).
