# AfterSales Diagnostic Sheet

**MAS002381**

## USB HUB port Anomalies Diagnostic Guide

**Models:** M157/M156/M161 starting from MY17

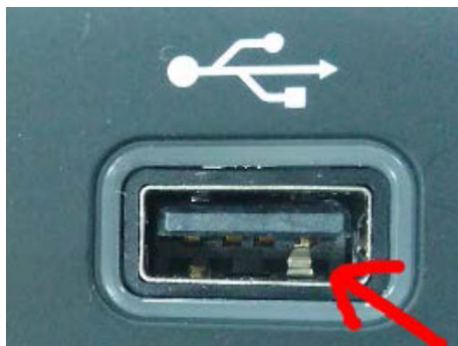
- Perform a visual inspection to verify there are no internal or external damage to the ports such as:
  - Missing, broken or bent Pins,

Figure 1: example of Missing or broken Pins

- yes -> The malfunction is caused by clear external damage and/or improper usage of the component..
- no -> go to step 2

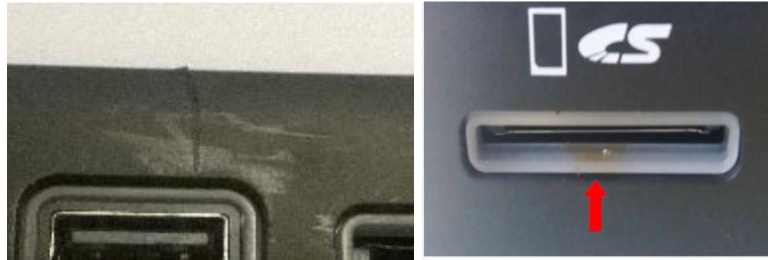
- cuts or breaks in the plastic frame,

Figure 2: example of cuts or breaks of the plastic frame

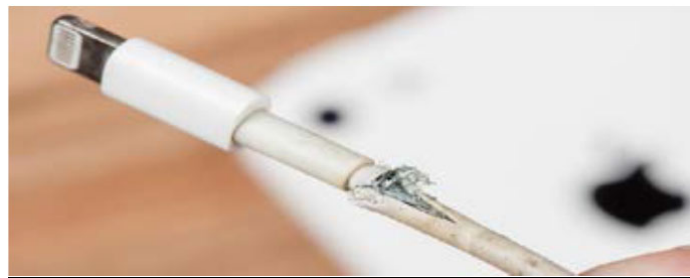
**NOTE:** If the anomaly is related to a Carplay connection or to a phone not charging, make sure the USB cable used to connect the phone to the HUB is original, that it does not show any sign of twisted or pinched wires, and that the two plugs ends are intact and clean.  
If any of the above is present, perform the test with an original and intact cable..

Figura 3:example of damaged cable

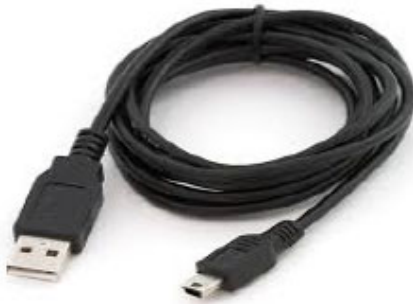
- no -> If you are in possession of a Laptop Computer and of a USB\_A to mini\_B cable (as shown figure 5) go to Step 4. Otherwise, submit a Blue on Line as Request for Authorization to claim (for M161 open a BOL as support request) selecting the USB HUB component, attaching the ETM DTC Report.

Figure 5: USB\_A to mini\_B
