### PIC6337A Rattle Noise from Exhaust

Brand:	Model:	Model Years:	VIN:		Engine:	Transmissions:
			from	to		
Chevrolet	Camaro	2018 - 2021	All	All	LGX	All

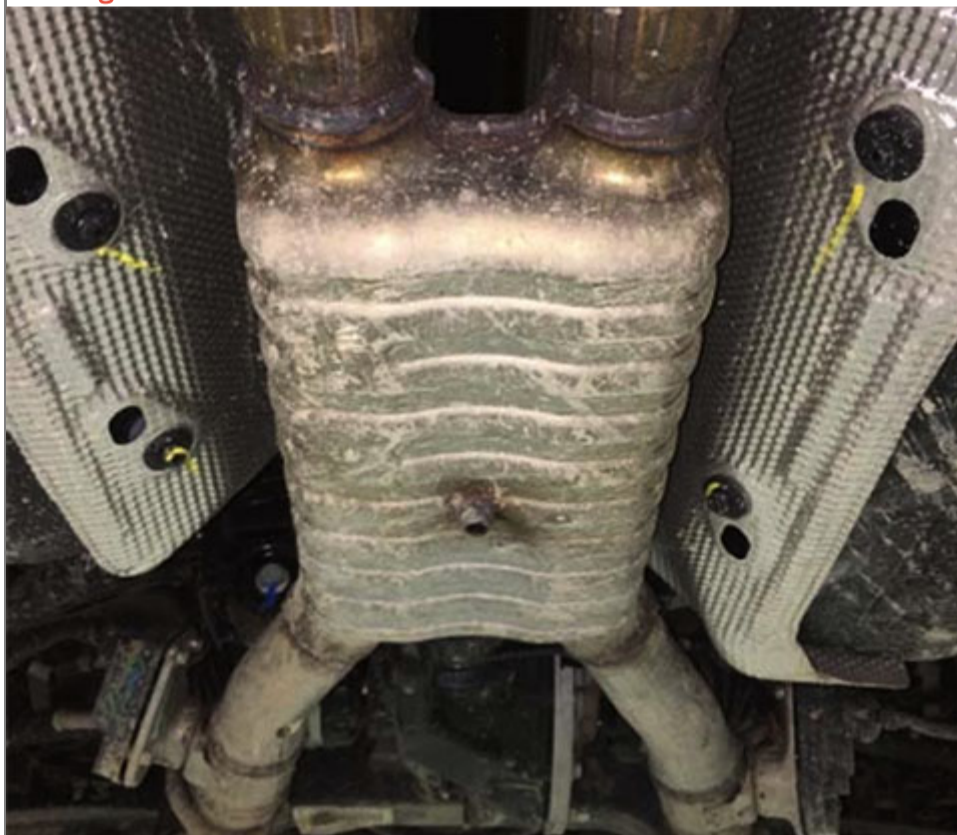
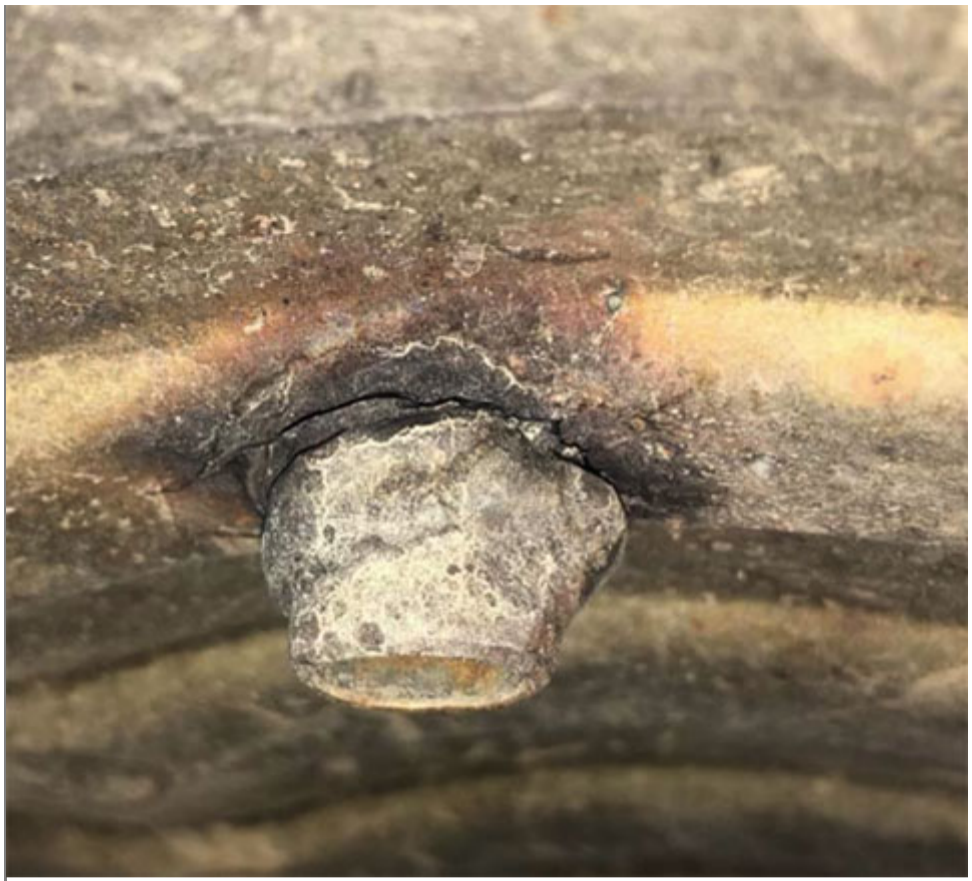
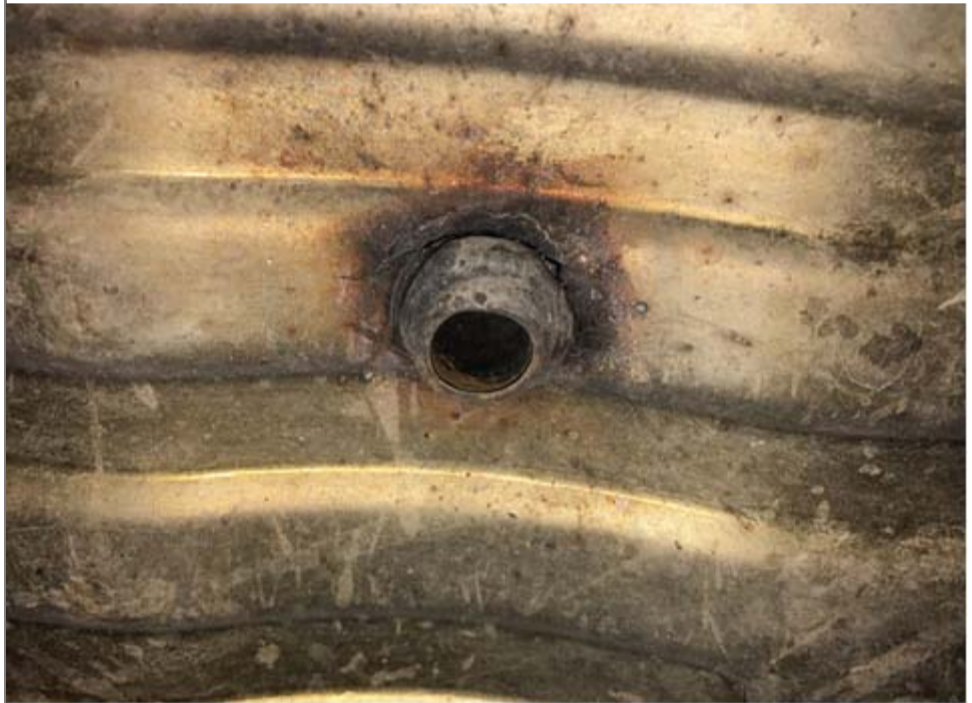
Some customers may comment about an exhaust rattle coming from the vehicle. Many technicians will automatically look at the exhaust valves for noise concerns. Before any repair is made, dealership technicians should also look at the resonator for the source of this concern. There is a tube that is located in the center of the resonator that can be seen in the first photo below. This is NOT a drain tube for condensation inside the exhaust system. This pipe is actually a structural component of the resonator that stiffens the upper and lower halves of the assembly. The welds holding this tube in place may crack, resulting in a rattle noise that can be heard by the owner of the vehicle. This will be most noticeable when starting the engine / applying the throttle.

**Note:** Corrosion alone will not cause this concern. The quality of the actual welds is the issue. Dealership technicians are to inspect both the lower weld on the bottom of the resonator, as well as the upper weld on top of the resonator for signs of cracking.

**Correction:**

If the concern listed above has been found, dealership technicians are to replace the rear portion of the exhaust system.
