Tesla, Inc. Service Bulletin		<i>Inspect X950 and X952 for Damaged Electrical Circuits</i>	
SB-20-17-010 November 3, 2020		R1	
Classification Campaign Bulletin		Section/Group 17 - Electrical	Mobile Service Cannot Perform
Model Year 2017–2020	Model Model 3	Country/Region All	Version All
<small>The model(s) and model year(s) listed are a general approximation of the affected VIN list. Refer to the VIN/Bulletin Tracker or Customer/Vehicle profile to determine applicability of this bulletin for a particular vehicle.</small>

On certain Model 3 vehicles, an open electrical circuit or short to ground near connectors X950 or X952 may display a restart alert on the touchscreen, or prevent the vehicle from starting altogether.

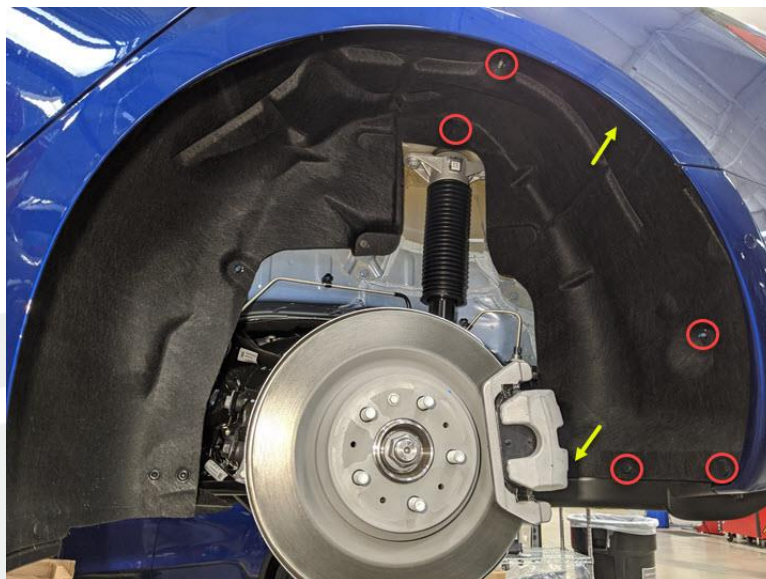
Figure 1

1. Remove the LH and RH rear wheels (refer to Service Manual procedure [34015001](#)).
2. Release the clips (x7) that attach the rear portion of the LH rear wheel arch liner to the vehicle (Figure 1).

7. Release the LH rear wheel arch liner from the brake rotor, and then install the clips (x7) that attach the arch liner to the body (Figure 1). Repeat this step for the RH side.
8. Install the LH and RH rear wheels (refer to Service Manual procedure [34015001](#)).

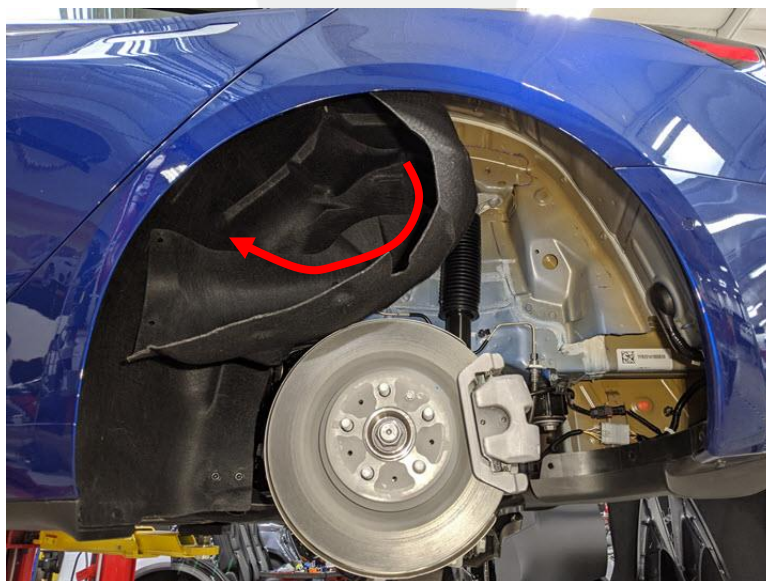
Figure 2

3. Move the arch liner so that it rests on the brake rotor as shown (Figure 2).

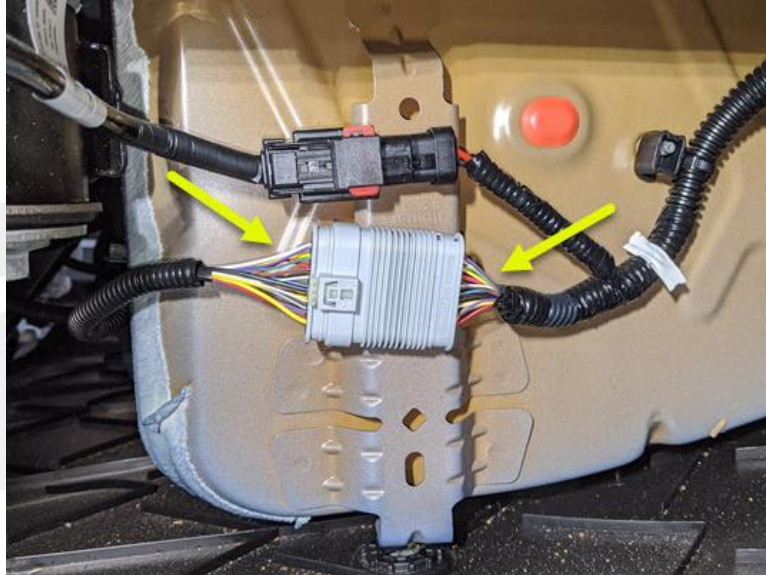
Figure 3

5. Inspect the electrical insulation on all electrical wires at the LH body harness electrical connector X950 (Figure 3):

**NOTE:** Clean the electrical wires at X950 with an Isopropyl Alcohol (IPA) wipe for better visibility, if needed.

- If the electrical insulation on all electrical wires at X950 is undamaged, continue to the next step.
- If the electrical insulation is damaged on any of the electrical wires at X950 (Figure 4), repair the damaged electrical wire(s) as described in [SI-17-17-002](#), “Electrical Harness Repair”.

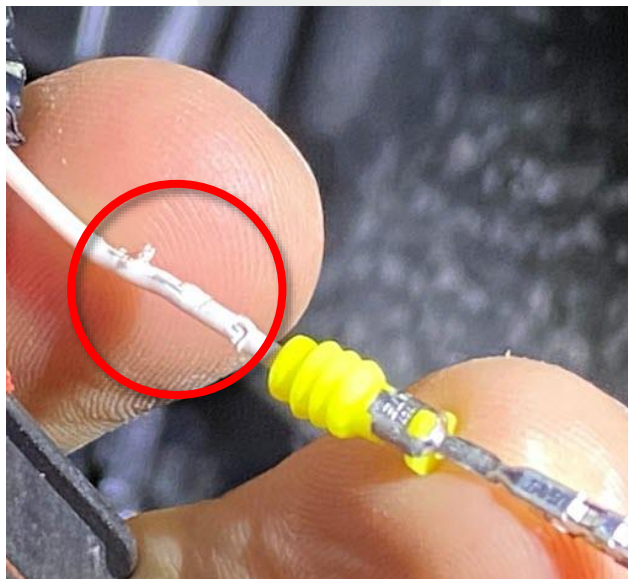
Figure 4 – Sample of typical damage of electrical wire

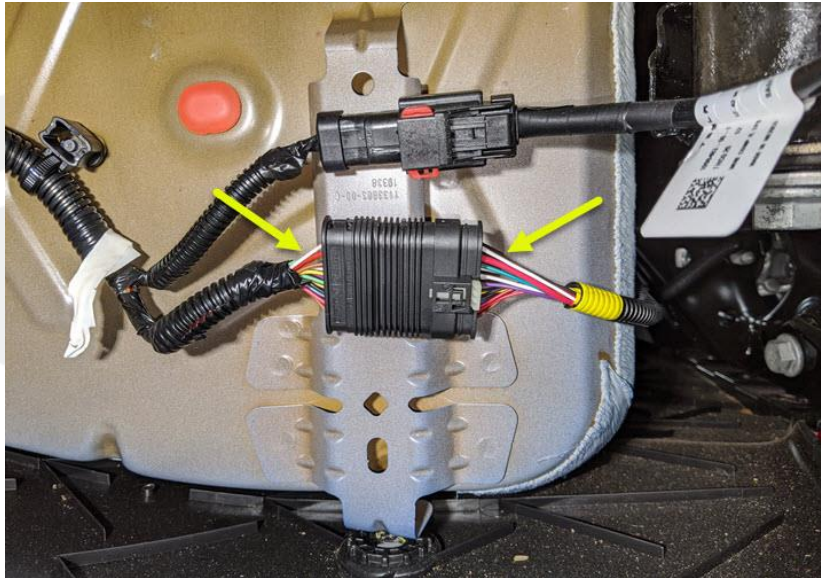
Figure 5

6. Inspect the electrical insulation on all electrical wires at the RH body harness electrical connector X952 (Figure 5):

**NOTE:** Pay close attention to electrical wires on terminals 8 and 9 (red/white wires). These are the HVIL electrical circuits that are damaged most often.

- If the electrical insulation on all electrical wires at X952 is undamaged, continue to the next step.
- If the electrical insulation is damaged on any of the electrical wires at X952 (Figure 6), repair the damaged electrical wire(s) as described in [SI-17-17-002](#), “Electrical Harness Repair”.

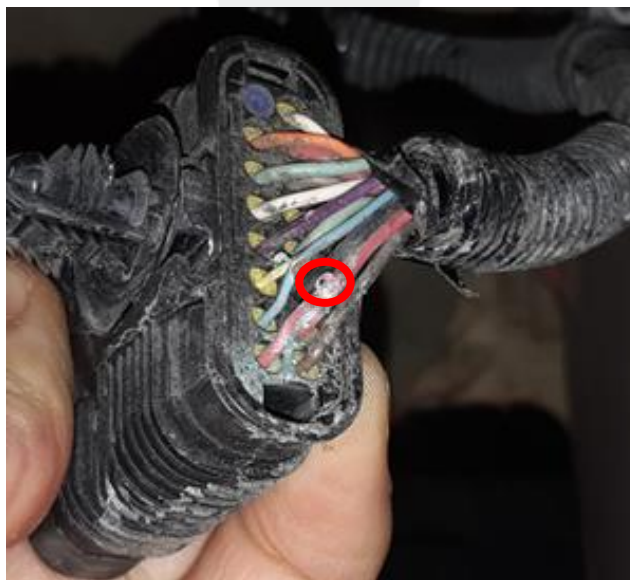
Figure 6 – Damaged electrical circuit at X952
