## UPDATE FROM WARRANTY OPERATIONS

## FIXED FIRST VISIT IMPROVEMENT

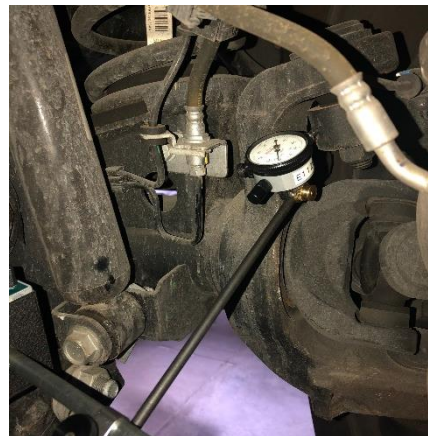
1. Raise and support the vehicle.
2. Turn the steering wheel into one direction until it is fully locked.
3. Use the dial indicator (C-3339A) with the magnetic base attached to the side of the axle tube yoke bracket and the plunger of the dial indicator resting on the steering knuckle as close as possible to the upper ball joint attachment point.

1. Verify no movement in the ball joint nut.
2. Add together the 2 measurements taken; if the sum is greater than 0.06 in (1.52 mm), please follow the Service Library procedure to replace the ball joint. Please record in the warranty claim narratives the measurements recorded in the diagnosis procedure.
3. If the sum of the 2 measurements is less than or equal to 0.06in (1.52mm), please don't change the ball joint and review other components.

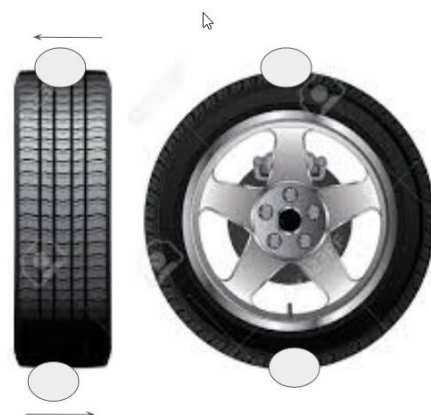
4. Set the dial indicator to zero.
5. Grasp the tire with both hands in the 12 o'clock and 6 o'clock position then push in on the top of the tire and pull out on the bottom of the tire. Record the reading on the dial indicator.

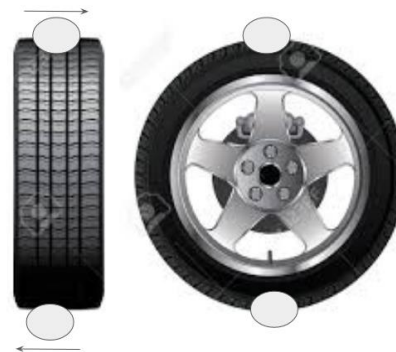
1. Verify no movement in the ball joint nut.
2. Set the dial indicator to zero.
3. Grasp the tire with both hands in the 12 o'clock and 6 o'clock position then pull out on the top of the tire and push in on the bottom of the tire. Record the reading on the dial indicator.

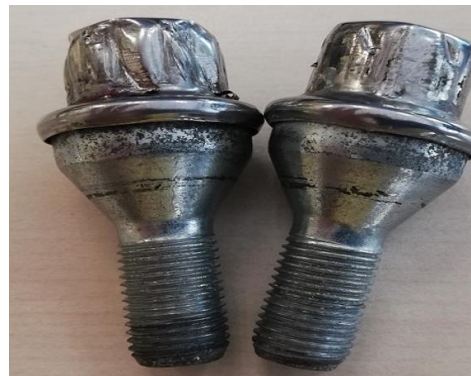
A technician may find the wheel lug nuts difficult to remove from a “swollen” condition or the lug nut caps have been damaged or have fallen off.

Conditions as indicated above are caused by the failure to use a 17MM - six sided socket to remove the lug nuts. A 17MM six sided socket is **mandatory** to remove these lug nuts properly. Damaged or swollen lug nuts claimed as

warranty will be charged back as not a defect in material or workmanship. This condition could be considered for Consumer Goodwill by using the 85-85-CG-09 LOP as a related lop for the repair. Business Center approval will be needed for this to be considered for Consumer Goodwill.

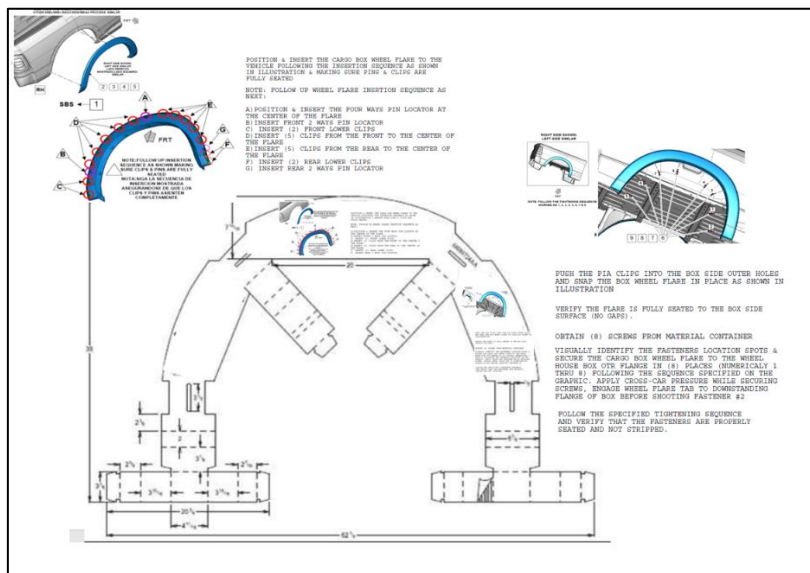
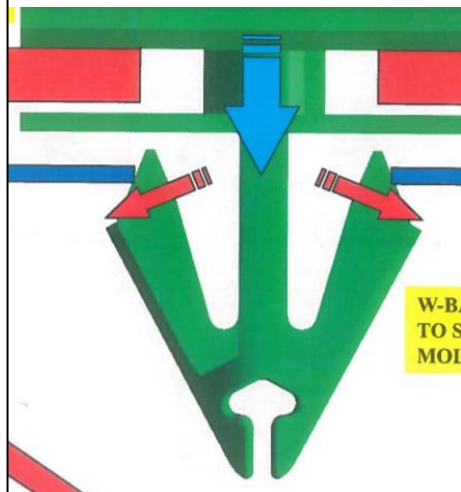
We have seen a number of warranty claims for reinstallation of Rear Wheel Flares on RAM 3500 Dual Rear Wheel vehicles. These vehicles are shipped to your dealership with the wheel flares packaged inside the vehicle, and require dealer installation at PREP. Any issues with gaps between the body panel and the wheel flare indicates poor workmanship during dealer installation of the flare clips and cannot be

considered a warrantable condition. The instructions on the box, the wheel flares are shipped in, MUST be followed very closely, and in exact order, to assure a proper clip installation to the body. Failure to follow those instructions will cause clip gaps to appear between the flare and the pick-up box side. Below are those instructions. Wheel Flare warranty claims filed for reinstallation or replacement due to poor installation of the Flare clips in the body will be charged back.
