# Service Bulletin

Bulletin No.: 17-NA-216

**Subject: Convertible Top Back Glass Separation from Top Cover Material**

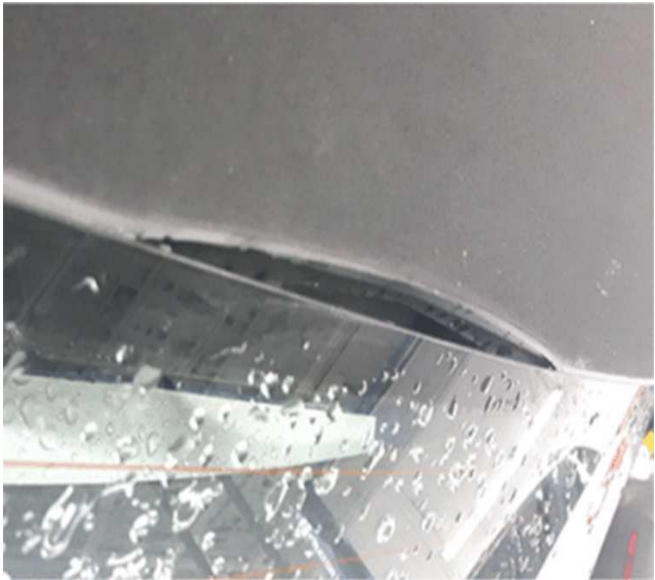
4794660

<b>Involved Region or Country</b>	North America, Europe, Middle East, Israel, Argentina, Brazil, Bolivia, Chile, Colombia, Ecuador, Paraguay, Peru, Uruguay, Japan
<b>Condition 1</b>	<p>Some customers may comment on seeing the back glass separating from the convertible top cover material.</p> <p>Several examples of the separation are shown in the graphic examples below:</p> <div style="text-align: center;">

<p>4794112</p> <p>It will be necessary to replace the convertible top cover (1). Refer to <i>Folding Top Cover Replacement</i> in SI.</p>

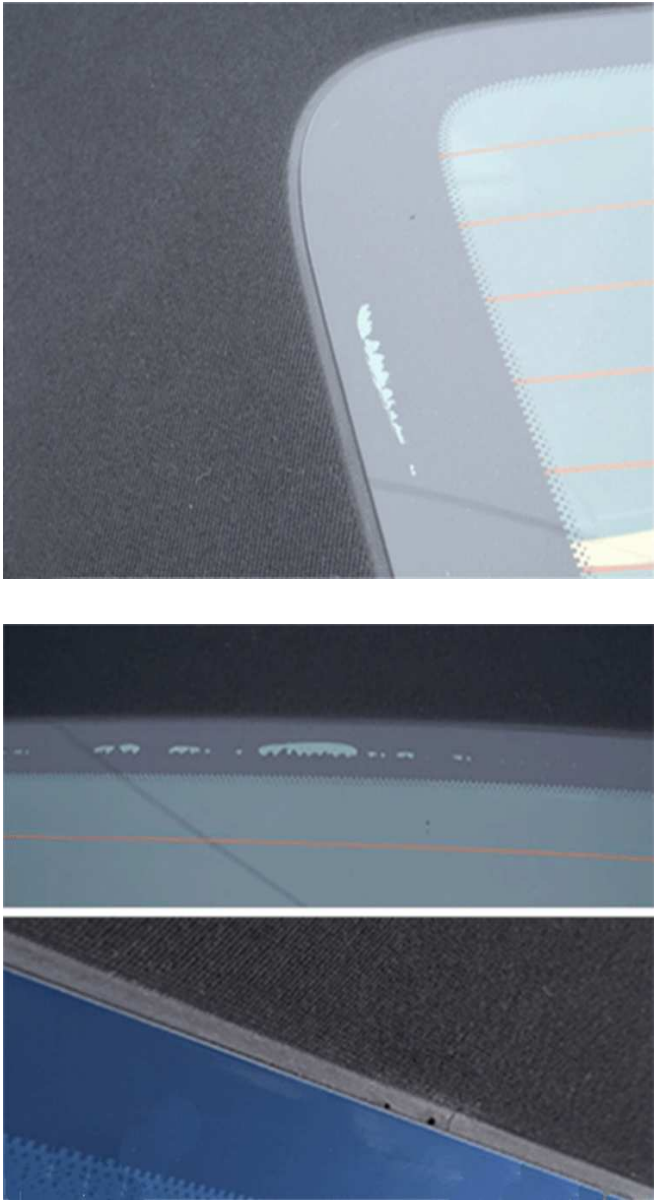
<p>4794670</p> <p>4794682</p>
<p><b>Cause 1</b></p>	<p>The cause of this condition may be an insufficient amount of primer used during the assembly process, which creates stress points allowing the material to separate from the glass.</p>

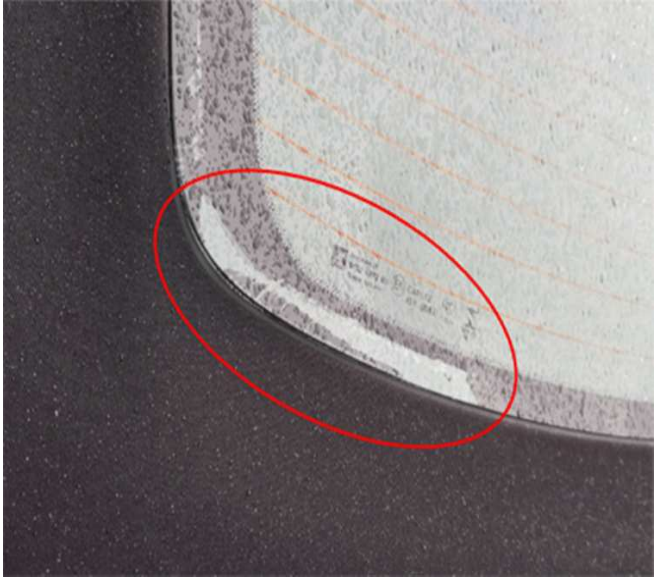
<p>5049793</p> <p>Some customers may comment that the vehicle may exhibit a condition where the back glass is separating from the top. This condition will typically start in the corner of the back glass.</p>
<p><b>Cause 2</b></p>	<p>The cause of this condition may be the back glass separating from the bond.</p>
<p><b>Correction</b></p>

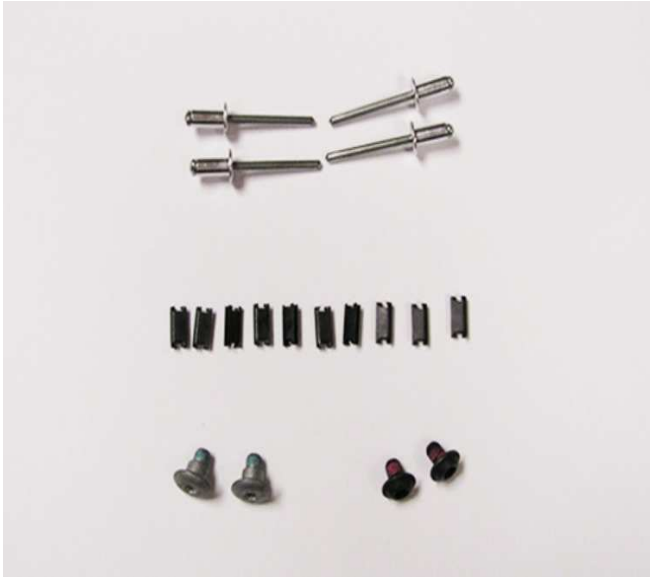
4588587

**Note:** When replacing the Buick Cascada top cover, it will also be necessary to order the fastener kit shown above. The fastener kit part number listed in the part table below contains non-reusable cover fasteners.
